# Short-Term Recommendations for Improving the Safety of High Crash Locations in Rural Aroostook County

December 2018

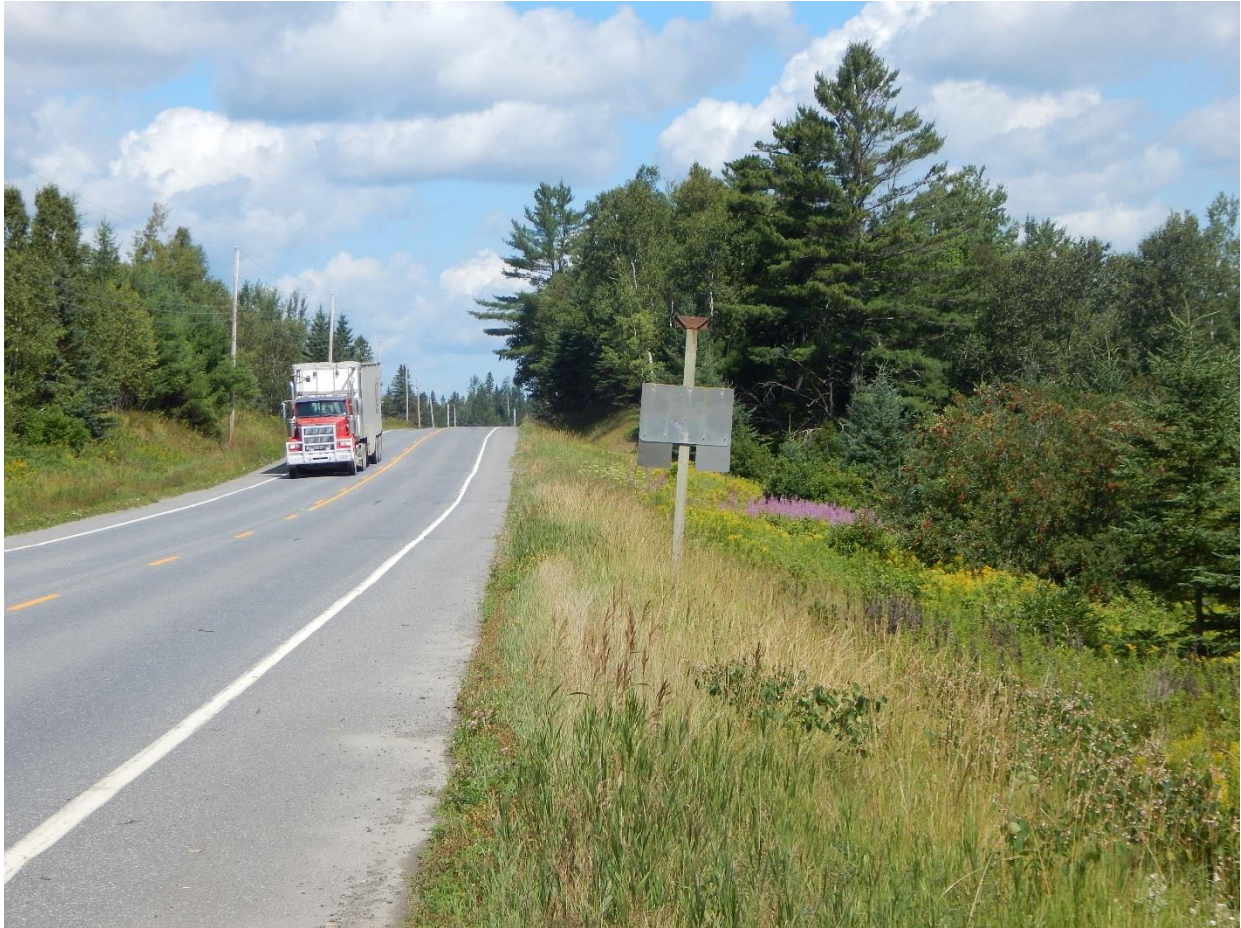
Portage Road looking north toward Wrightville Road. Seasonal Deer Crossing sign is covered (uncovered during the winter months). Notice vegetation close to road to the north.

- Continue to work with landowners to adjust wildlife feeding locations, especially during the winter months.
- Consider the creation of educational programs for driver concerning the presence of high concentrations of deer.
- Consider trimming/removing vegetation to the greatest practical extent along link to improve visibility and potentially improve road surface conditions during the winter months.
- Consider installing additional Speed Limit signage.
- Consider installing flashing Deer Concentration signs that can be turned on in the winter months.

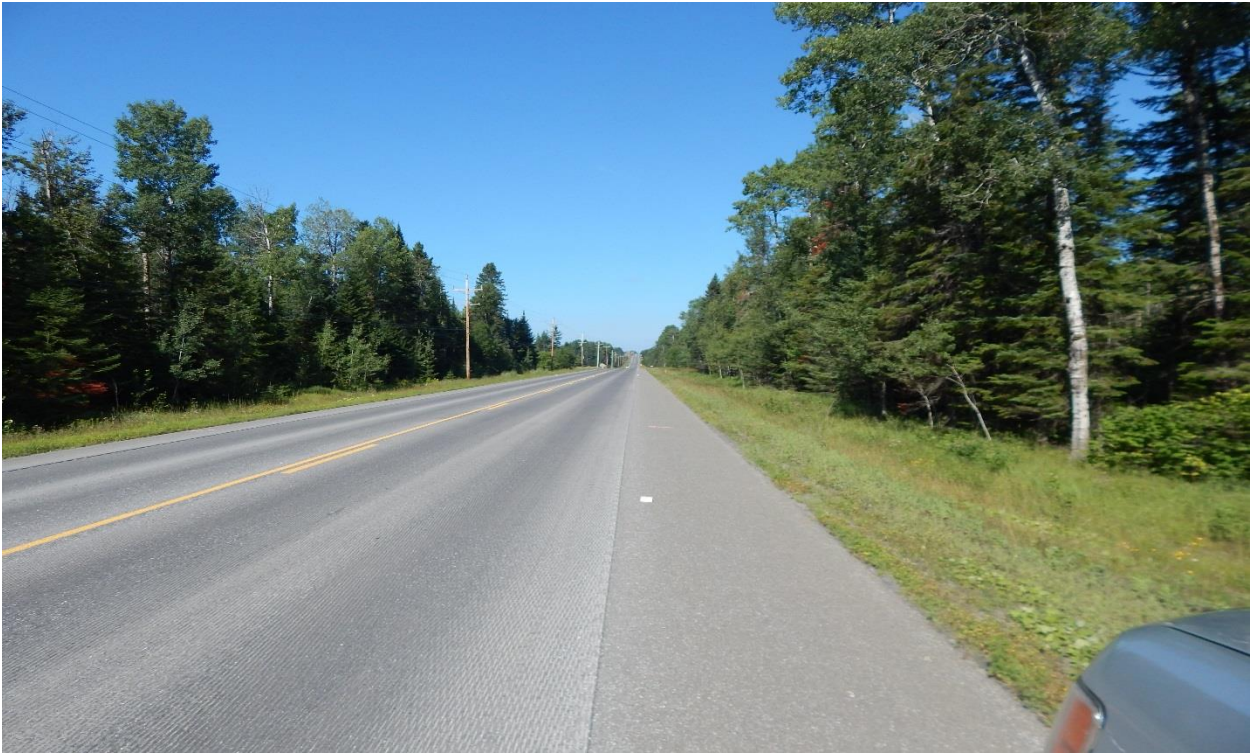
Presque Isle Road (Route 163) looking west towards Ashland. Note vegetation close to road.

- Continue to work with landowners to adjust wildlife feeding locations, especially during the winter months.
- Consider trimming/removing vegetation to the greatest practical extent along link to improve visibility and potentially improve road surface conditions during the winter months.
- Consider installing flashing Deer Concentration signs that can be turned on in the winter months.

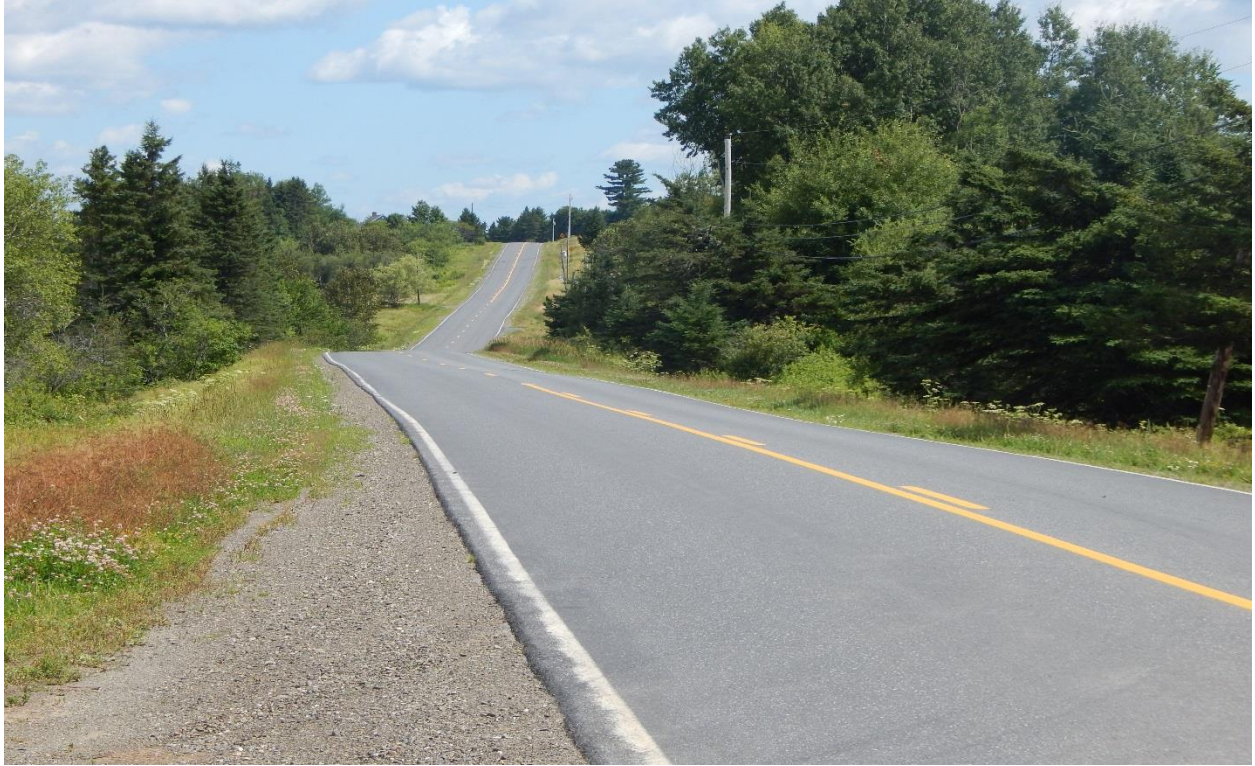
Route 227 looking east. Note decreased visibility due to vegetation.

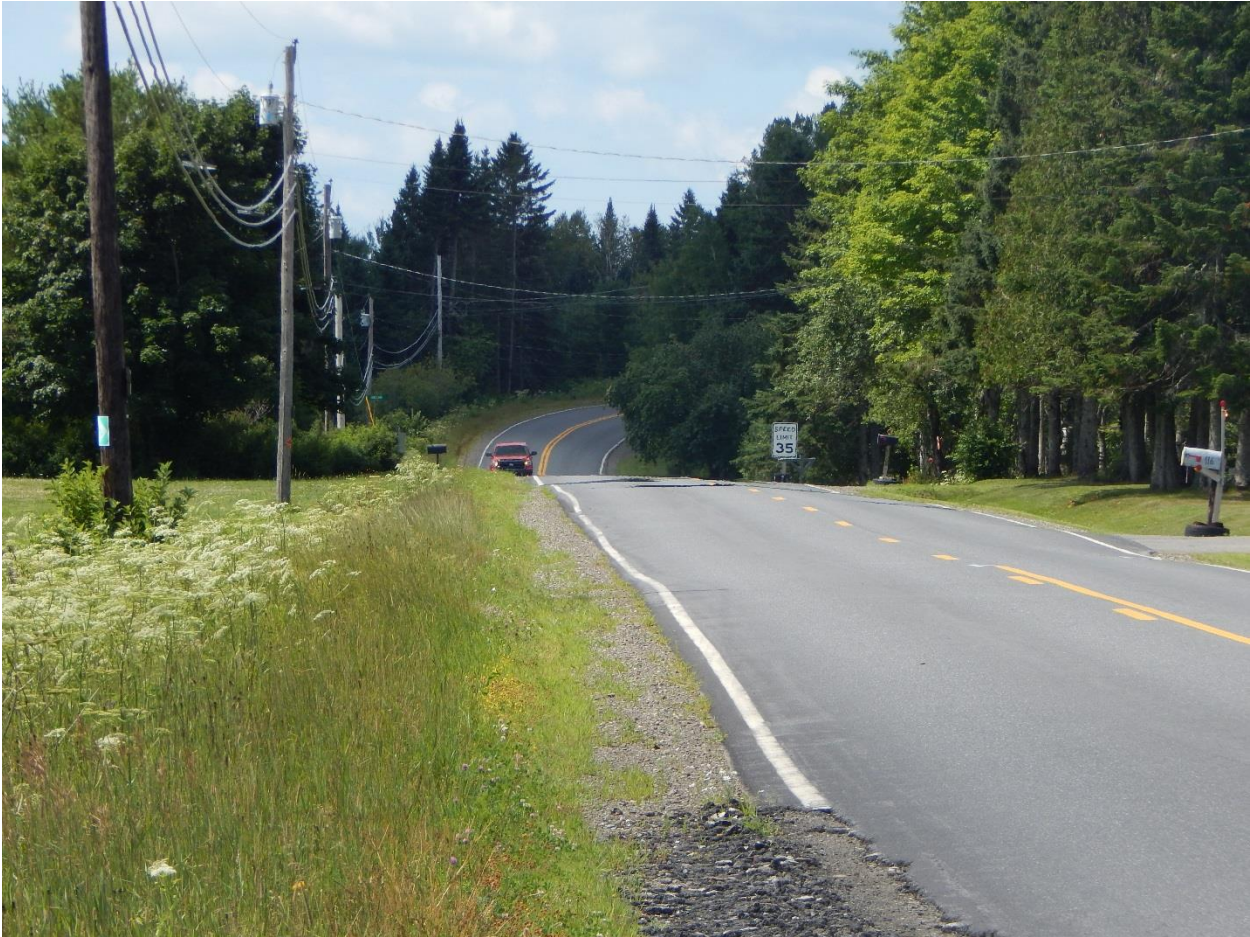
Route 227 looking east. This is a known deer crossing area.

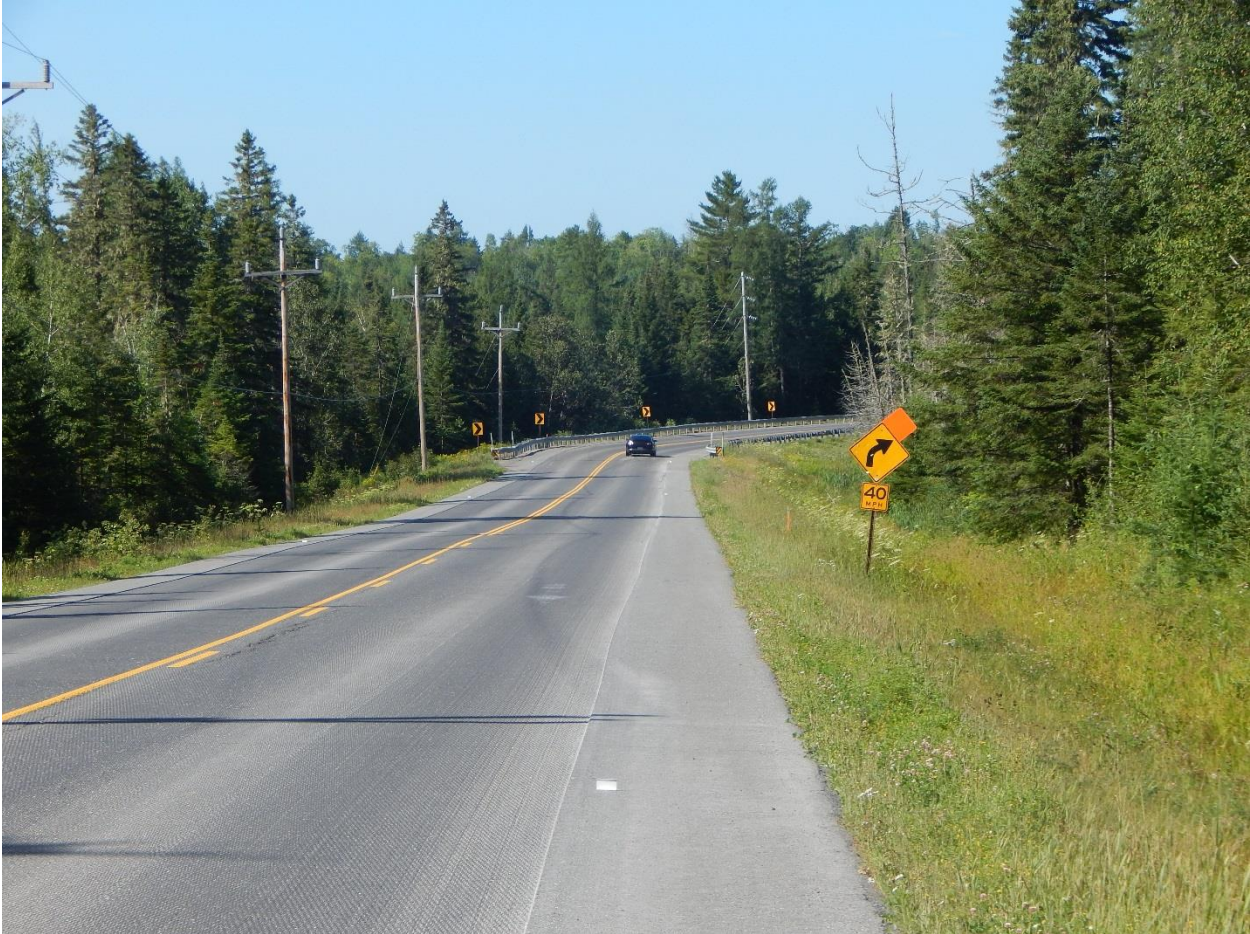
Presque Isle Road at the Ashland townline. Notice curve signs, guardrail, and speed reduction sign.

- Signage warning motorists of potential icy conditions at curve.

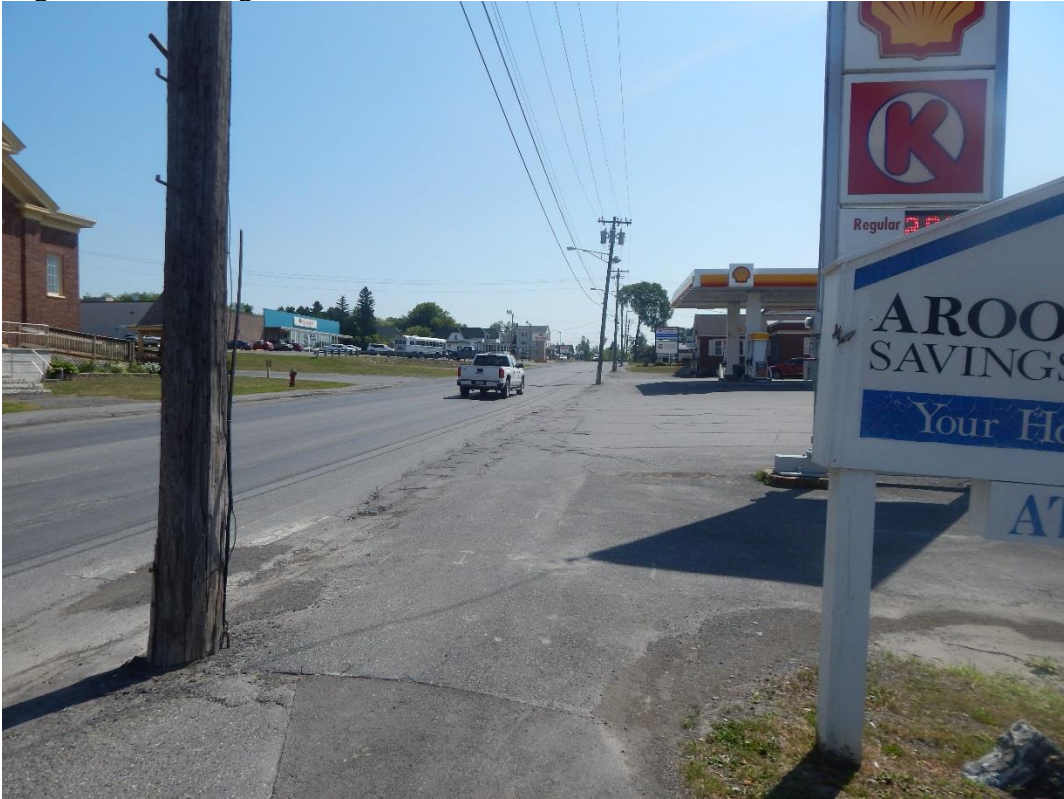
High Street looking east toward Goldfrank Dr. Notice the unrestricted access to local business.

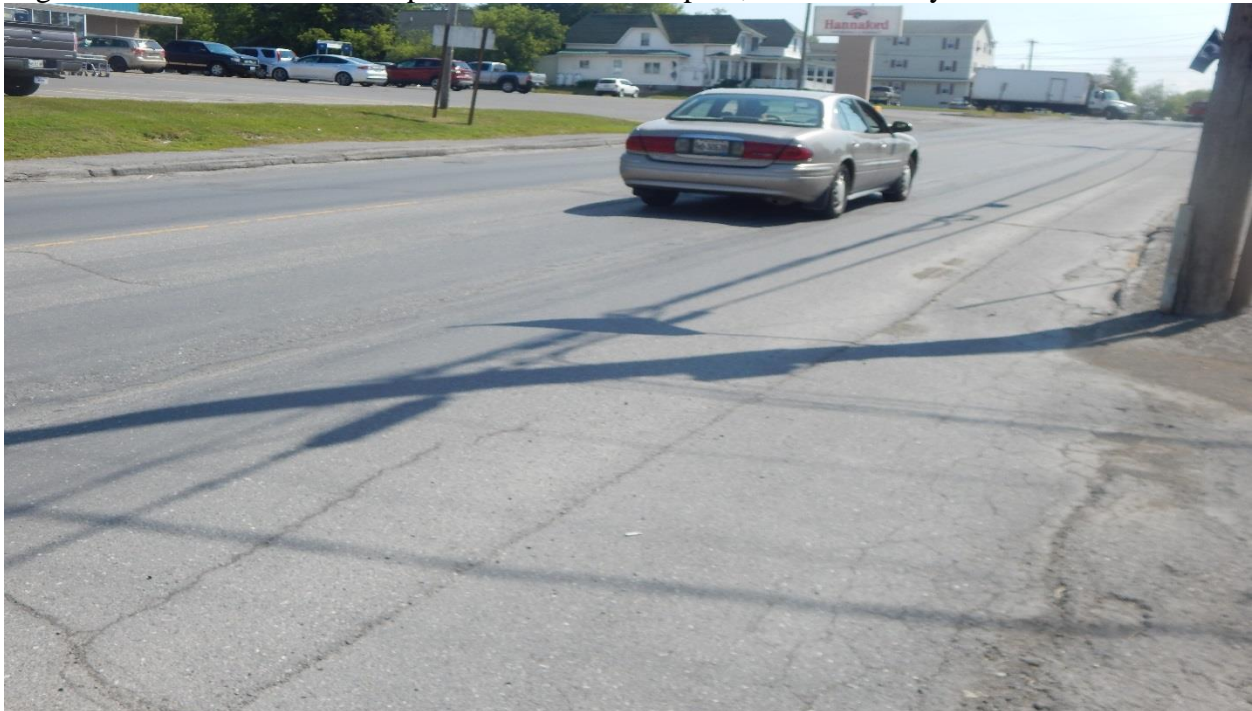
High Street east bound. While picture is hard to decipher, road is heavily rutted.

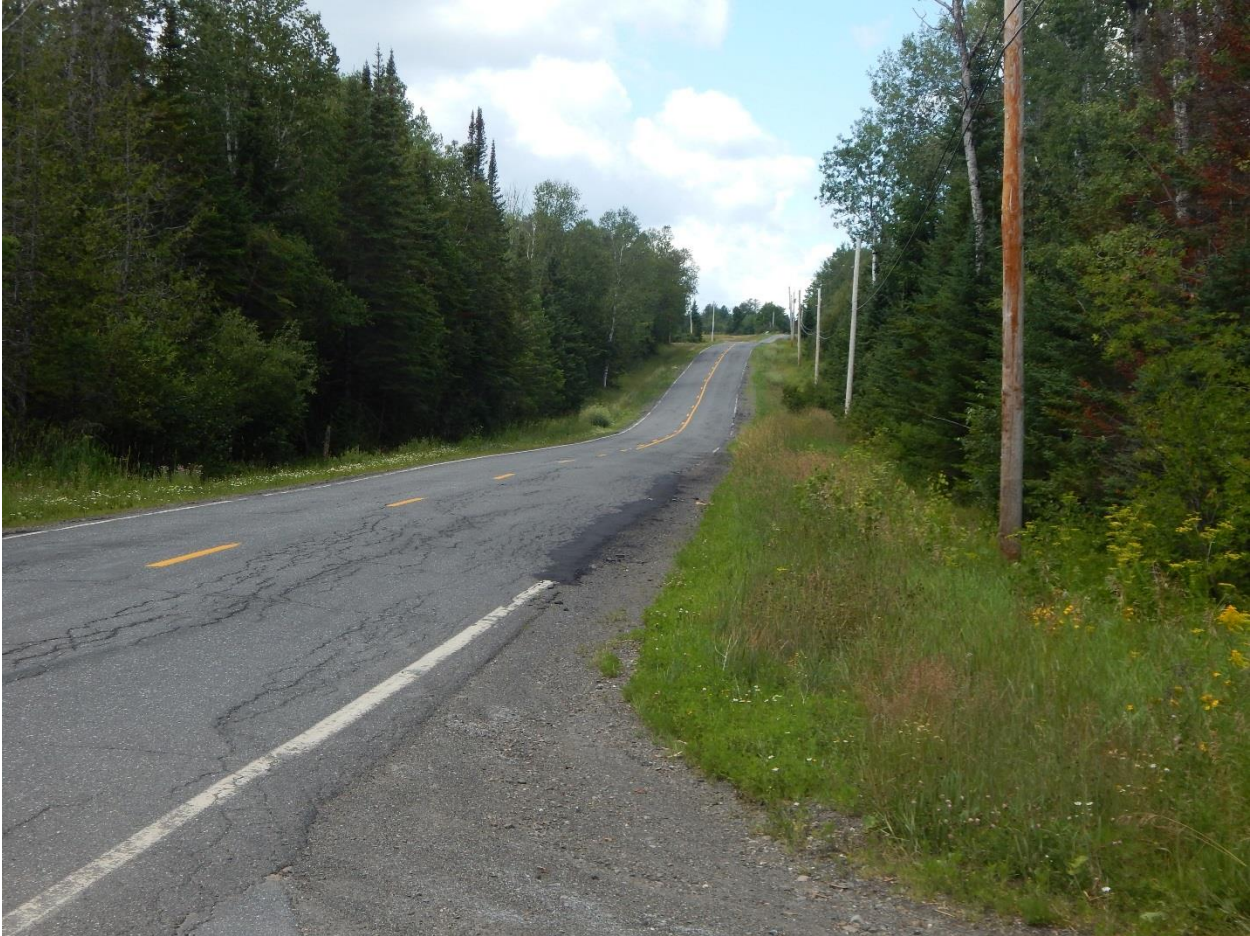
Route 227 looking west toward Ashland

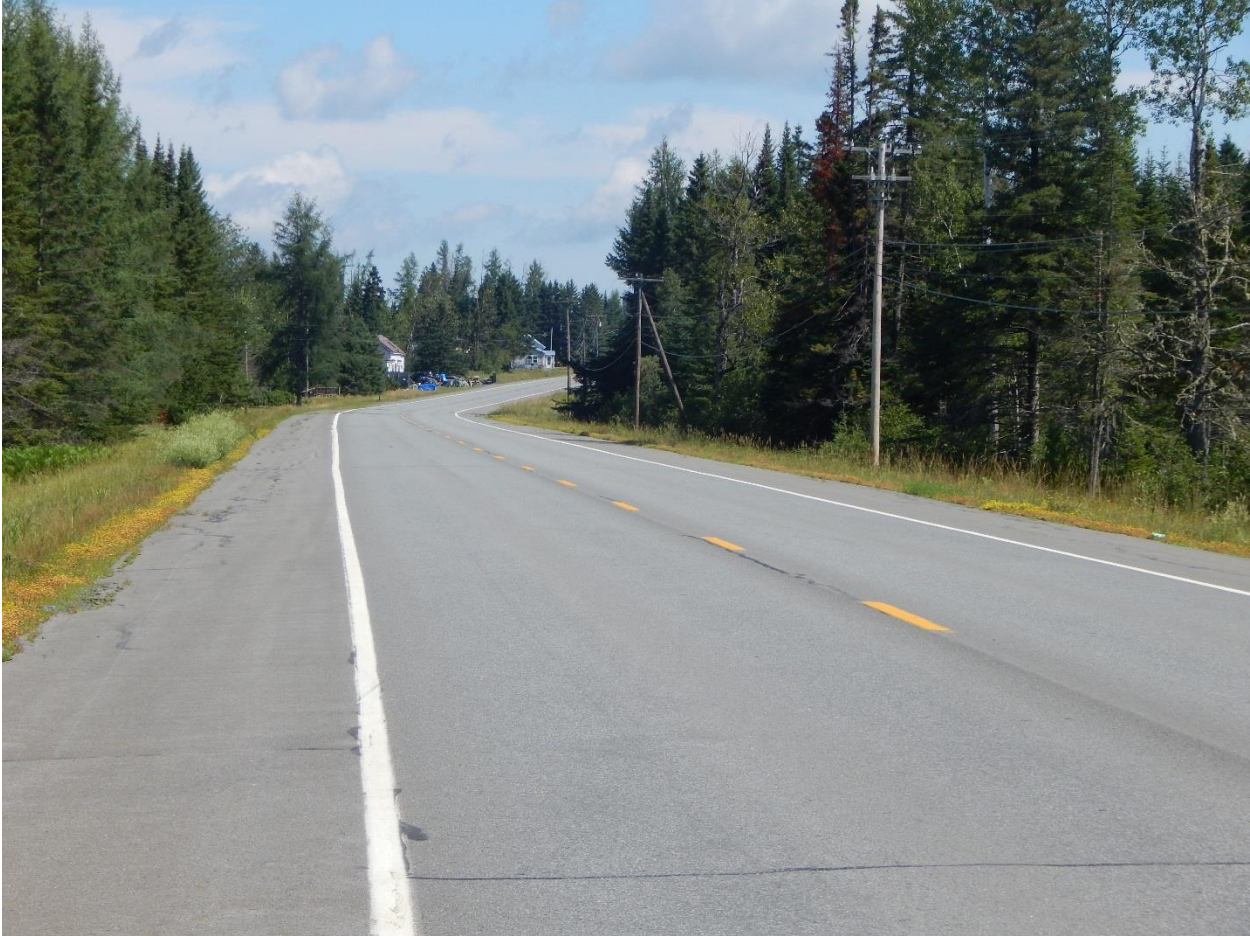
Vegetation close to road which is reducing sight distances.

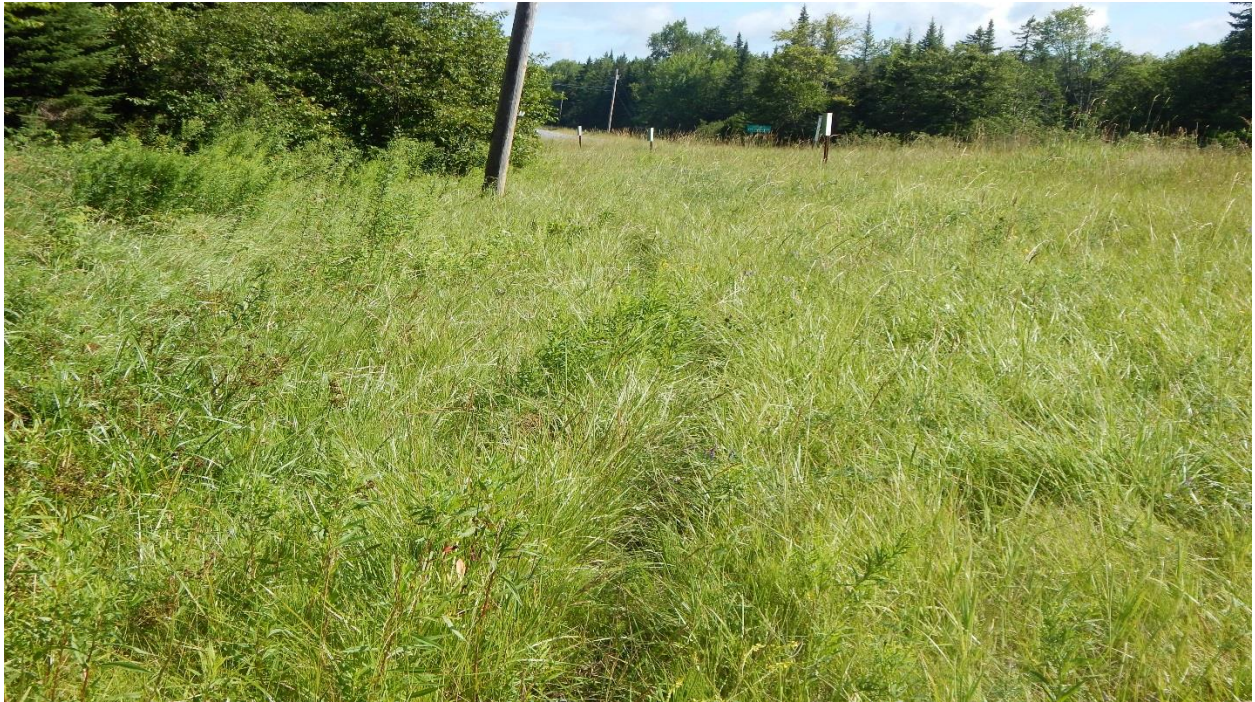
Moose trail and reflector system along link.

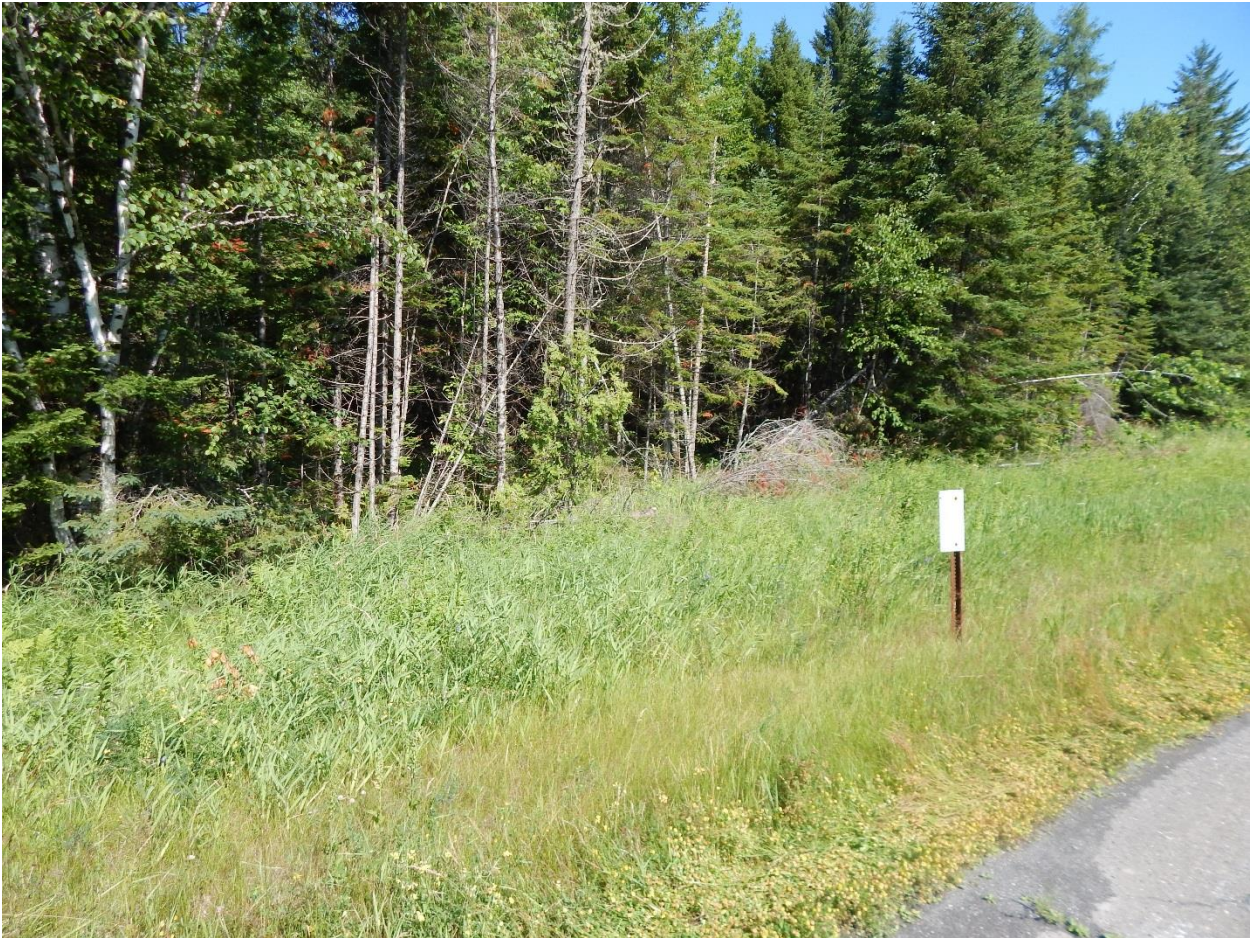
Tall grass behind reflector. Route 1 heading north in Cyr Plantation.

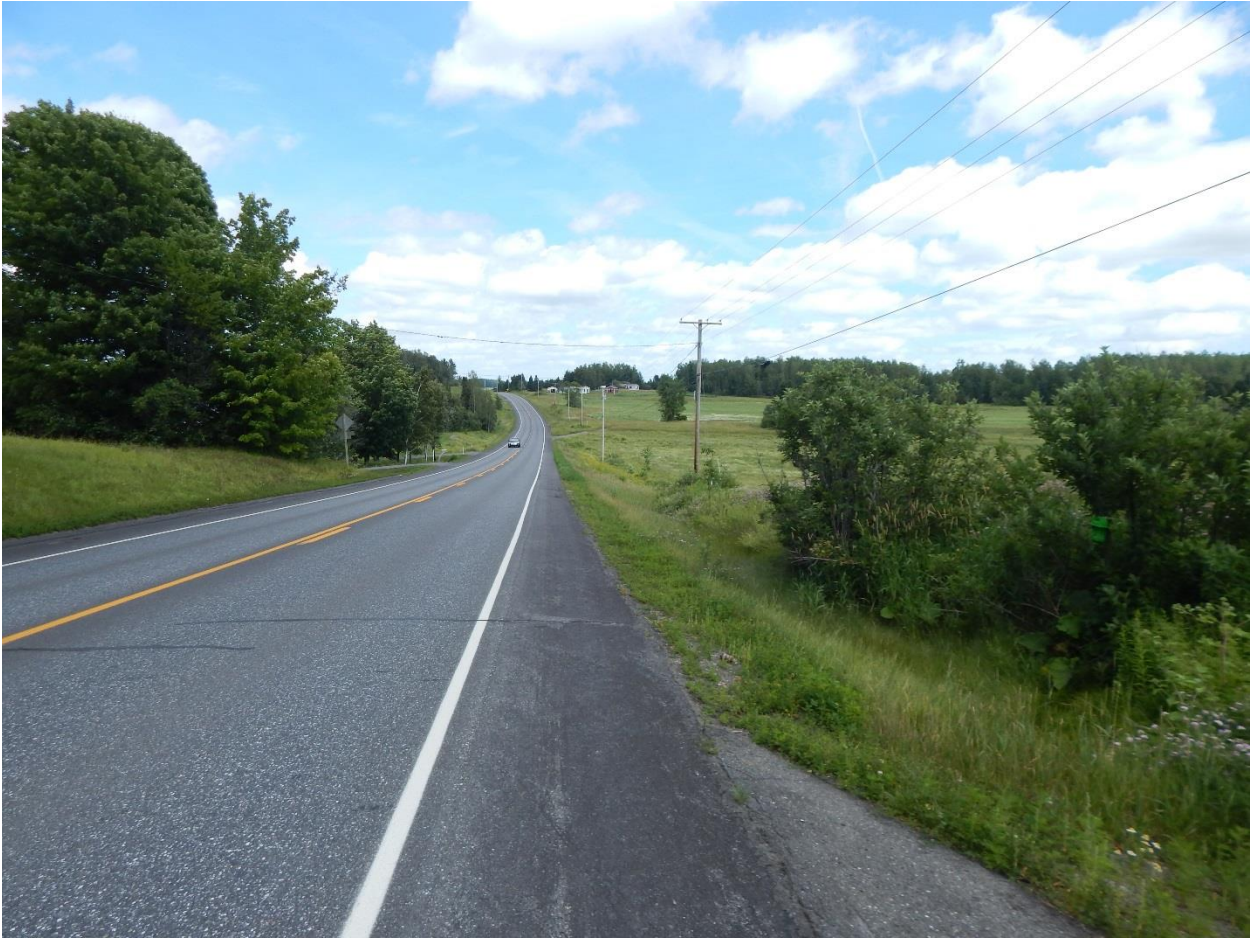
Presque Isle Road looking towards the Conant Road intersection. Typical deer and moose habitat. But notice the good sight distance.

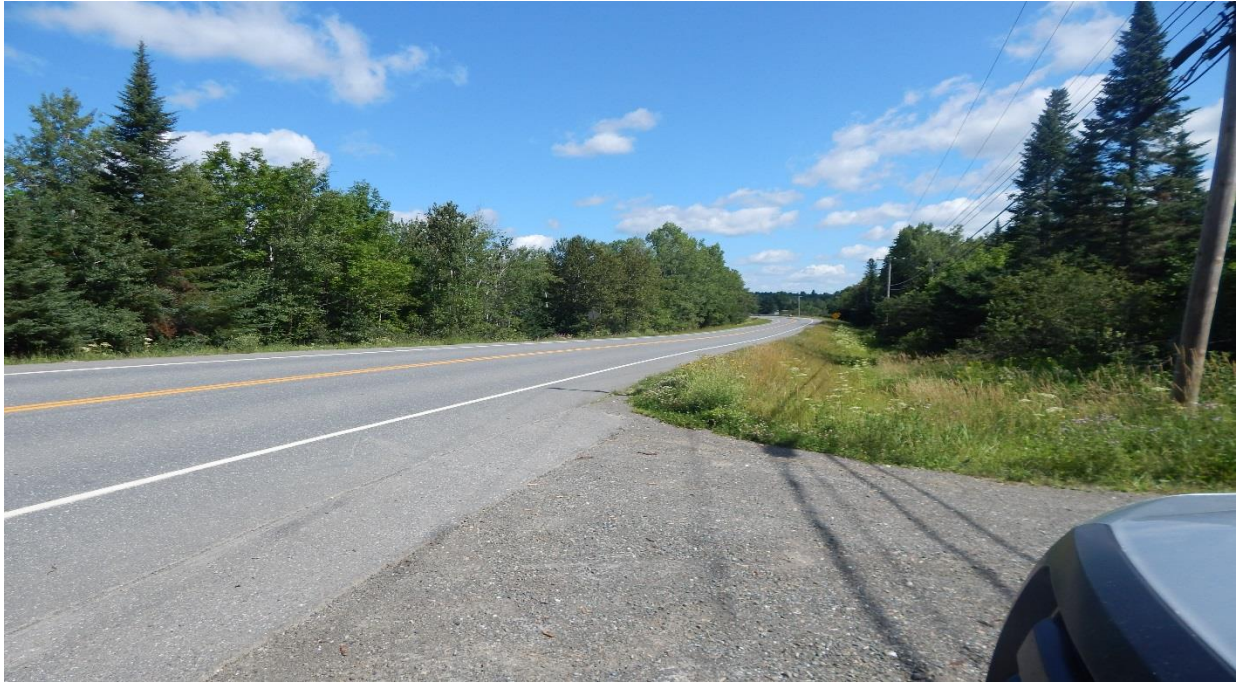
Masardis Road (Route 11) looking north toward Ashland. Passing zones are well marked. Notice vegetation close to road.

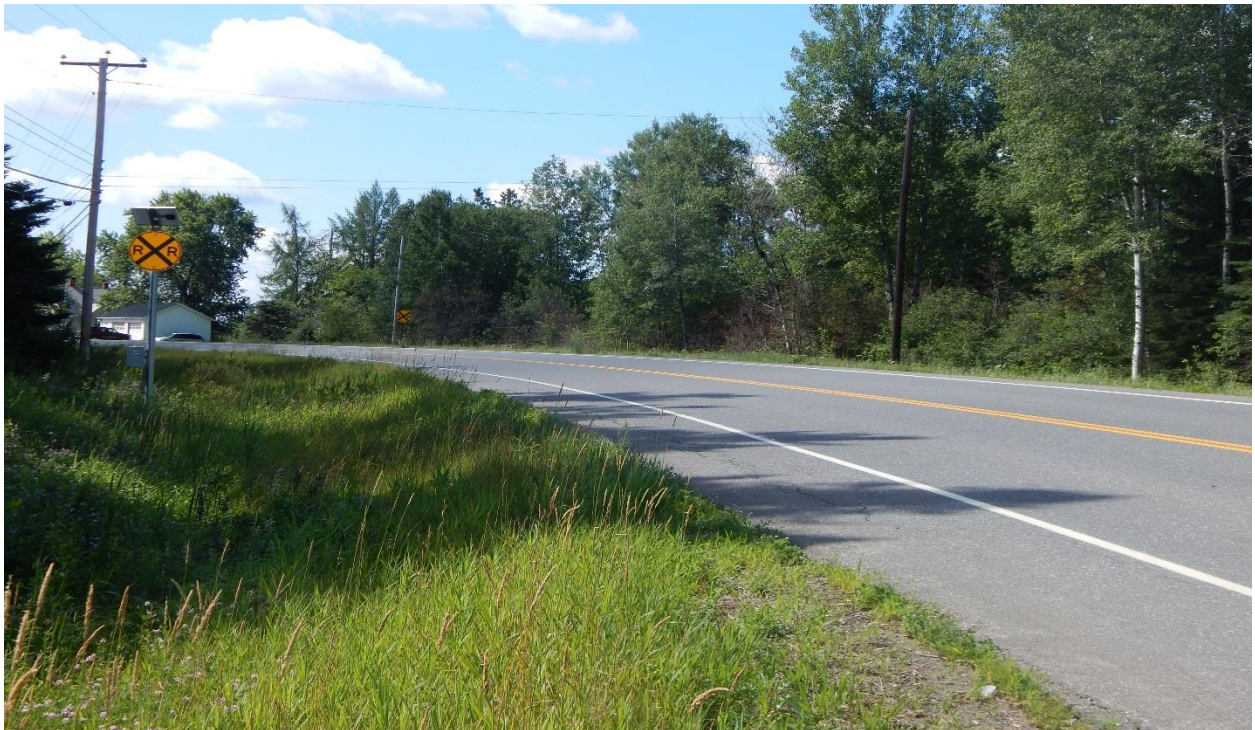
Same location looking south toward railroad crossing. Crossing is well marked. Vegetation is close to road.

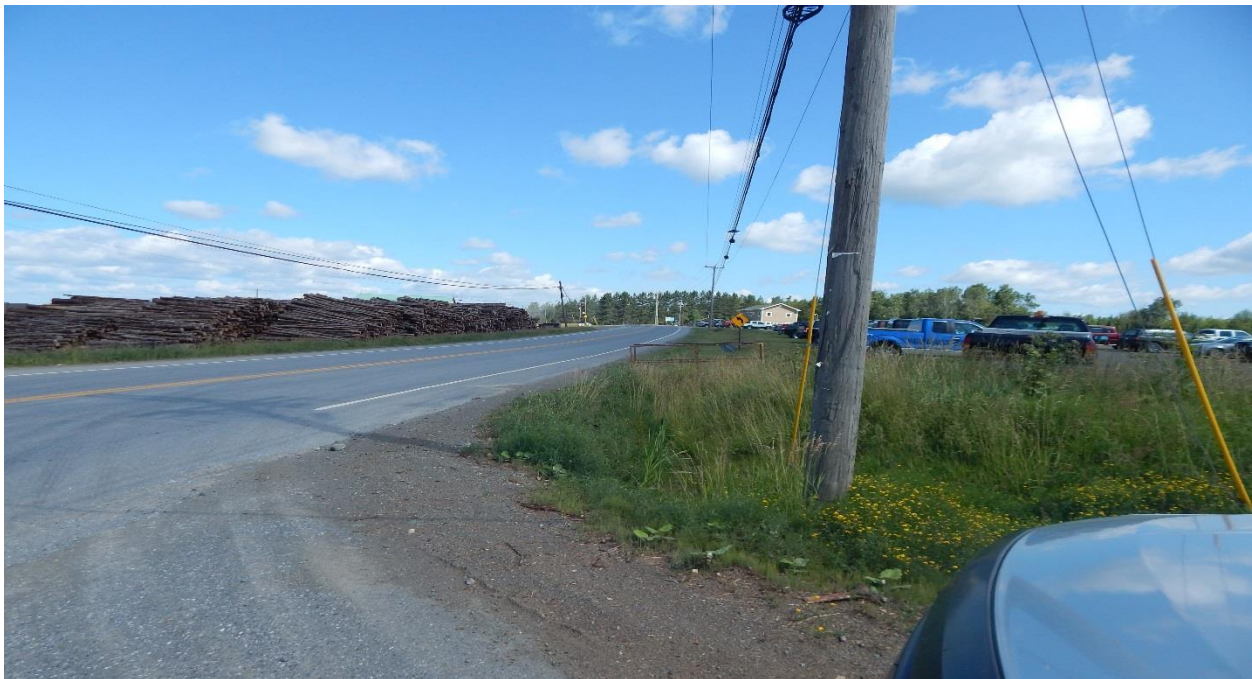
Masardis Road (Route 11) at the Sterling Ridge Road intersection. Notice mill parking across from mill and sharp curve sign.

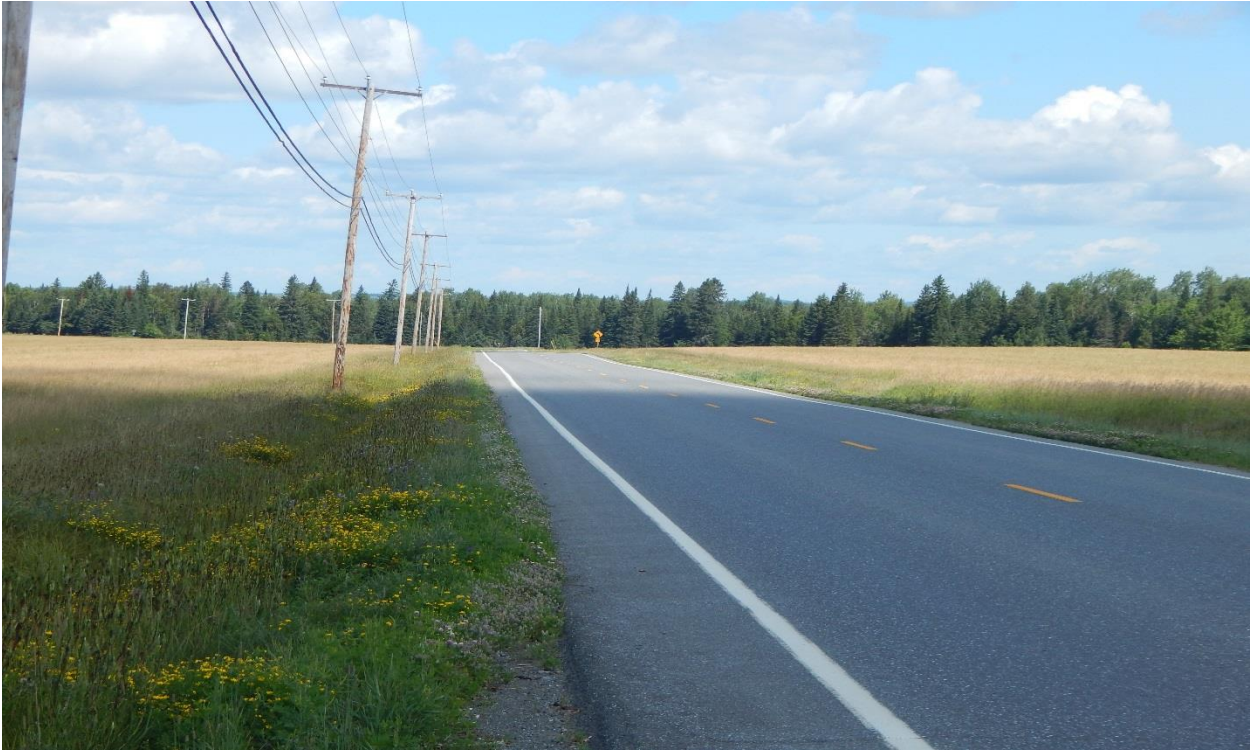
Masardis Road looking north towards Ashland townline and railroad crossing. Sharp curve marked as is passing zone.

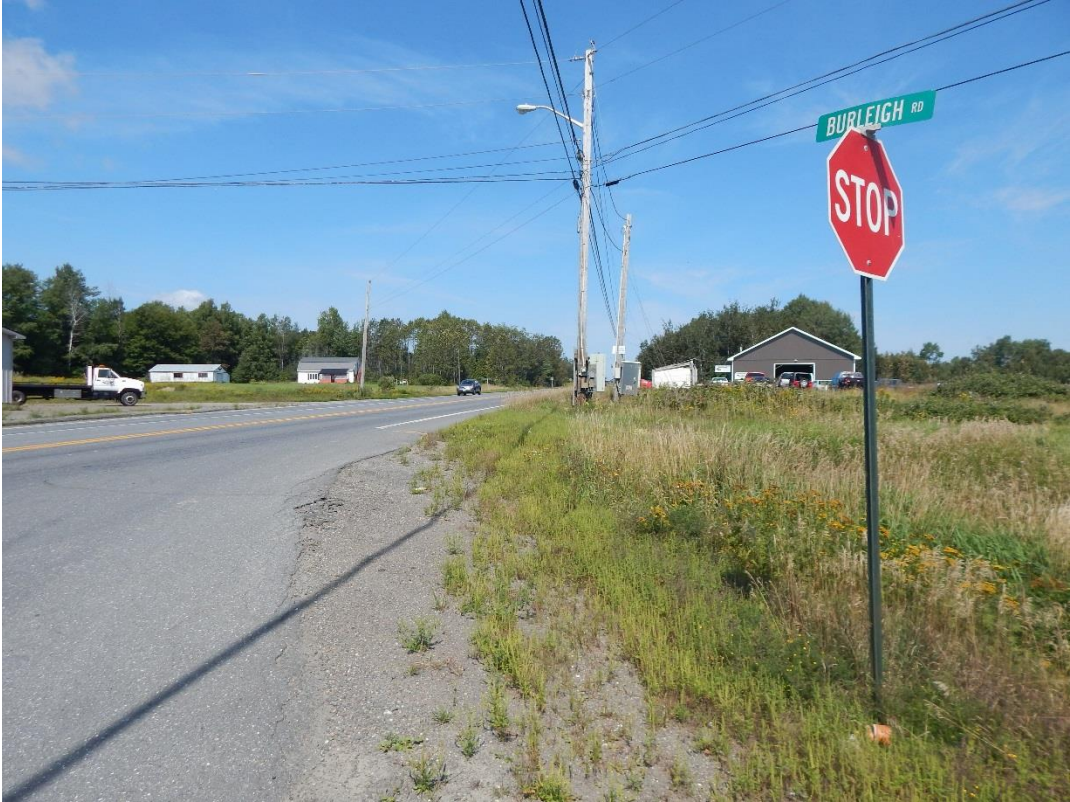
Burleigh Road intersection looking north. Note vegetation and utility poles blocking view.
