# **Short-Term Recommendations for Improving the Safety of High Crash Locations in Rural Aroostook County**

**Northern  
Maine  
Development  
Commission**

December 2016

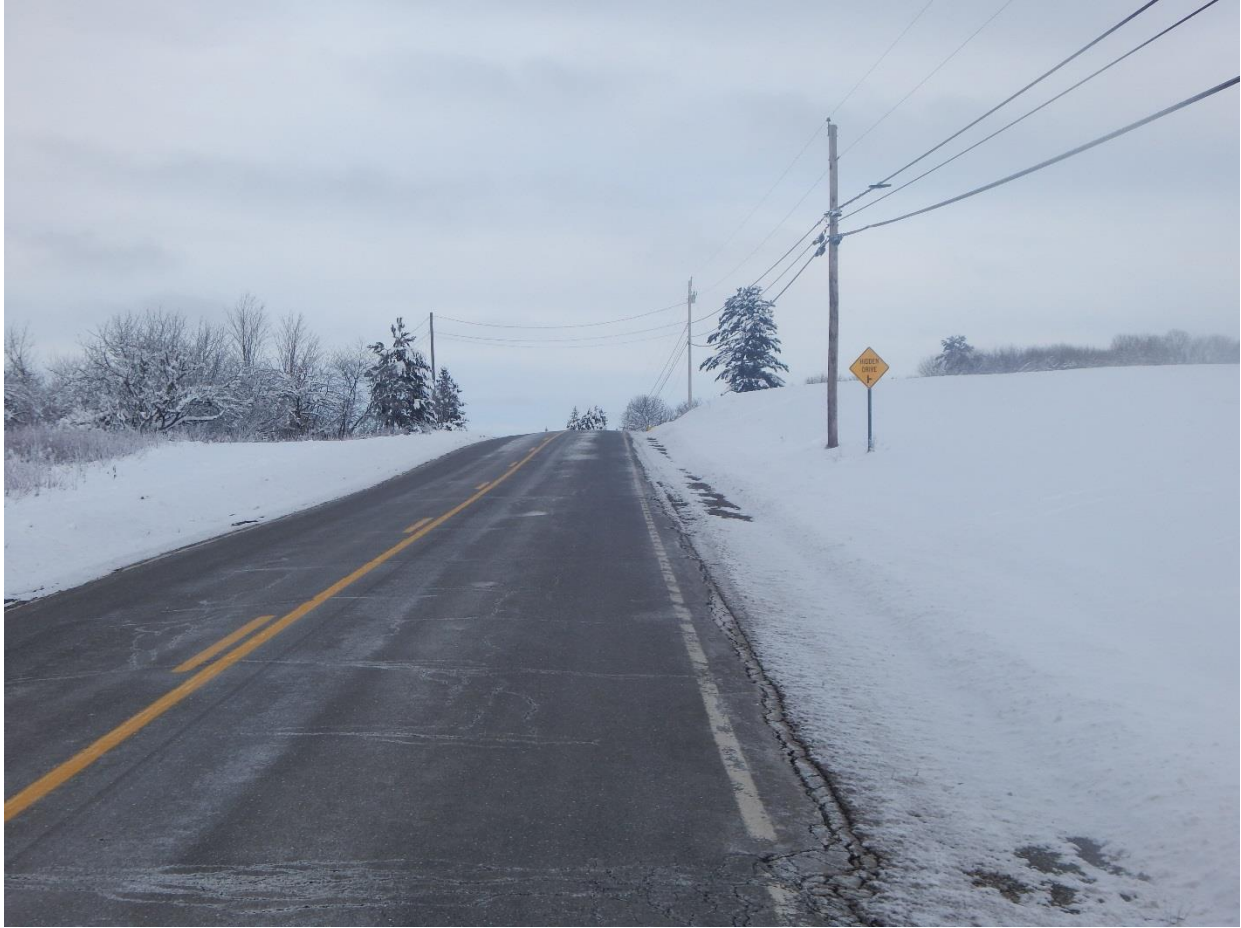
Route 227 eastbound. Blind drive that is noted with sign.

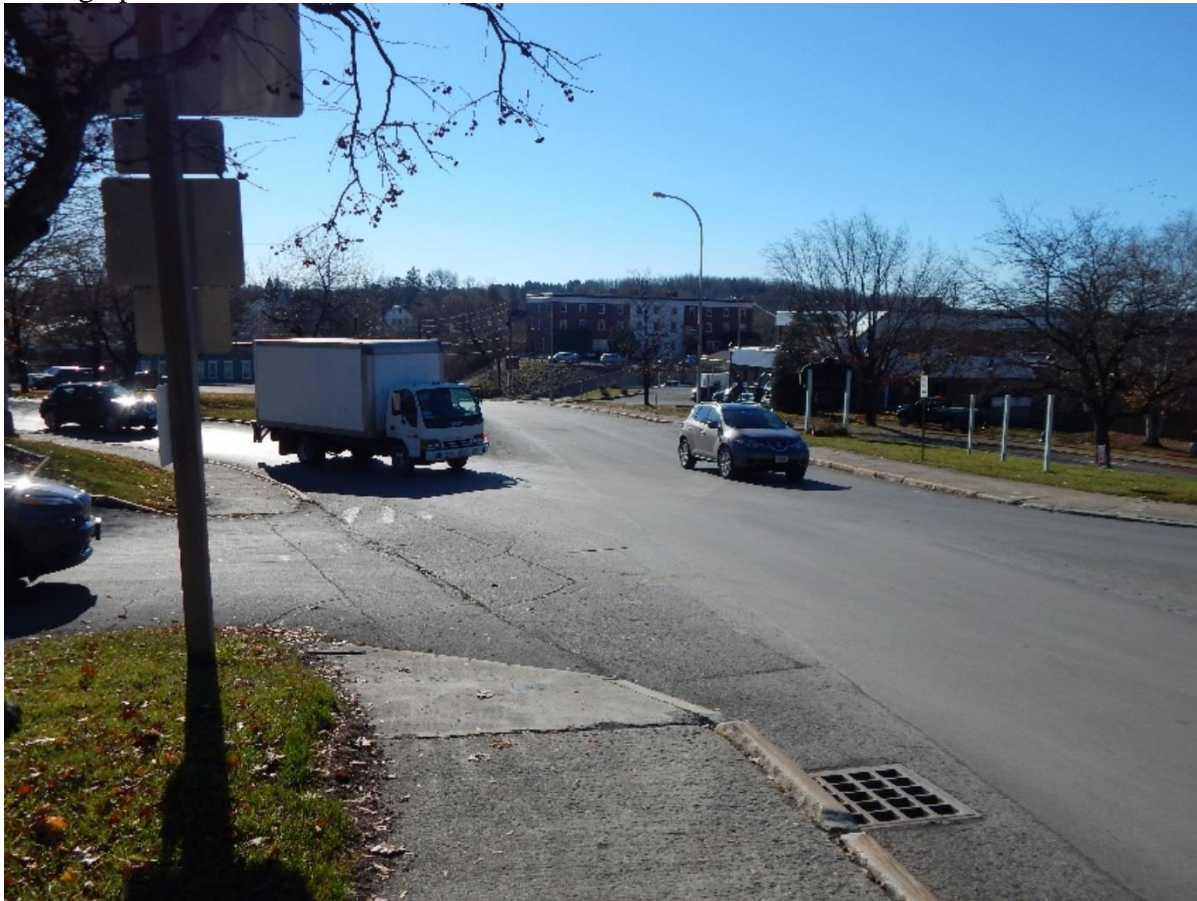
High and Herschel Street Intersection looking south. Notice lack of lane designations and accesses located directly next to intersection.

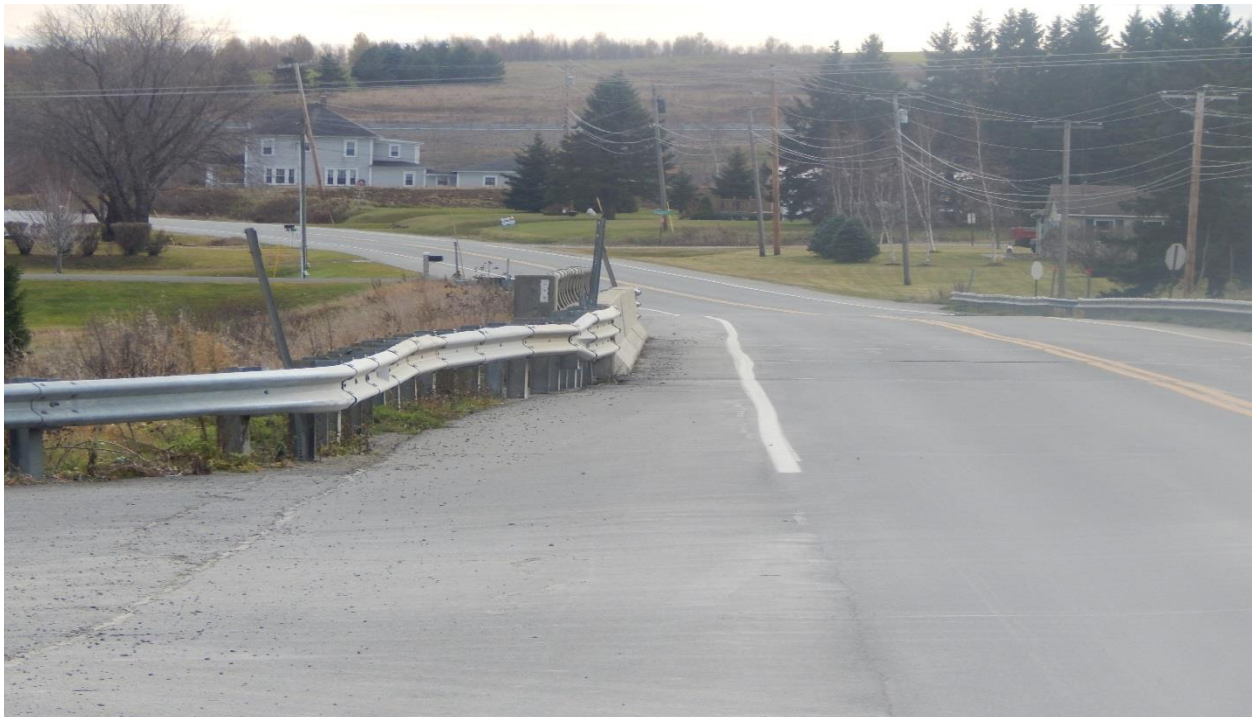
Barrett Siding (node 8741) looking south towards Caribou from an agricultural entrance. Sight distances are limited at this location.

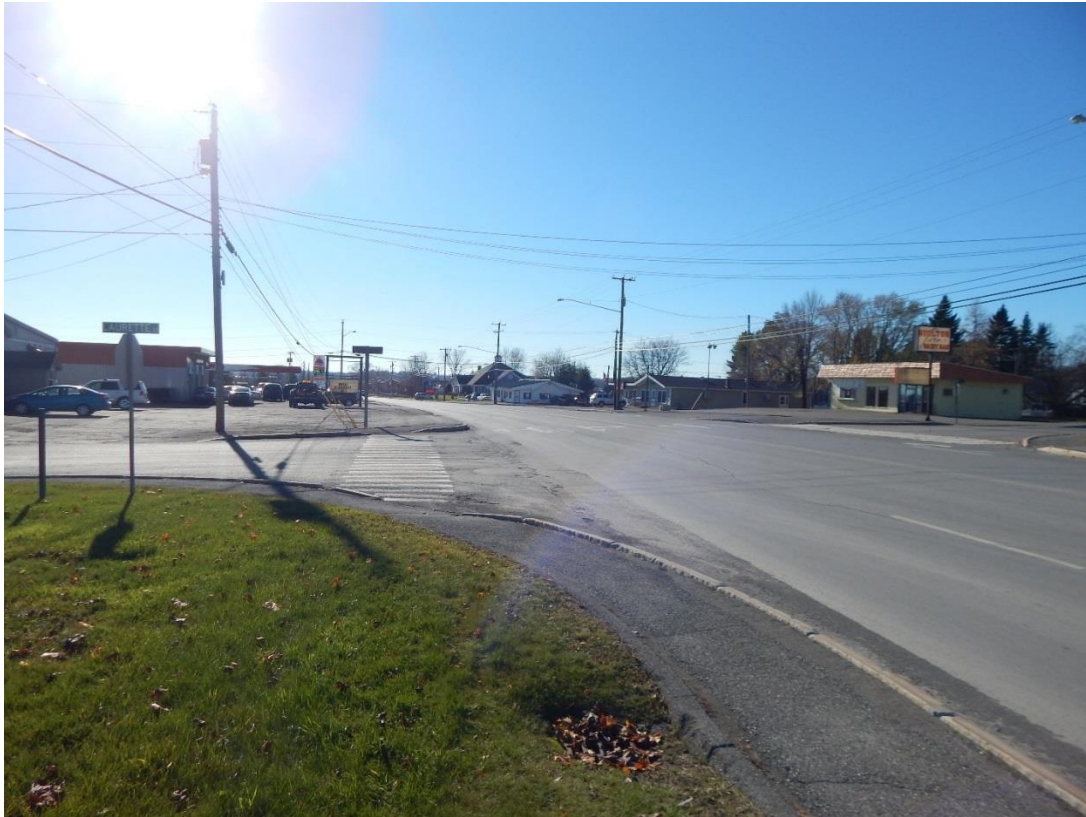
Intersection of Bennett Drive and Laurette Circle. Right Lane Must Turn Right sign not prominent.

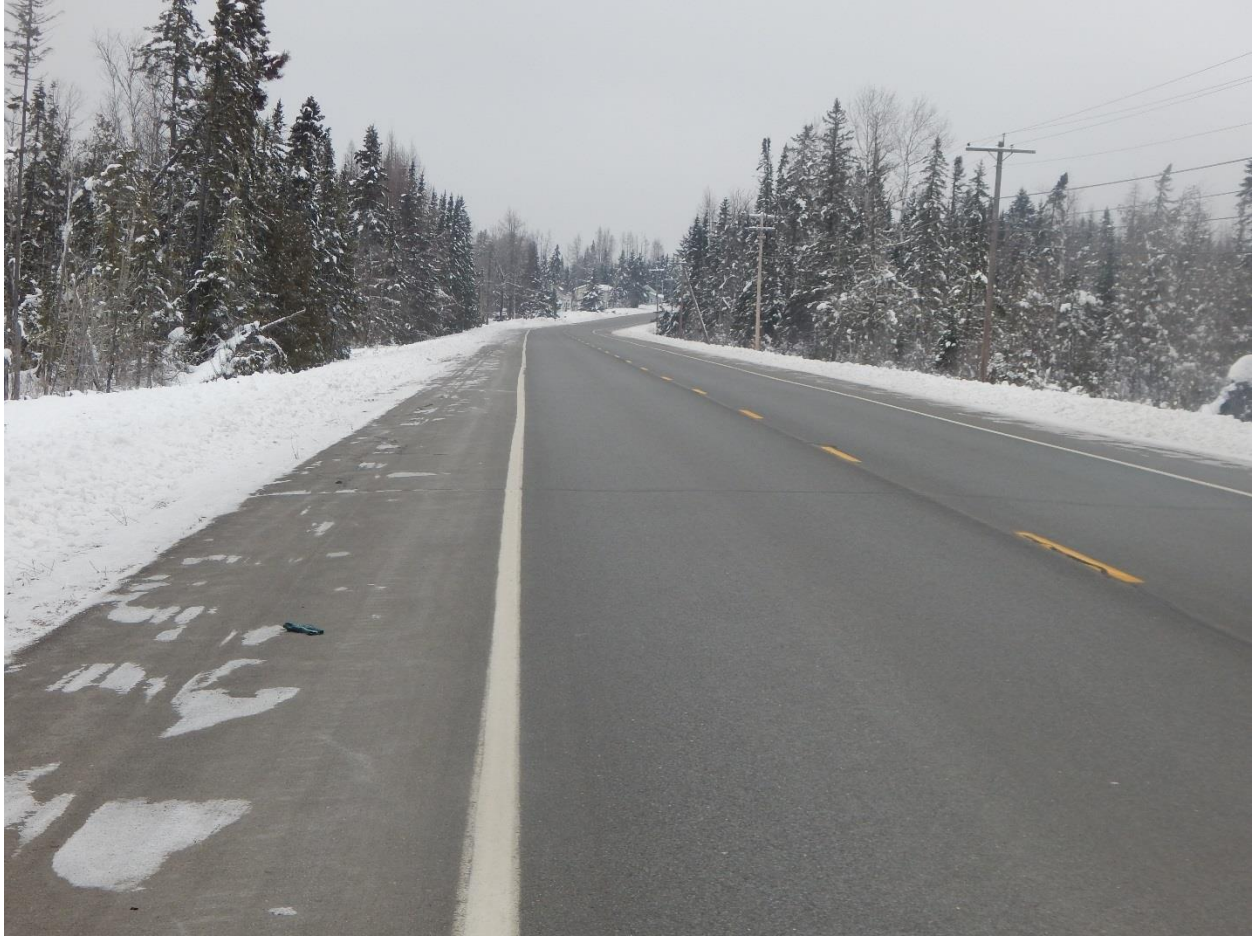
US Route One in Connor Township northbound. Location is just before sharp corner at Sheen Road. Notice the two way passing zone.

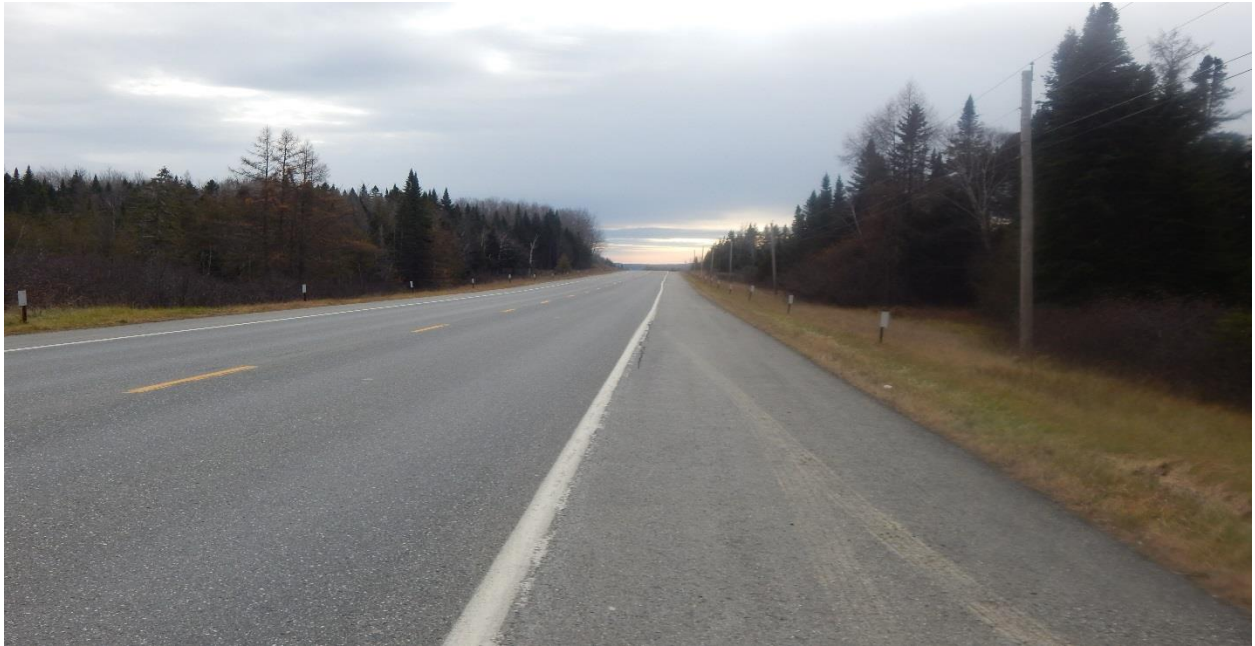
Van Buren Road in Connor Township at Cyr Planation Townline. Road is straight with animal reflectors and vegetation has been trimmed.

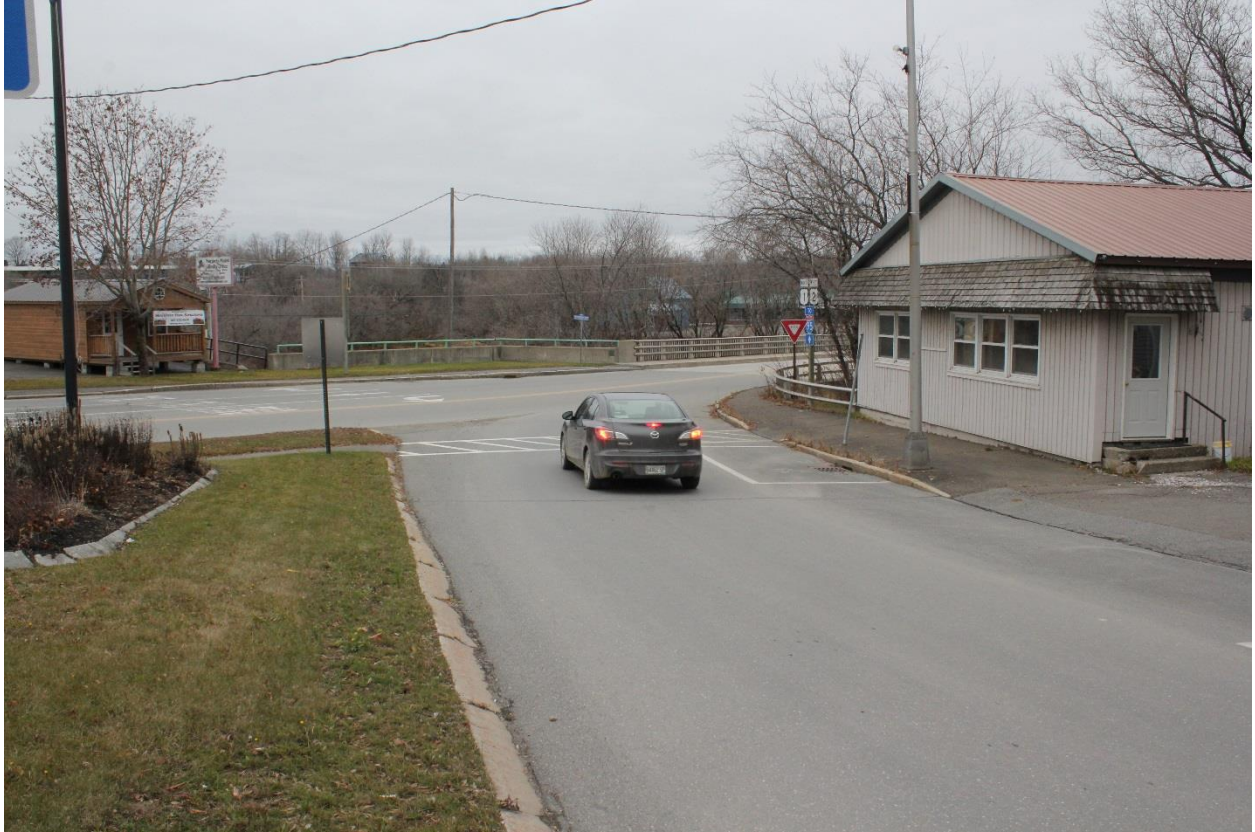
Intersection of Union Square and North Street, looking at North Street. Vehicles must turn right at this location.

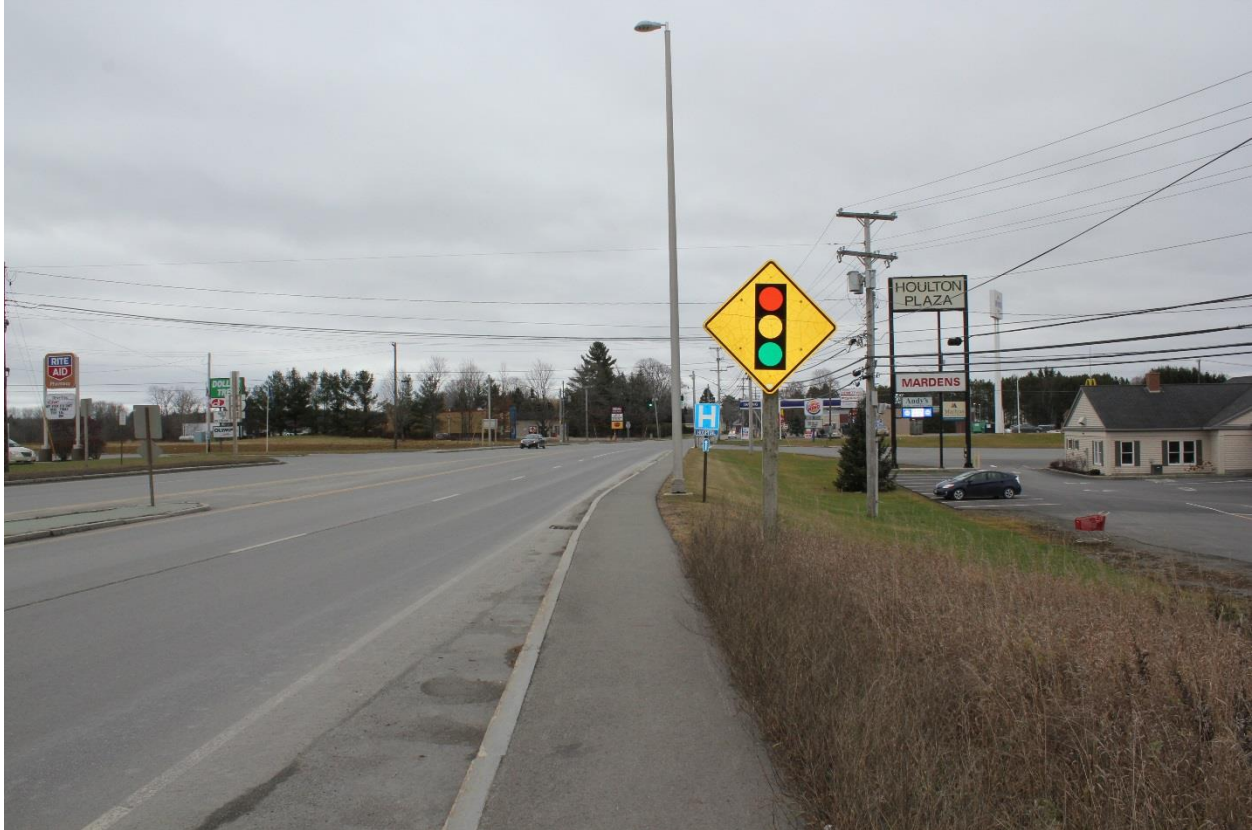
Shopping Center entrance at North Street looking north. Notice the numerous access points along the link.

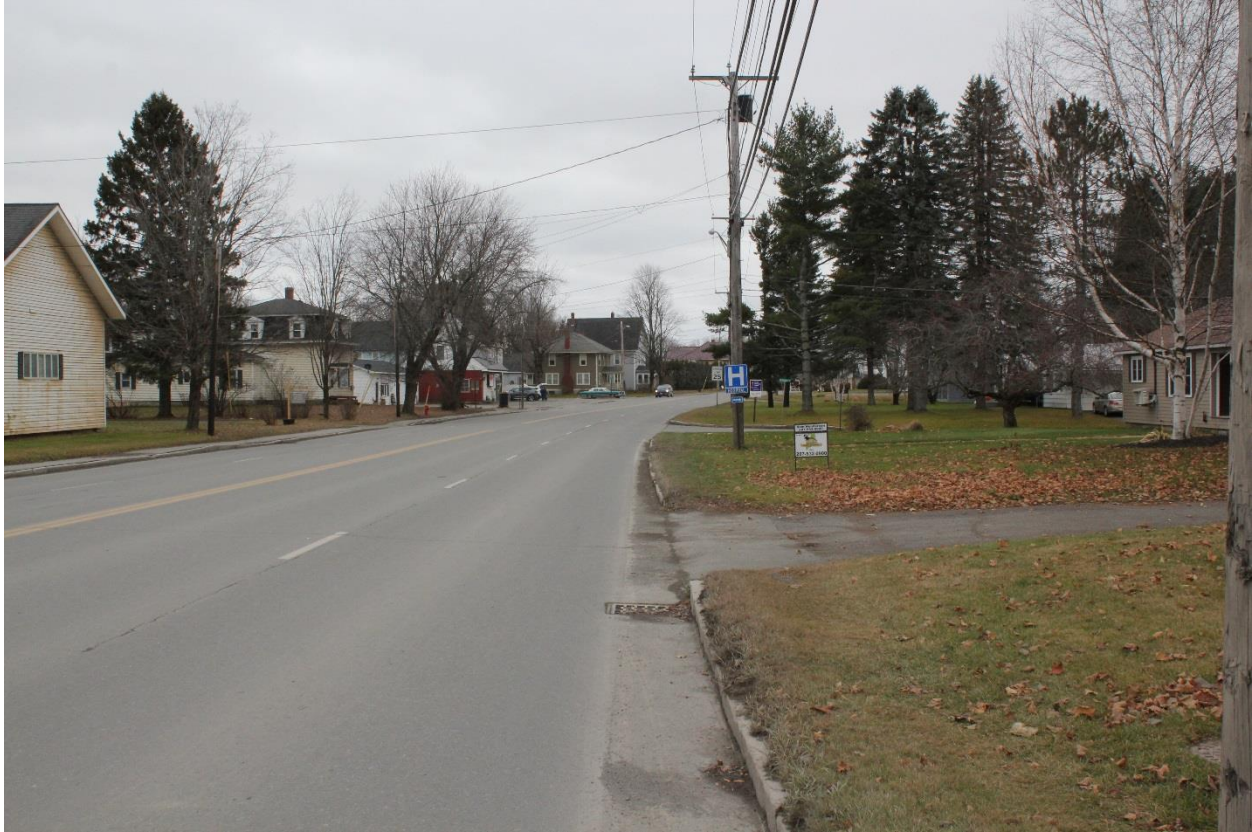
North Street and Putnam Street Intersection. Consider a turning traffic sign and a flashing signal at this location.

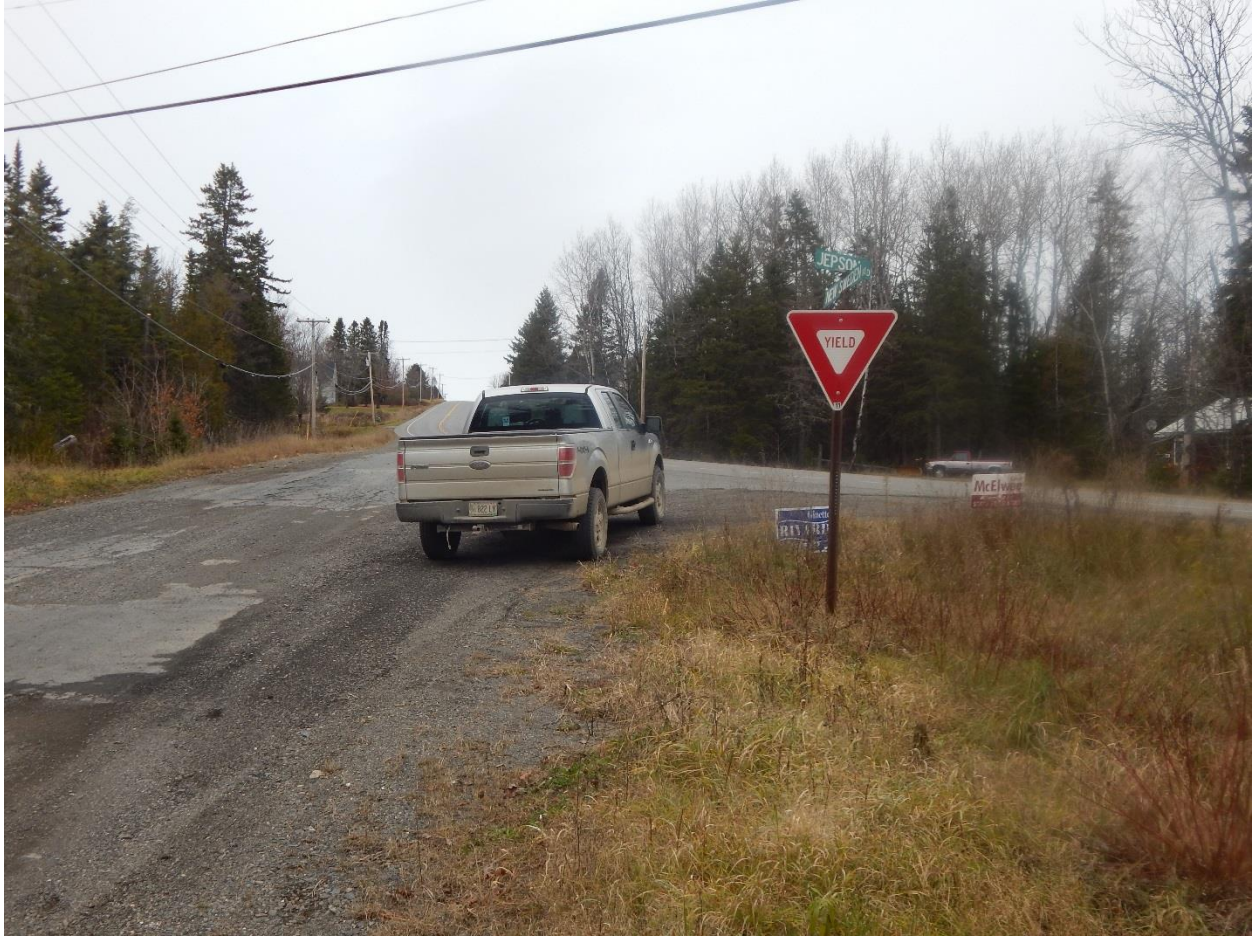
Intersection of Jepson Road and New Sweden Road looking north. Notice the Yield sign and the angle of the intersection.

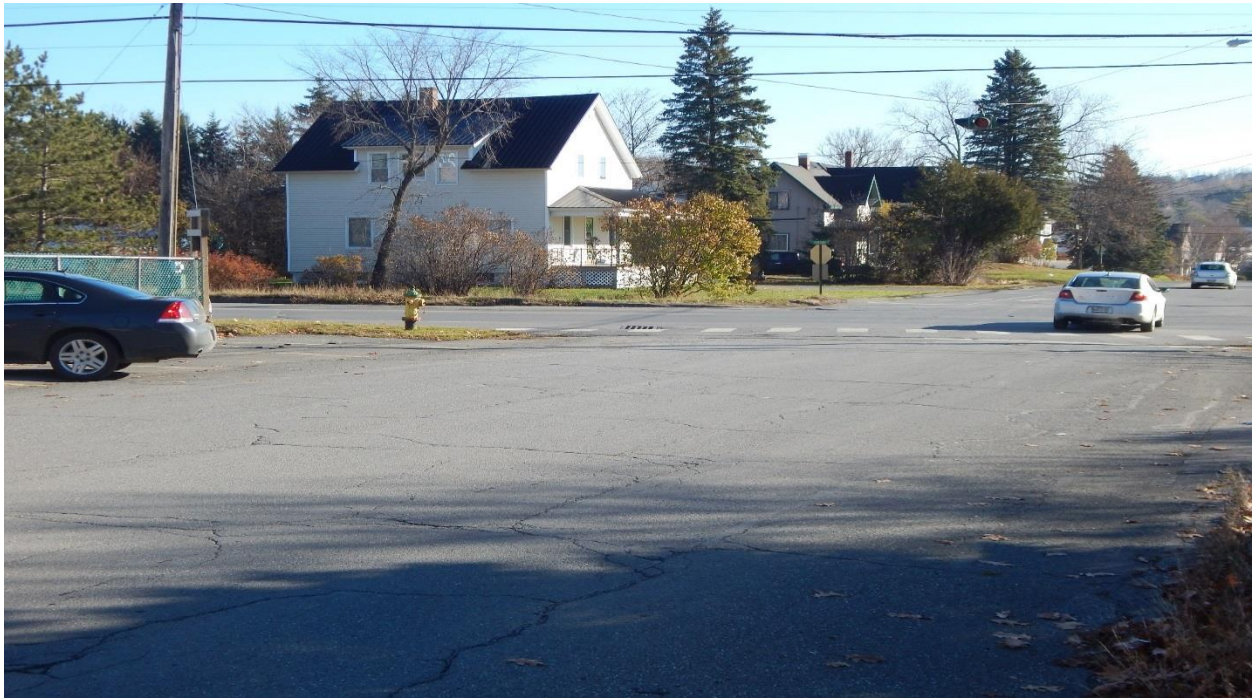
Intersection of Parson and Park Street looking east. Notice parking space located at intersection.

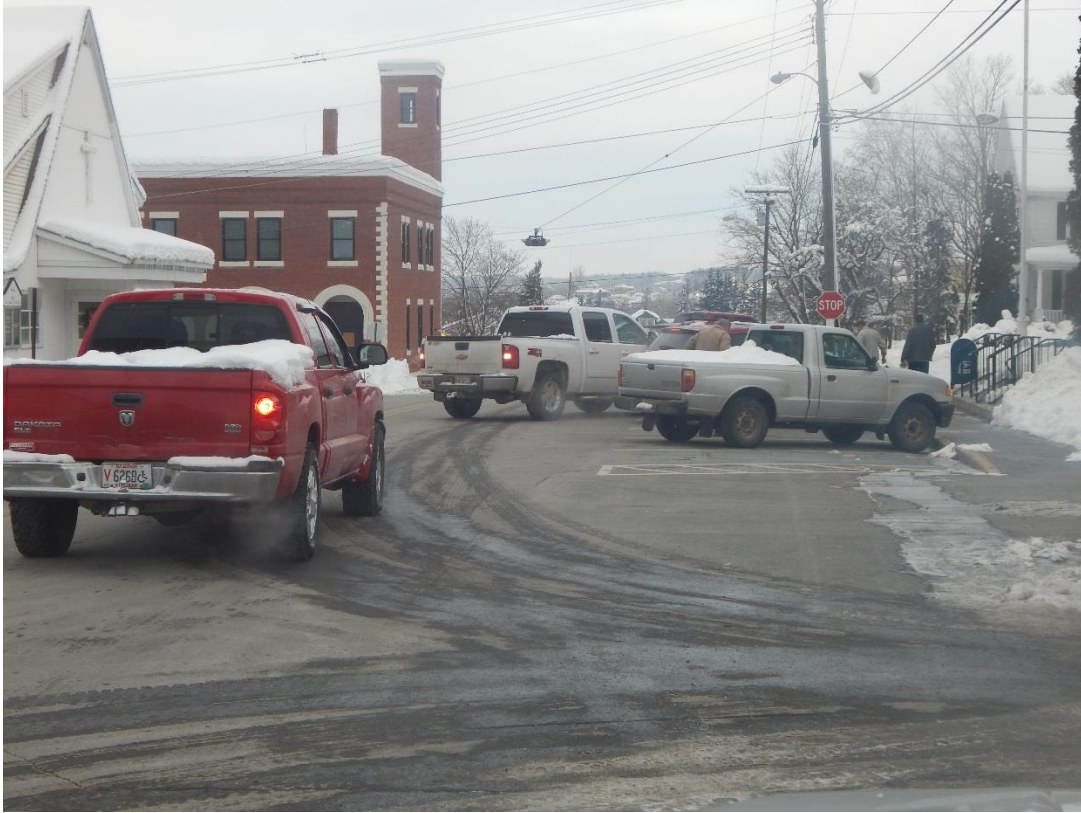
Intersection of Church and Second Street. Notice vehicles backing out into on-coming traffic.

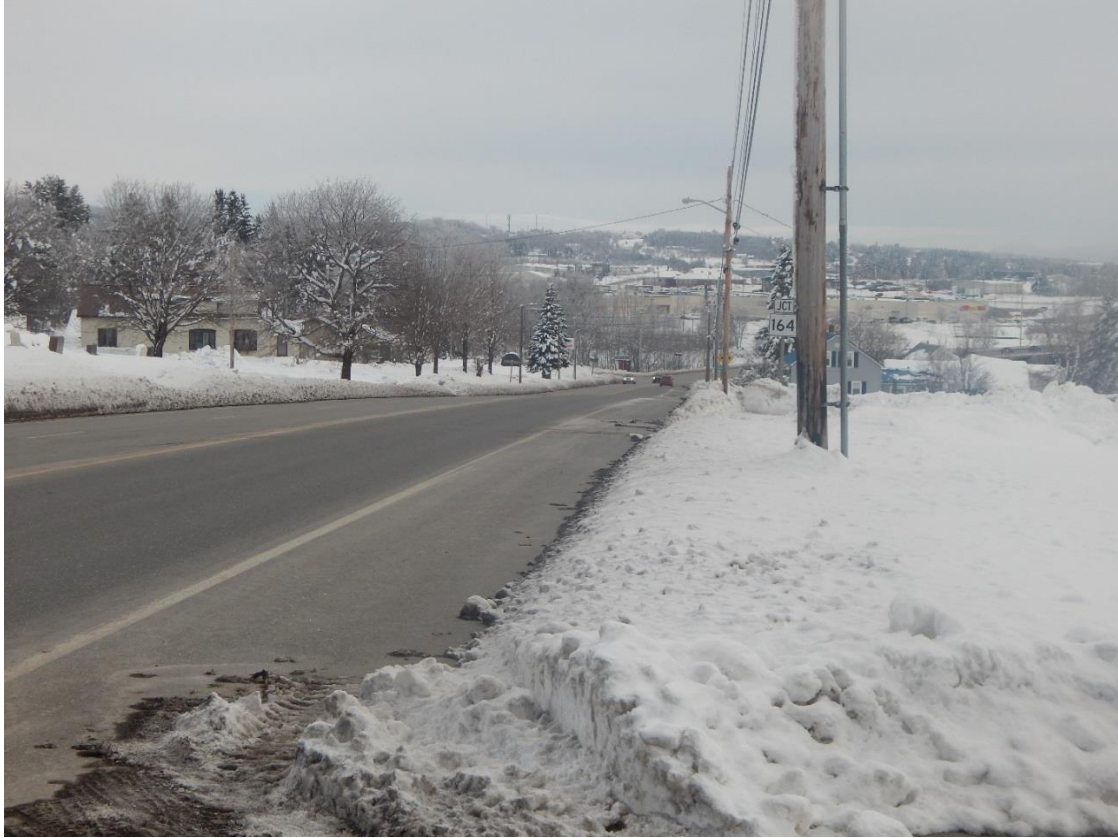
US Route One southbound into Presque Isle. Long straight stretches are conducive for speeding.
