# Short-Term Recommendations for Improving the Safety of High Crash Locations in Rural Aroostook County

December 2018

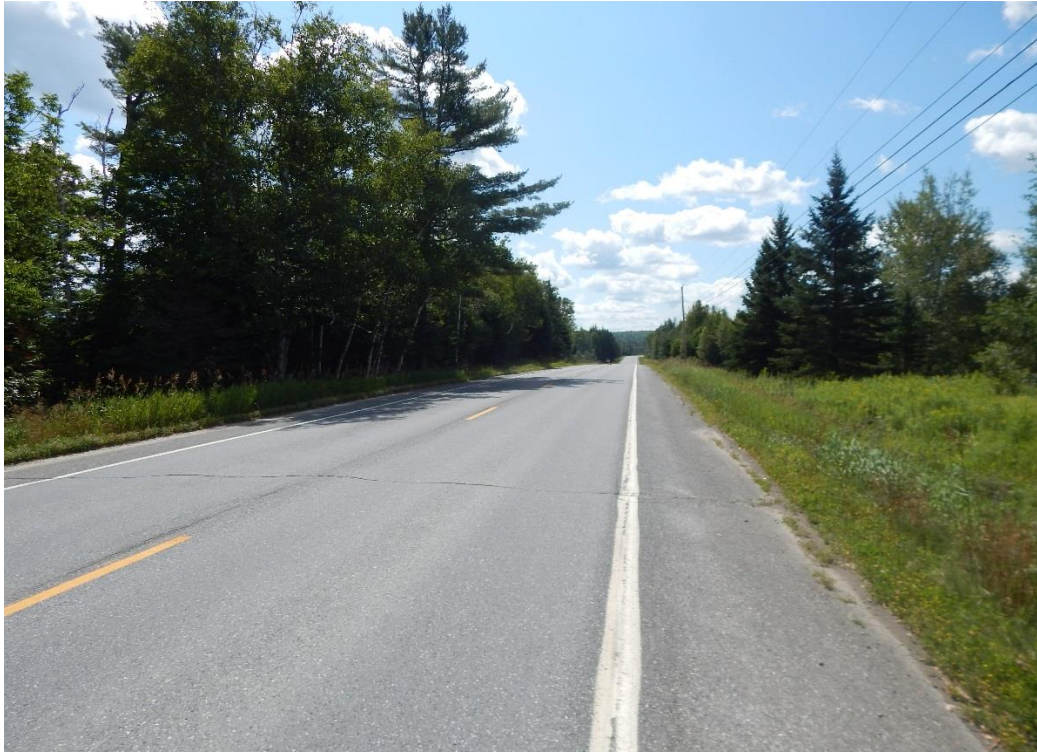
Portage Road looking south towards Ashland. Just north of the season Deer Crossing Sign. Notice vegetation close to road reducing visibility.

- Continue to work with landowners to adjust wildlife feeding locations, especially during the winter months.
- Consider trimming/removing vegetation to the greatest practical extent along link to improve visibility and potentially improve road surface conditions during the winter months.
- Consider installing flashing Deer Concentration signs that can be turned on in the winter months.

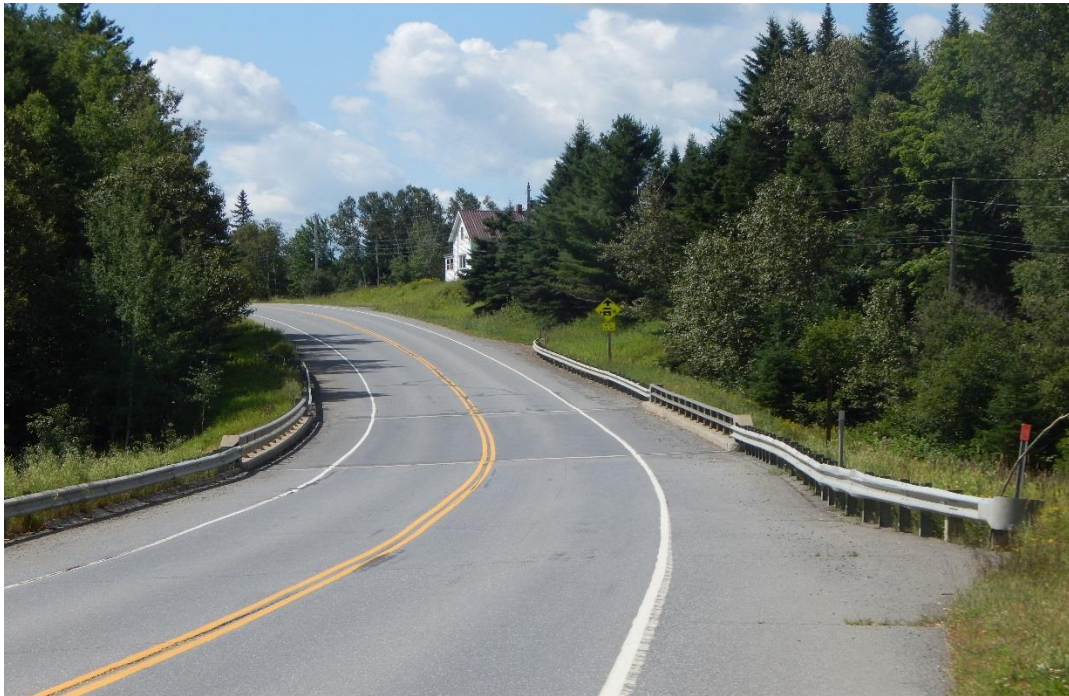
Portage Road looking south toward Ashland. Notice school bus crossing sign.

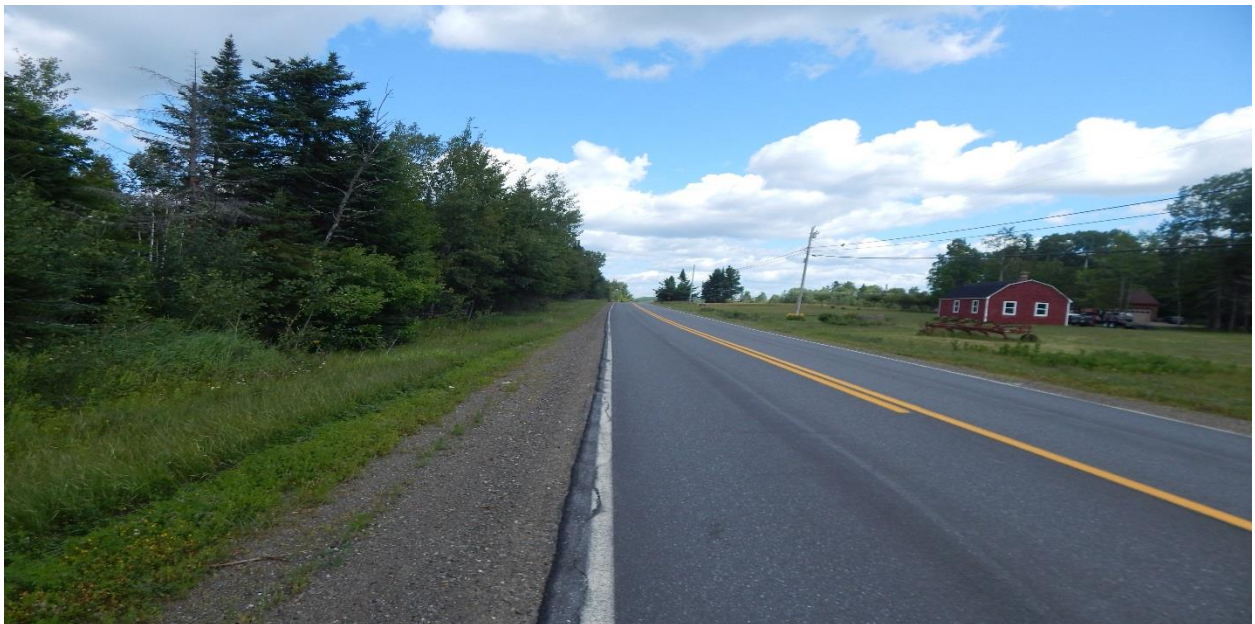
Route 227 looking east at known deer crossing.

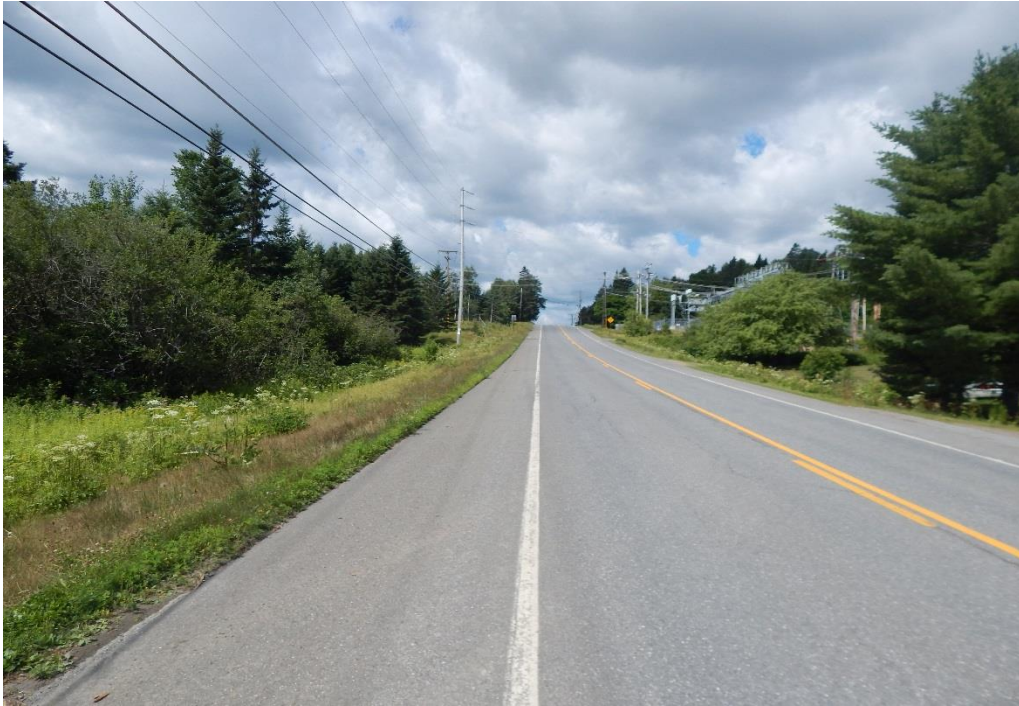
Route 227 near Exchange Street, looking west. Note vegetation close to road and lack of mowing.

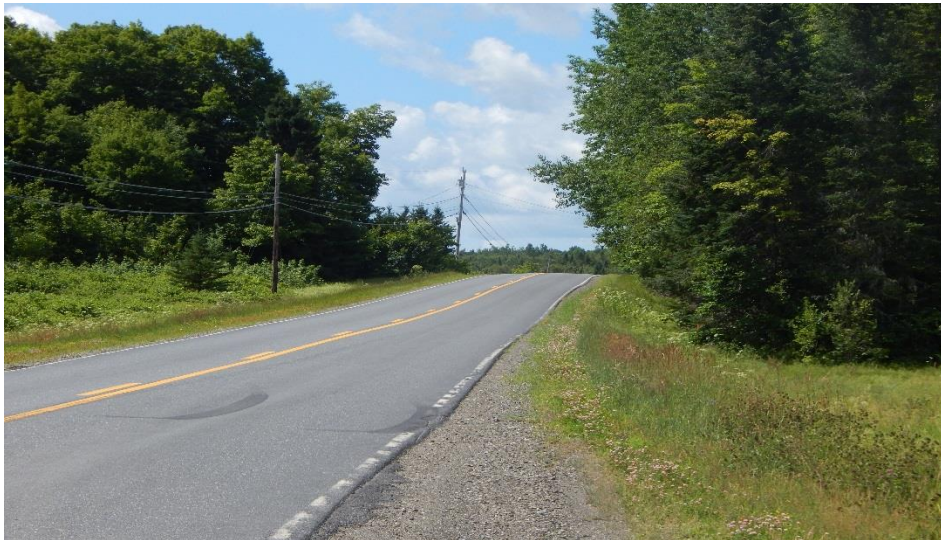
Route 227 near Ashland's downtown, looking west. Vegetation in need of clearing and a blind hill.

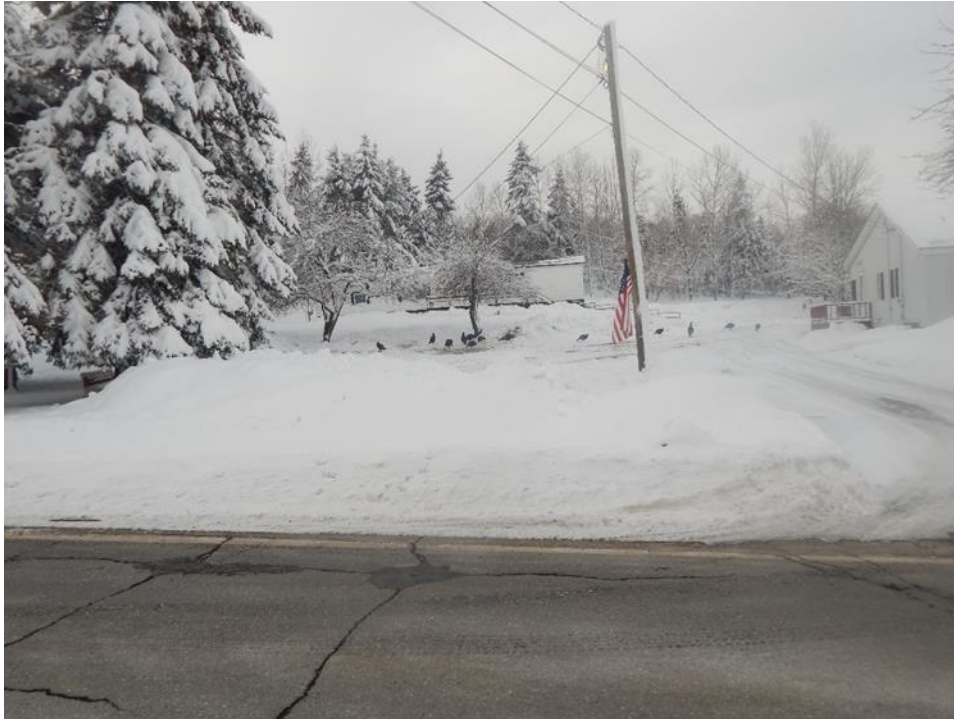
Route 227 just east of Ashland's village area. Notice the flock of Wild Turkey that are being fed by a landowner. This area is also heavily utilized by white-tailed deer. (2016 Photo)

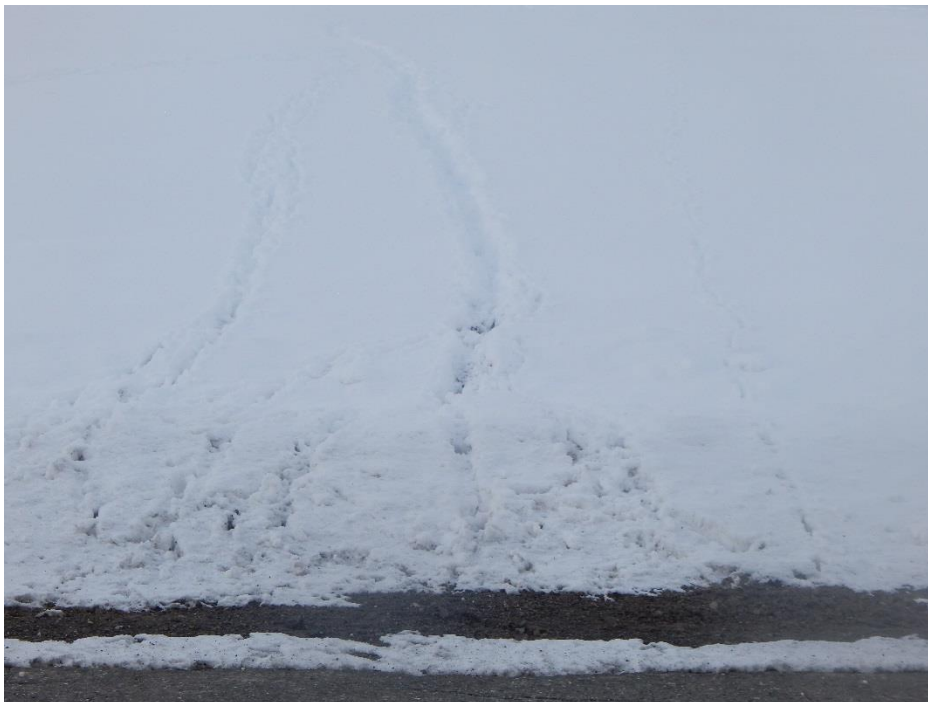
Deer Trail crossing Route 227. (2016 Photo).

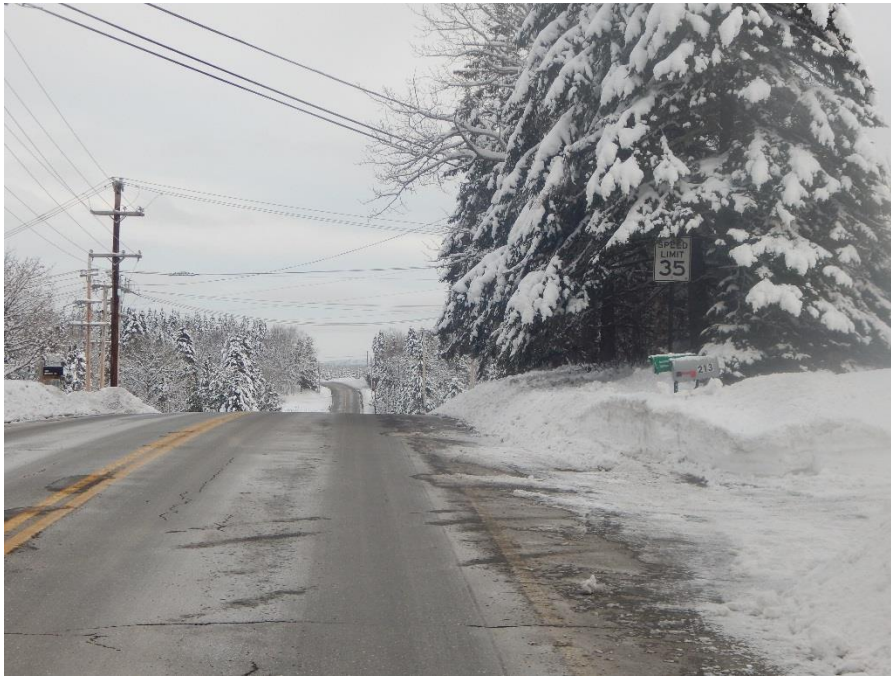
Route 227 looking east. Notice Speed Limit sign is hidden by tree. This area is heavily utilized by deer. (2016 Photo)

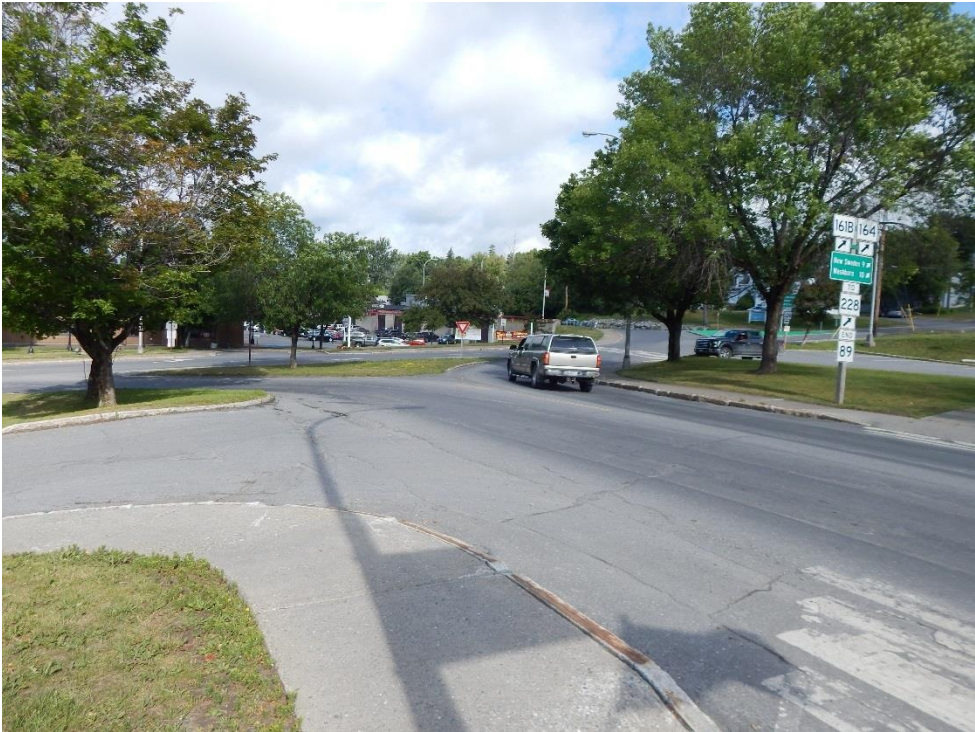
High and Herschel Street intersection looking west. Pedestrian crosswalk not well marked.

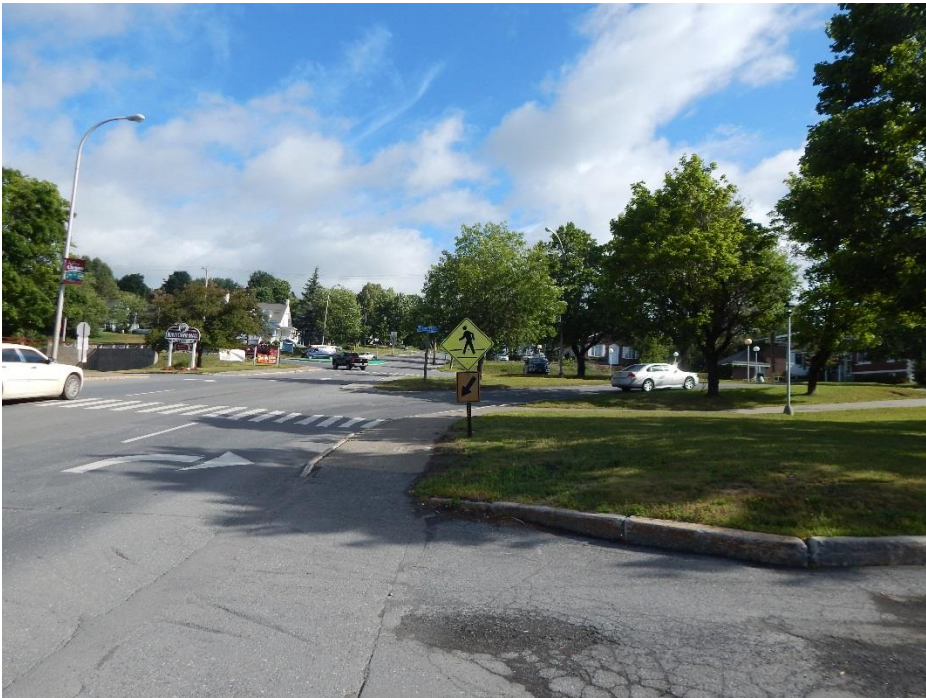
High and Herschel Street looking north. Pedestrian crosswalk well marked. Also, better lane designation since 2016 report.

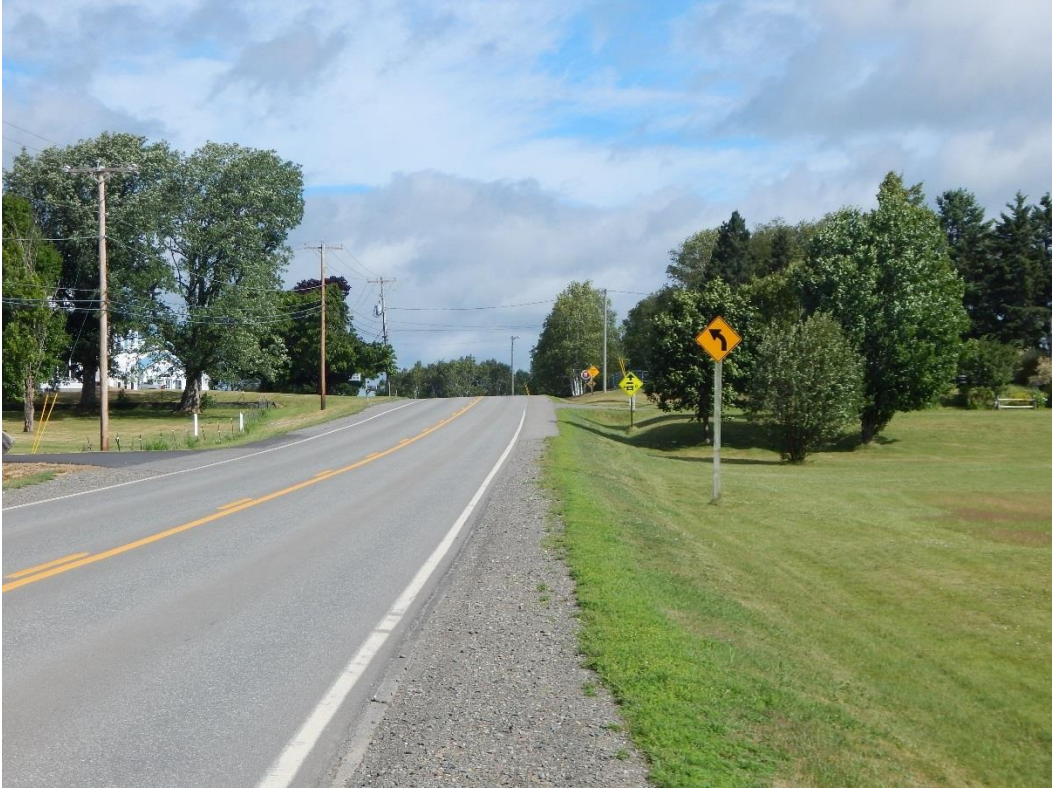
South Main Street looking west toward downtown Caribou. Notice location of commercial entrance and sight distance. Speed limit at this location is 50 mph.

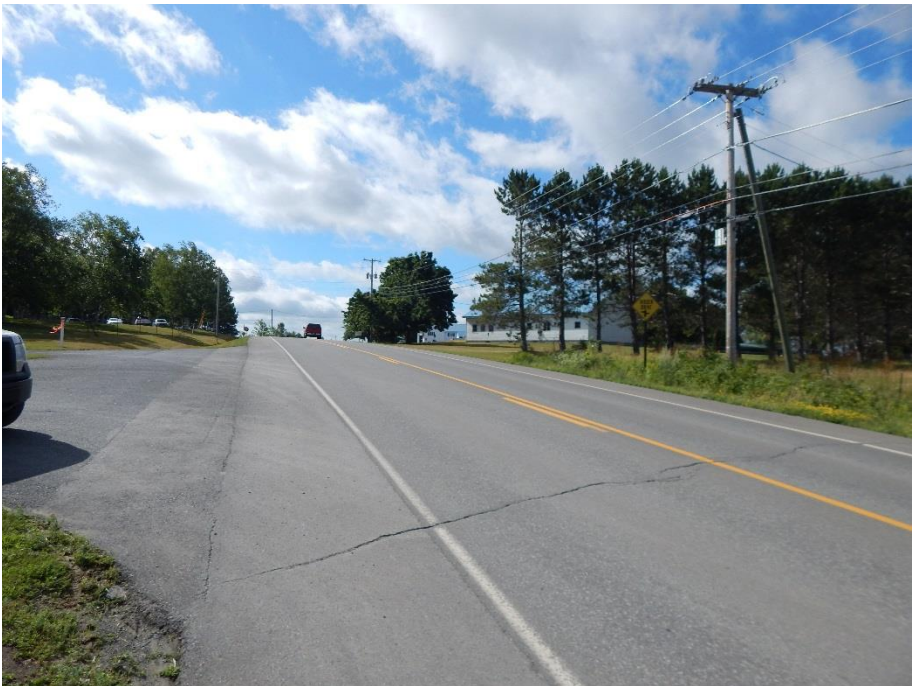
South Main Street looking south toward US Route 1. Hidden Drive sign and vehicle turning into commercial establishment.

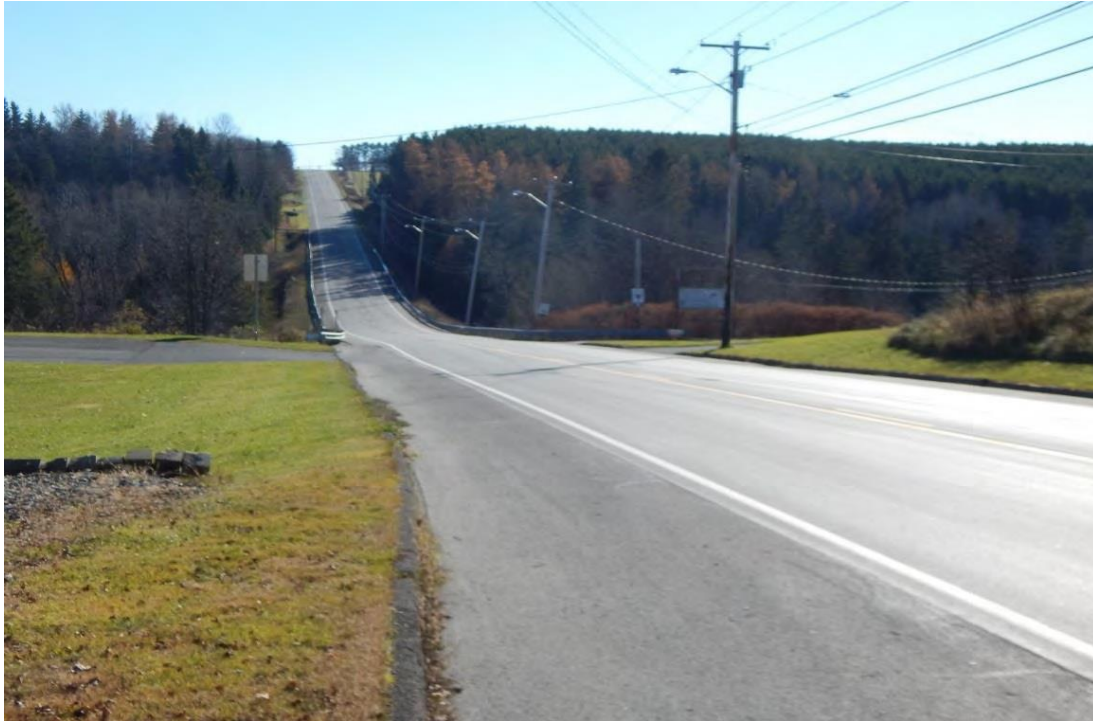
South Main Street looking south toward US Route 1. Steep slope with two commercial entrances (2016 photo)

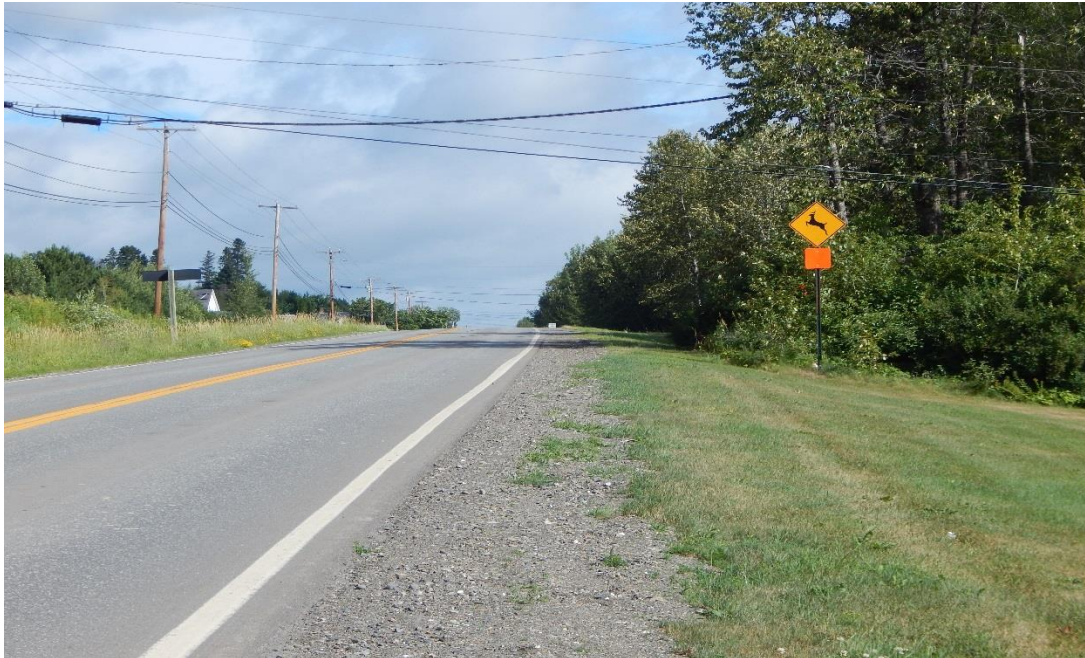
South Main Street looking north towards Caribou's downtown. Deer Crossing signs have been placed.

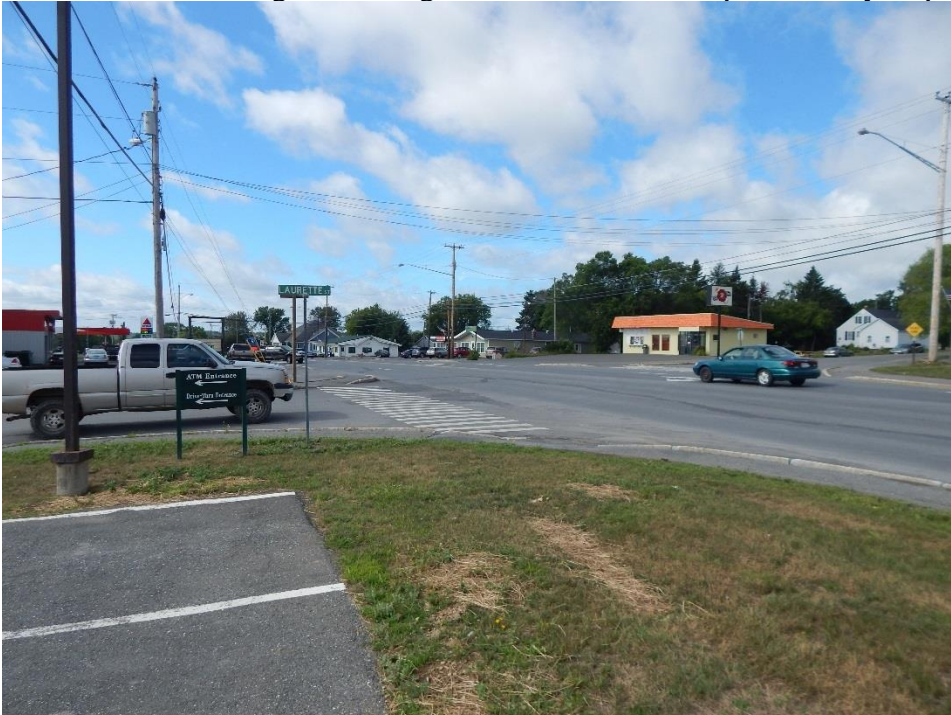
Bennett Drive looking south. Right Lane Must turn not prominently displayed.

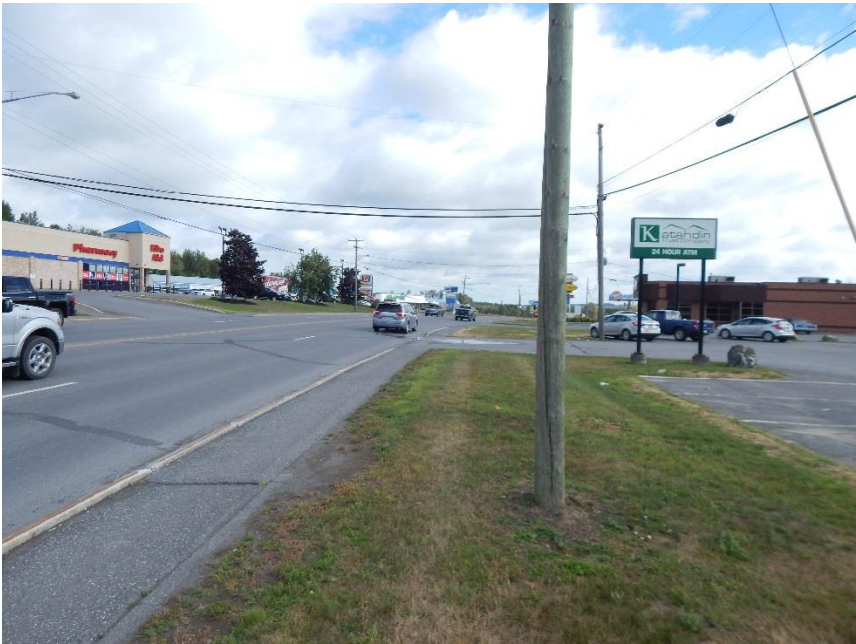
Bennett Drive looking south. Better lane marking since 2016 report.

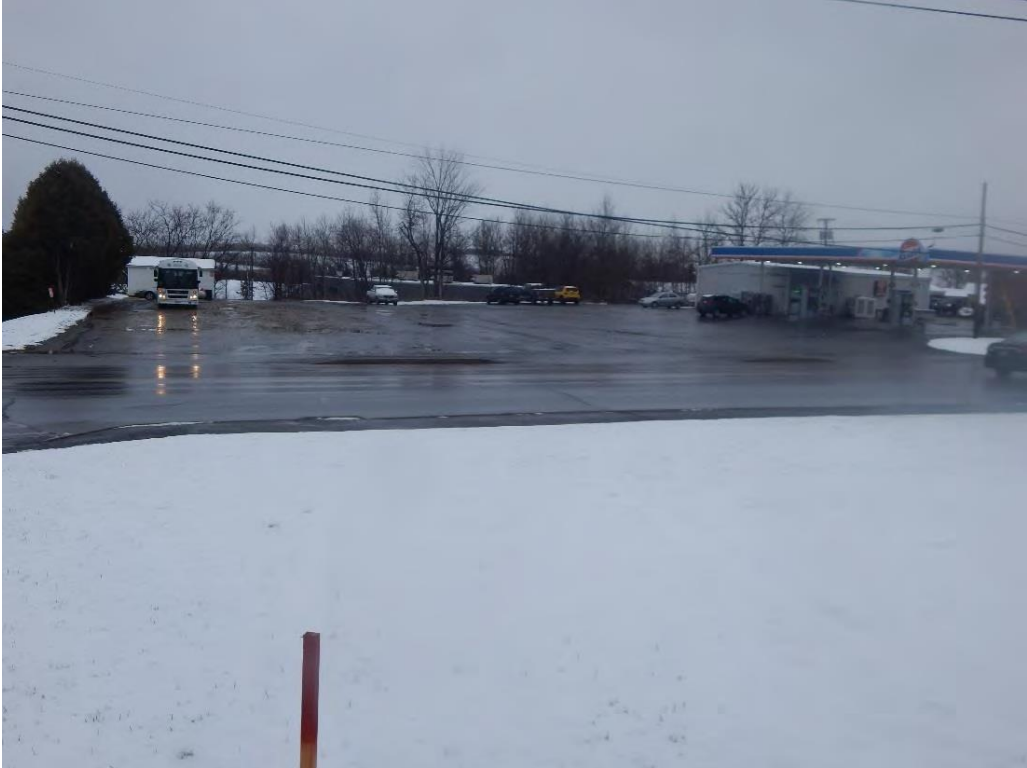
Bennett Drive. A local business still has at least 4 entrances onto link. (2016 photo)

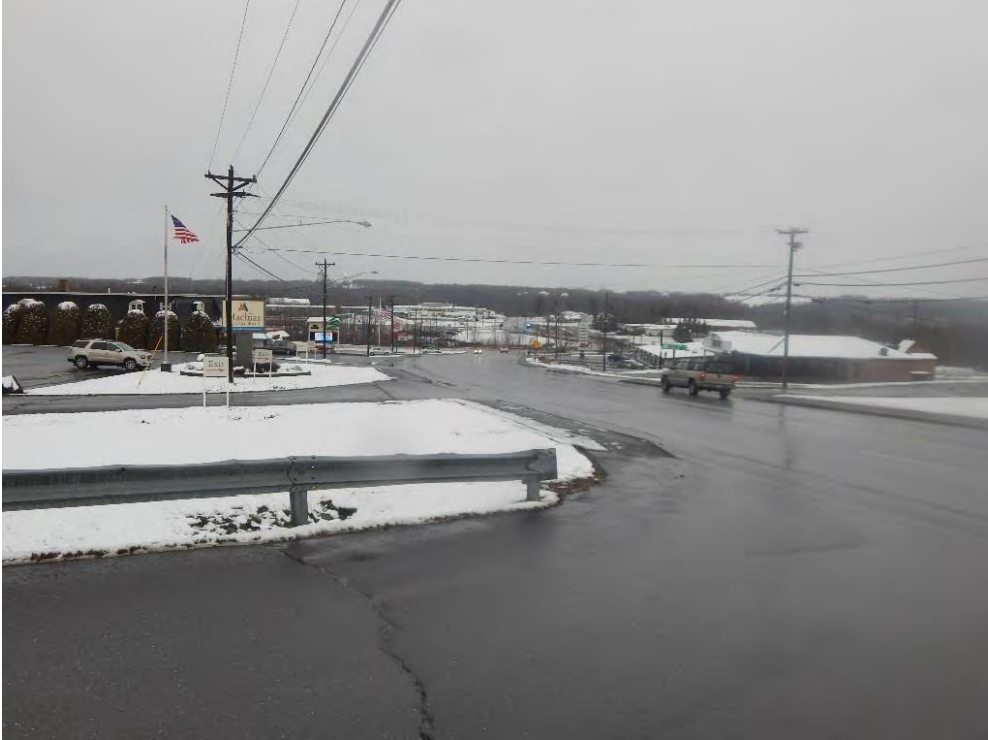
Bennett Drive looking north. Notice number of entrances. (2016 photo)

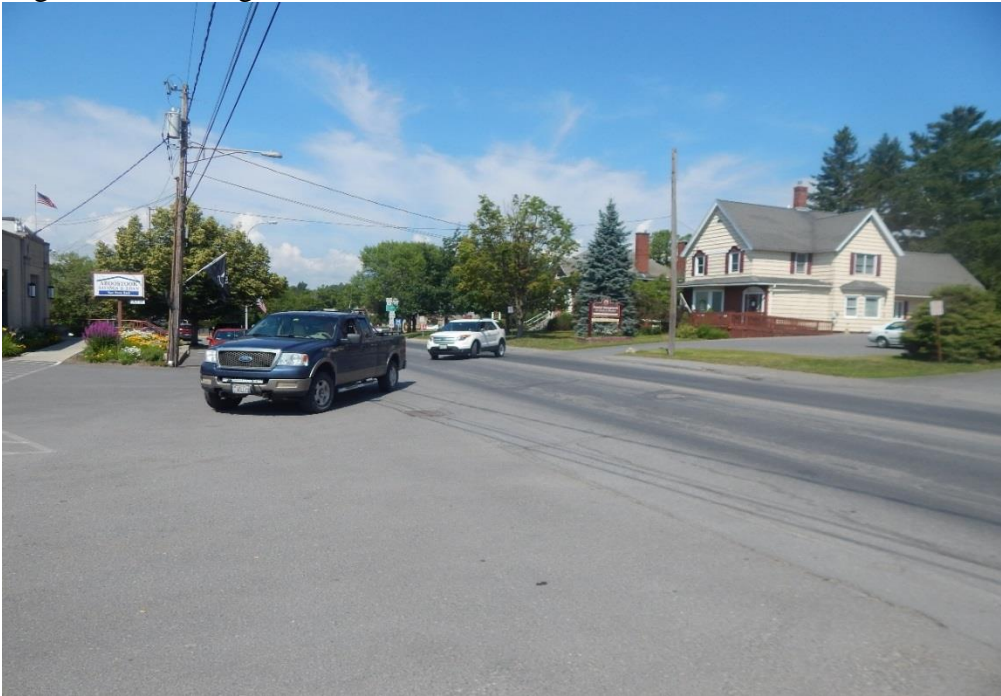
High Street. Notice unrestricted access.

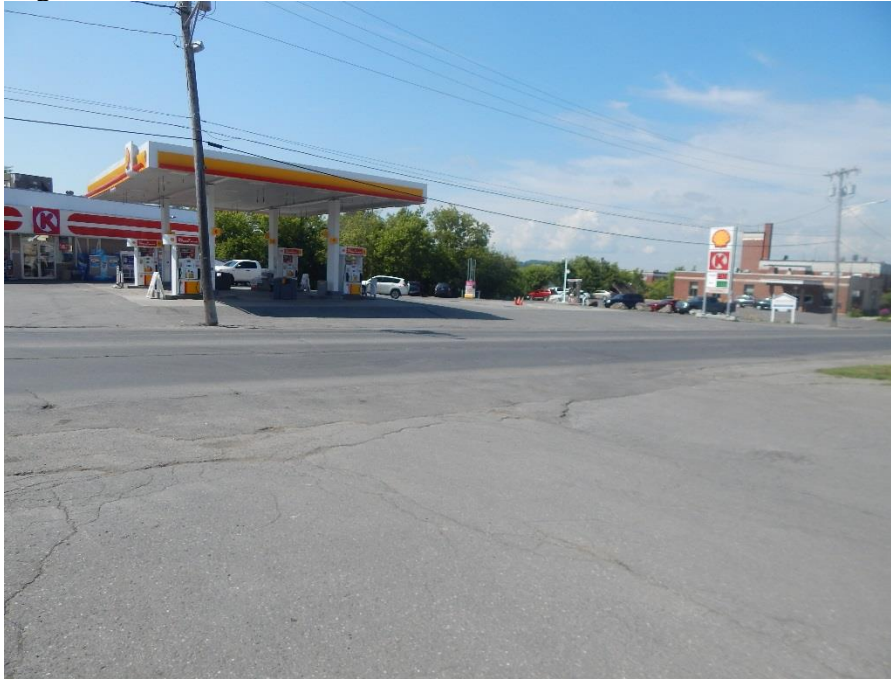
High Street east bound. While picture is hard to decipher, road is heavily rutted.

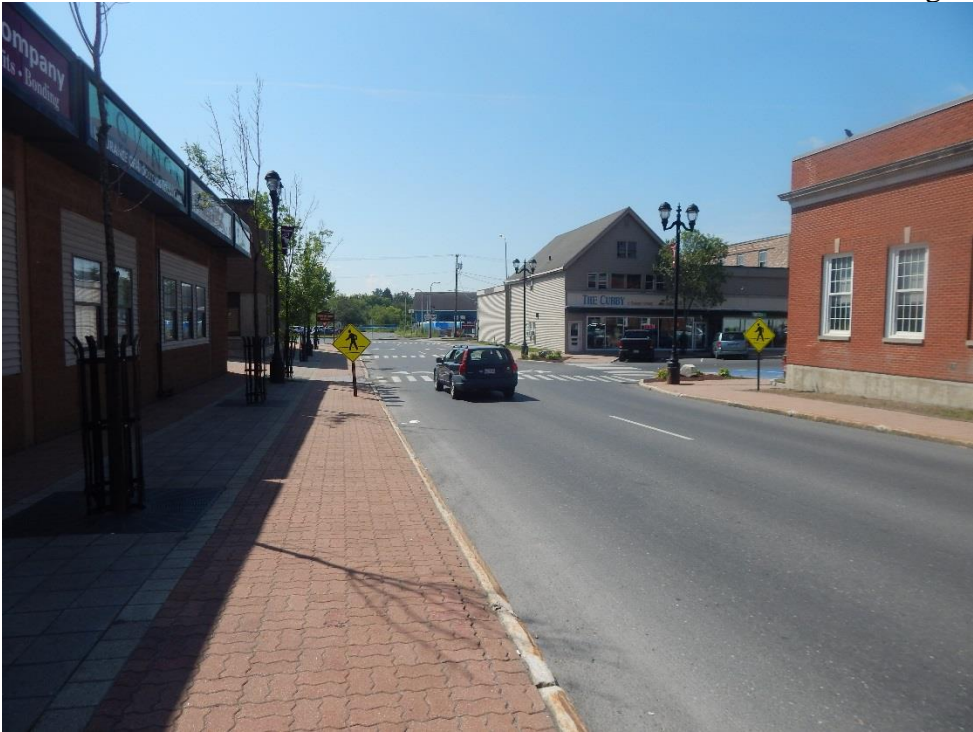
Sweden Street at Record Street looking north. Notice traffic calming measures in place. Vehicles on Sweden Street must back out into on-coming traffic.

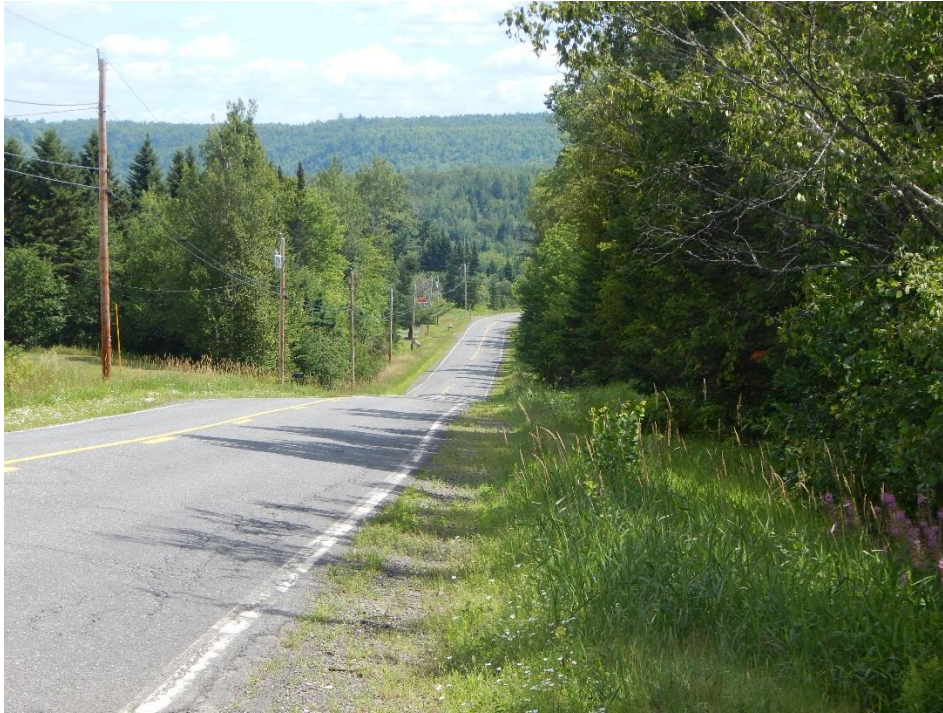
Route 227 east towards the MacDonald Road. Vegetation close to road. Also notice Work Area signs. MaineDOT was completing a road ditching project near the MacDonald Road.

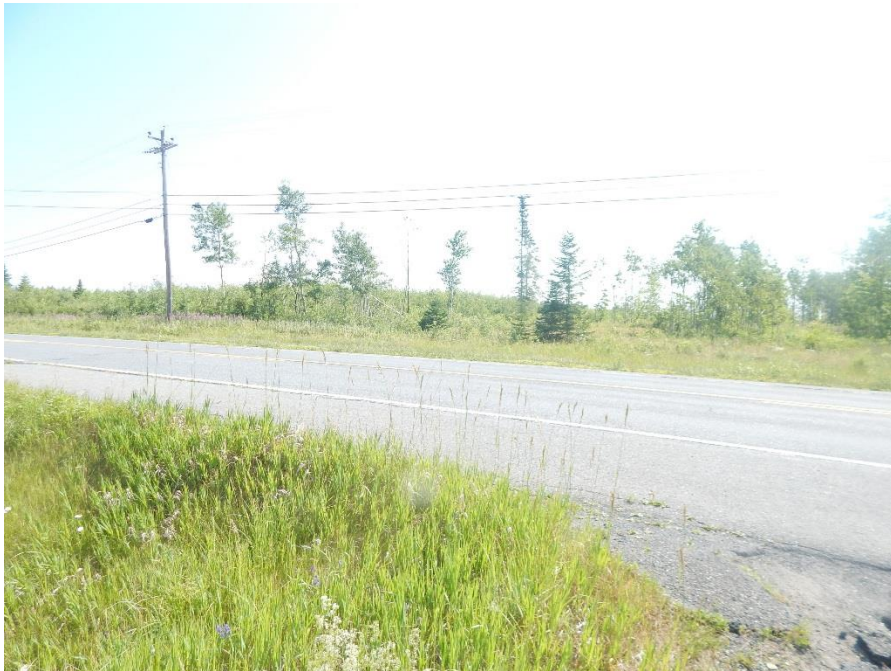
Moose crossing located near node 8069. While most of the moose/vehicle collisions occurred during the winter months, this is indicative of the moose population in the area.

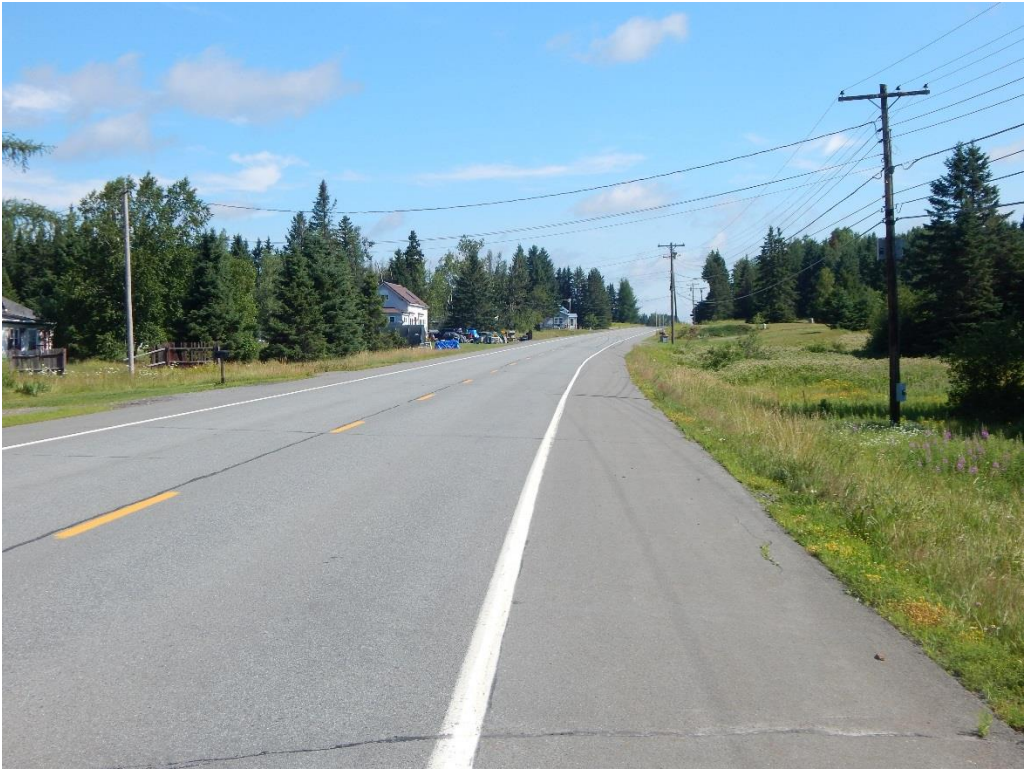
Residential development with numerous access. Speed limit is reduced to 50 mph along this section.

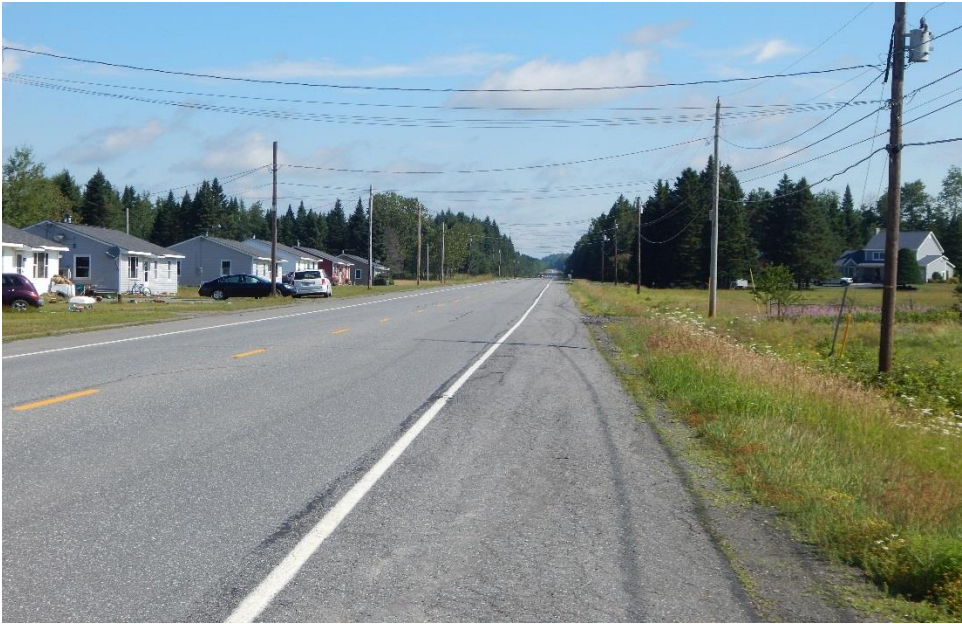
Vegetation close to road which is reducing sight distances.

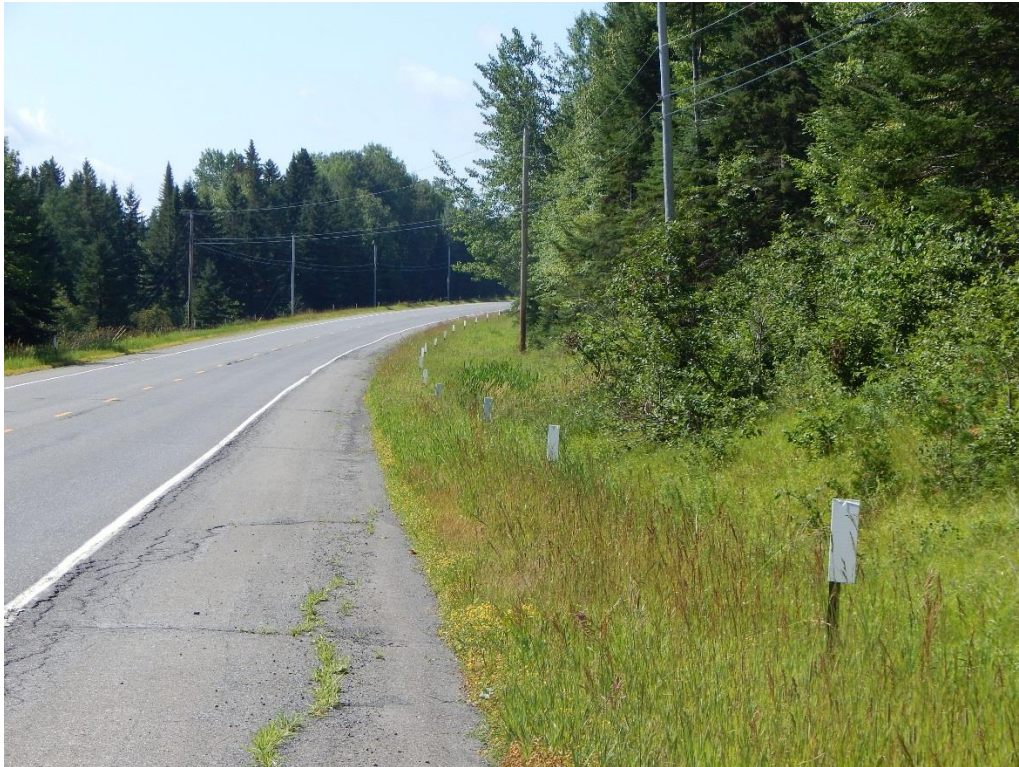
Vegetation close to road and grass not mowed. Note shadows in travel lane. Route 1 looking south in Cyr Plantation.

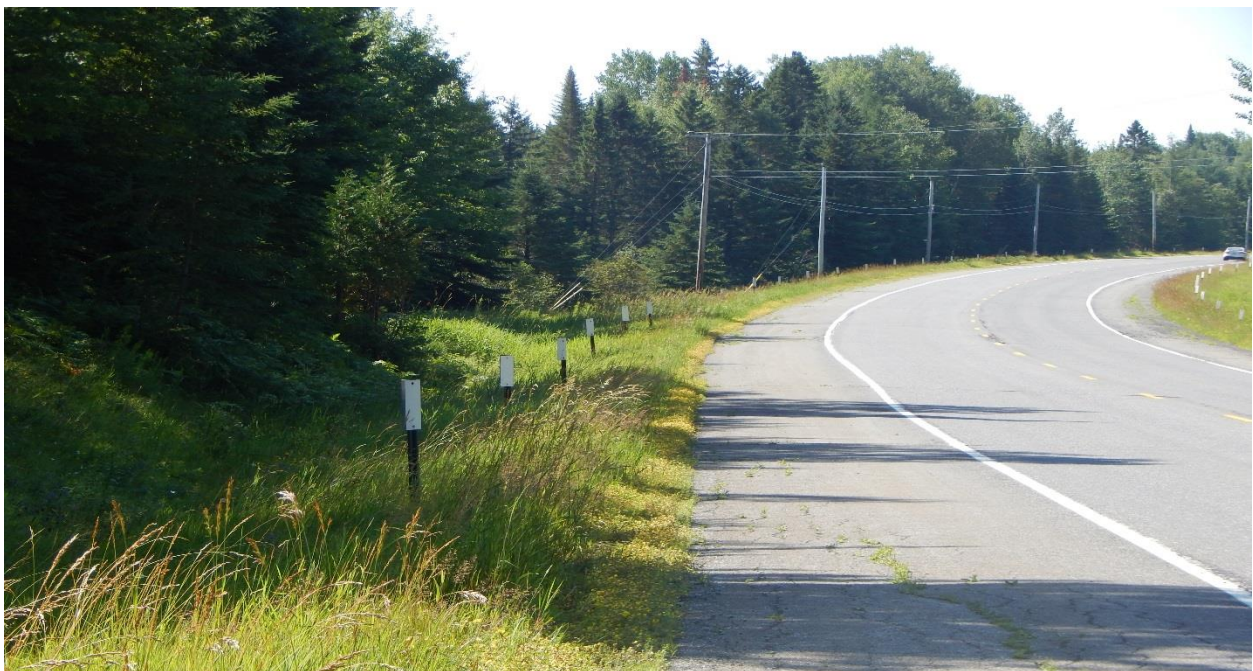
Tall grass behind reflector. Route 1 heading north in Cyr Plantation.

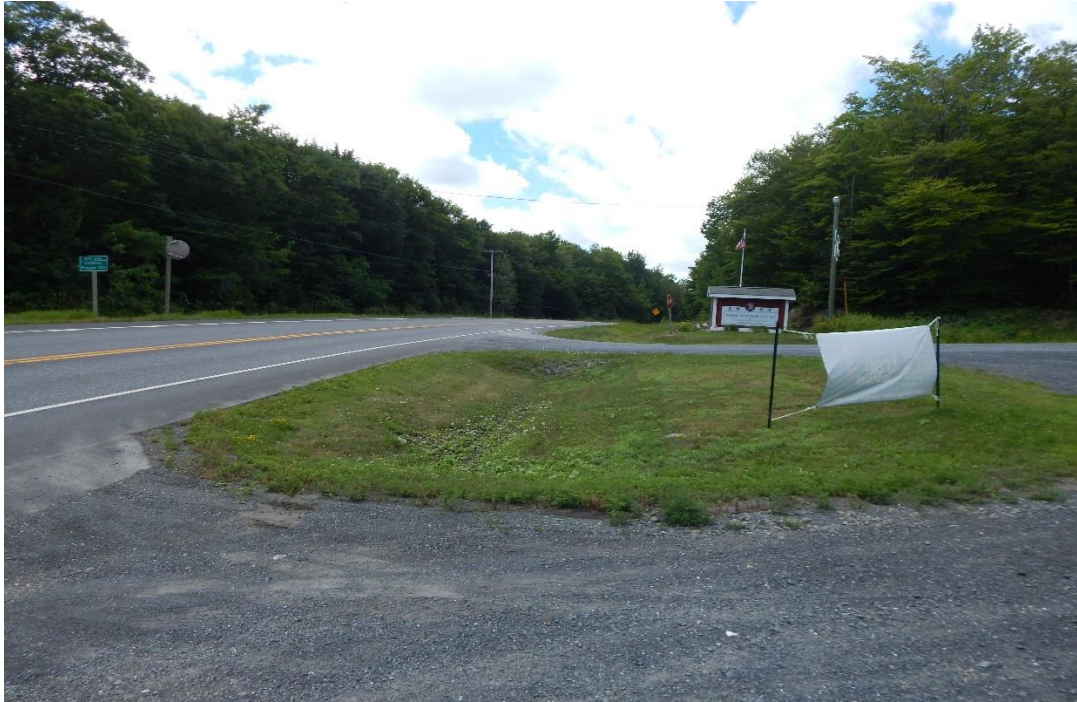
Entrance of Nordic Heritage Center looking northeast towards Fort Fairfield.

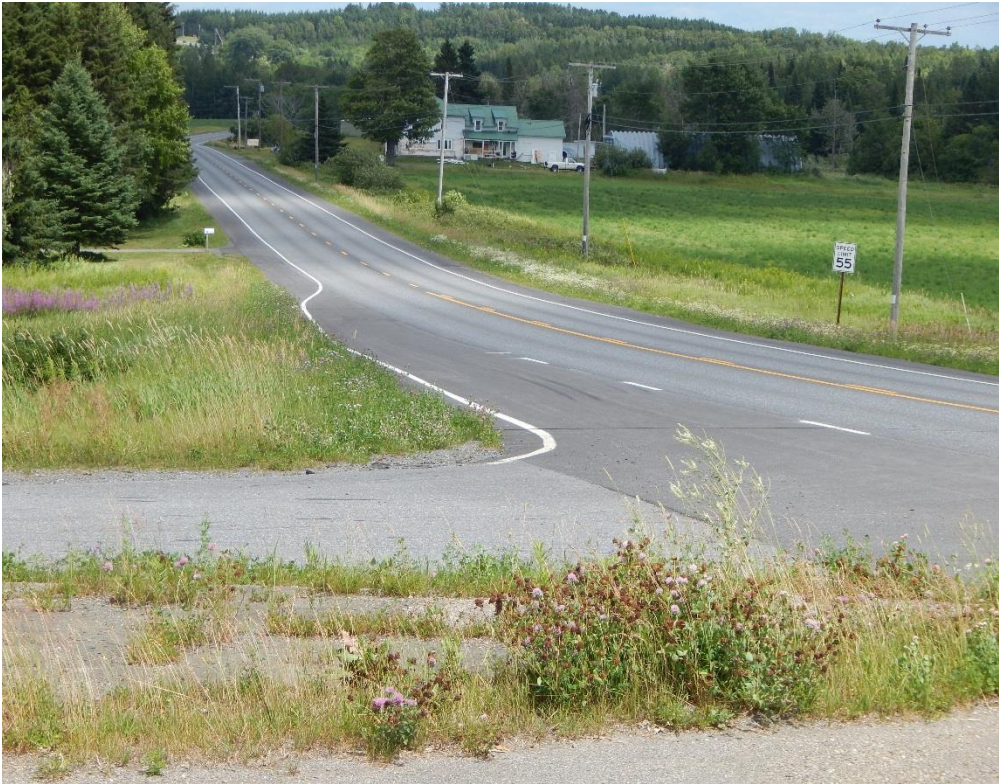
Presque Isle Road at Conant Road intersection looking towards Presque Isle. Blind hill with driveway. School bus stop is well marked with signs in both directions.

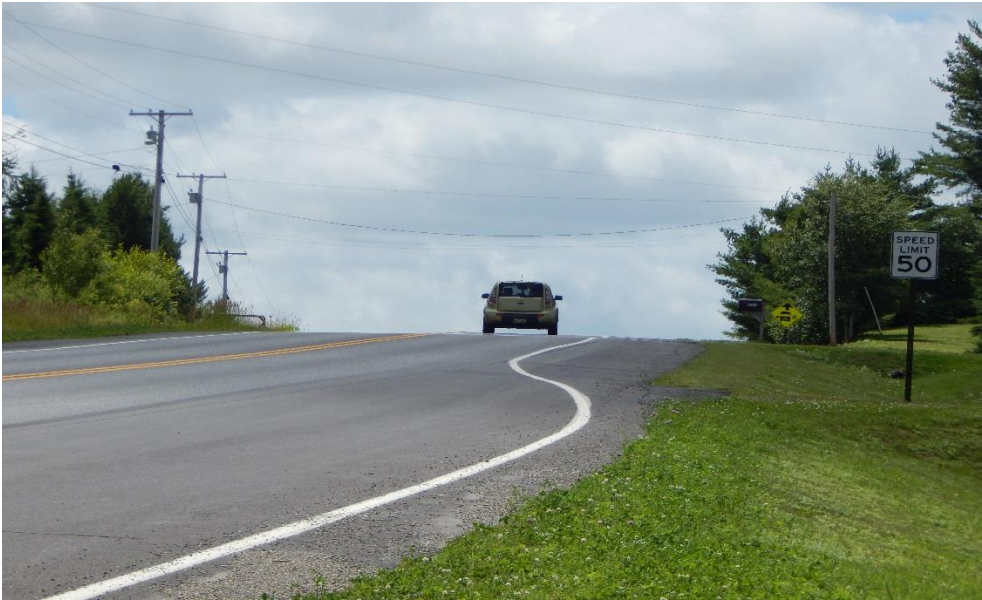
Presque Isle Road looking towards the Conant Road intersection. Typical deer and moose habitat. But notice the good sight distance.

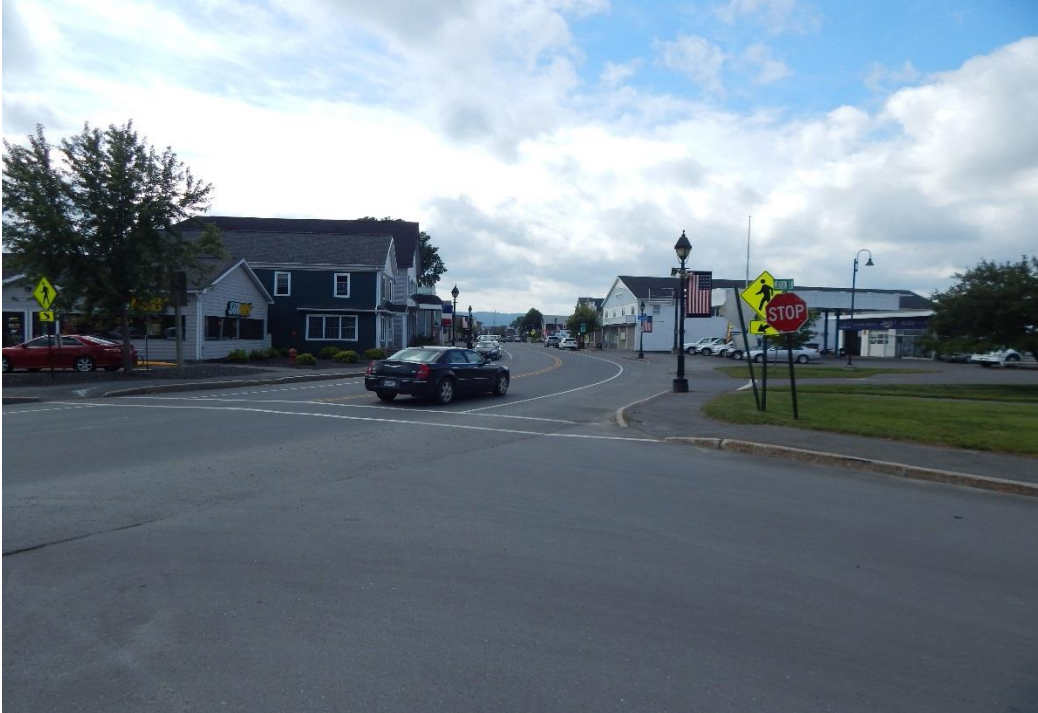
West Main Street looking east toward Meadow Lane. Notice number of curb cuts.
