# Short-Term Recommendations for Improving the Safety of High Crash Locations in Rural Aroostook County

December 2018

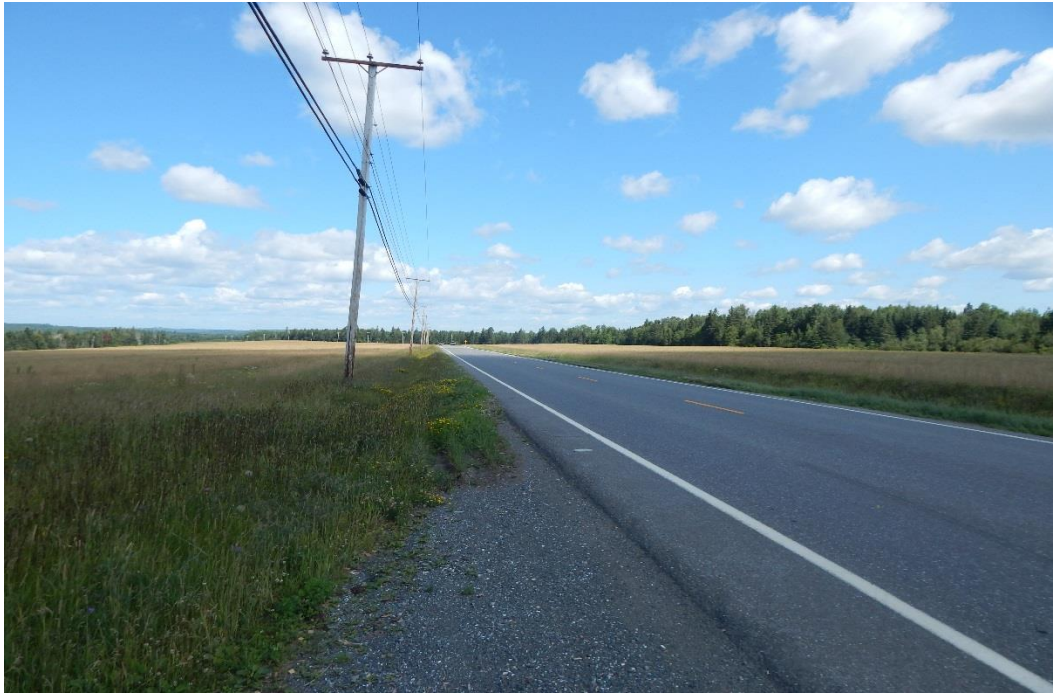
Masardis Road (Route 11) at the Sterling Ridge Road intersection. Notice mill parking across from mill and sharp curve sign.

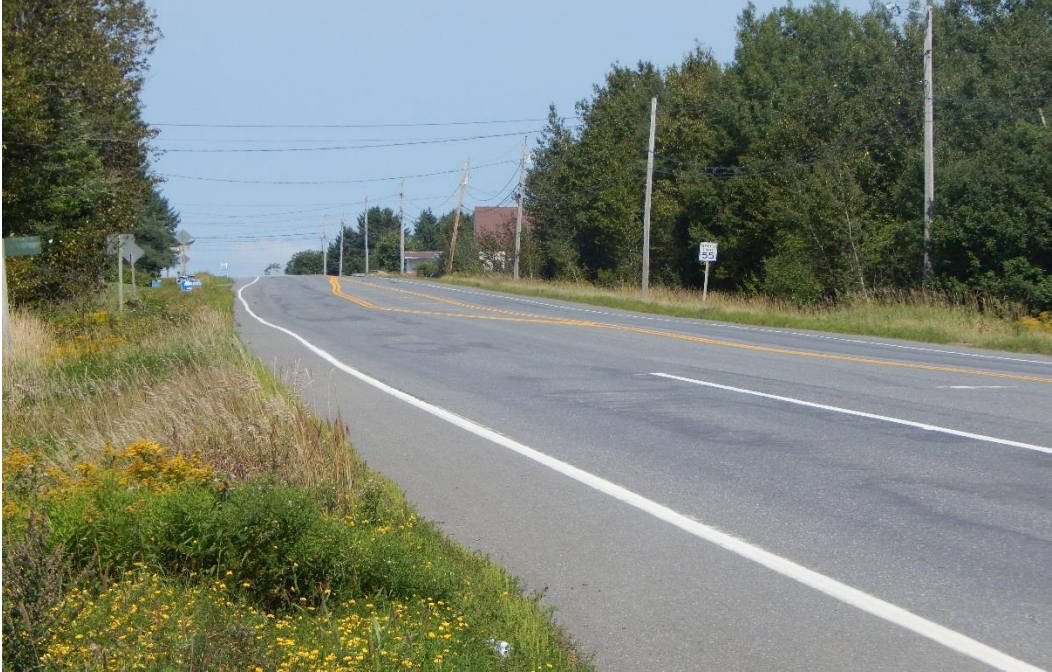
Intersection of Cambridge Road. Passing lane (southbound) ends at crest of hill.

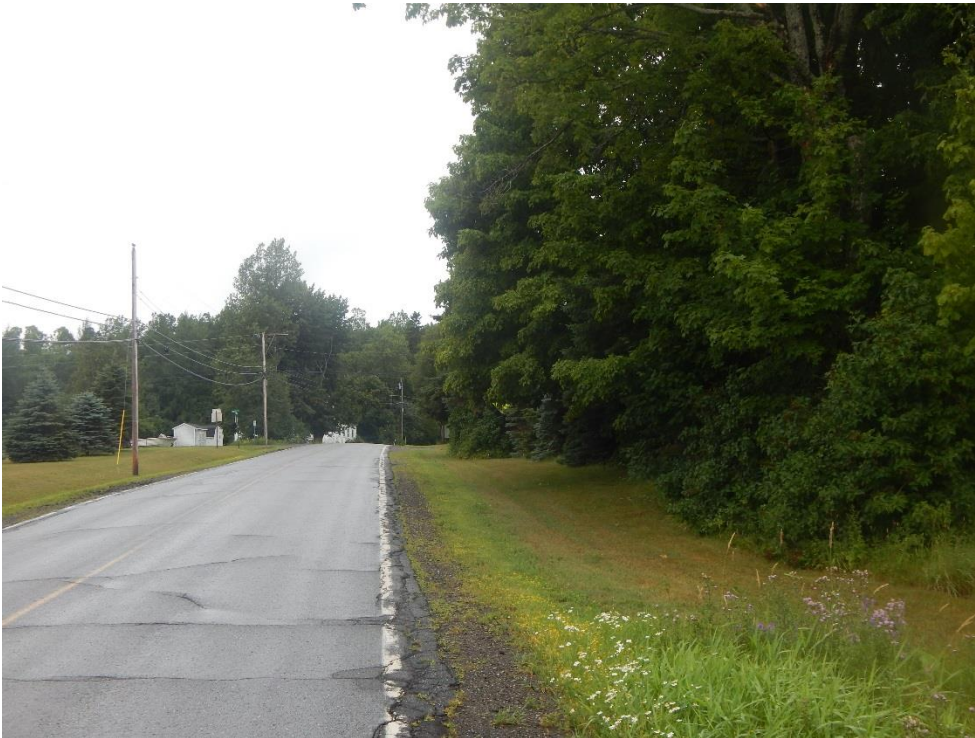
Same location from the Eastbound lane. Looking west.
