# **Short-Term Recommendations for Improving the Safety of High Crash Locations in Rural Aroostook County**

**Northern  
Maine  
Development  
Commission**

December 2016

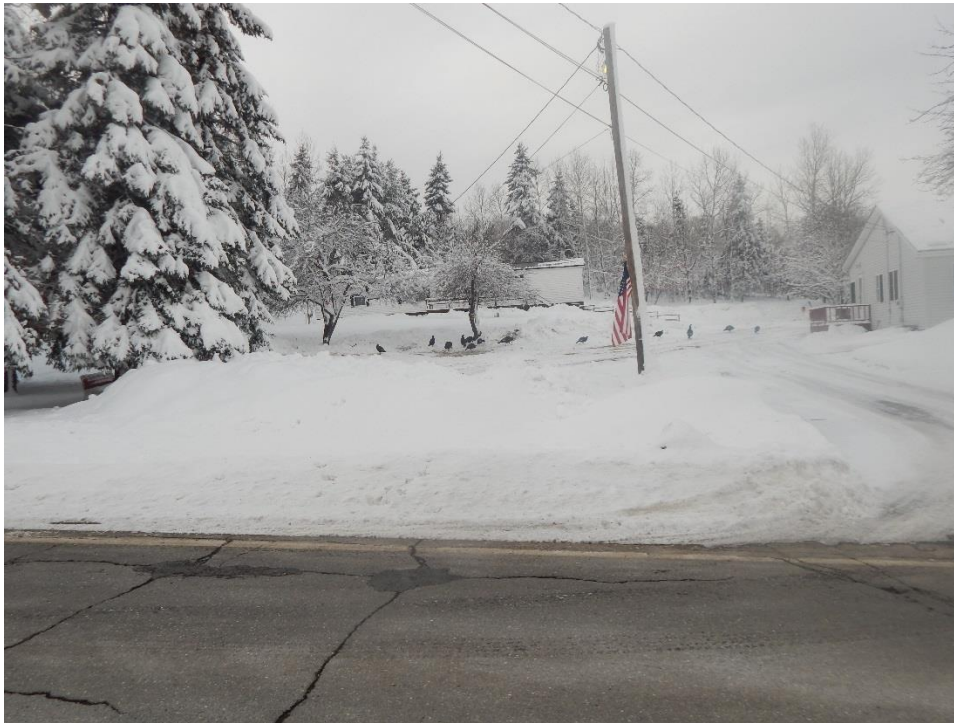
Route 227 just east of Ashland's village area. Notice the flock of Wild Turkey that are being fed by a landowner. This area is also heavily utilized by white-tailed deer.

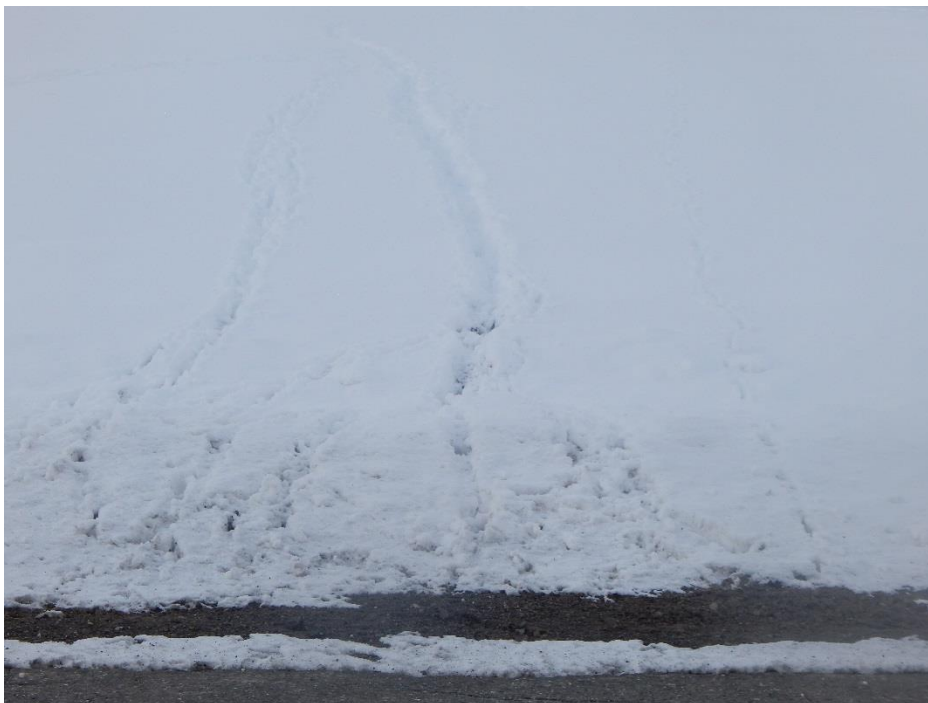
Route 227. Notice deer trails

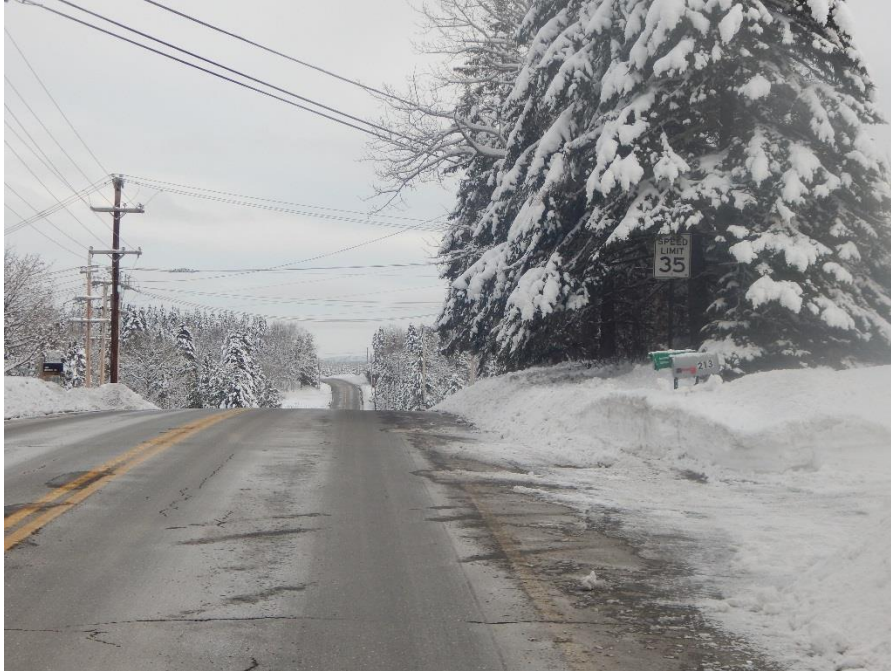
Route 227 looking east. Notice Speed Limit sign is hidden by tree. This area is heavily utilized by deer and several landowners feed deer during the winter months.

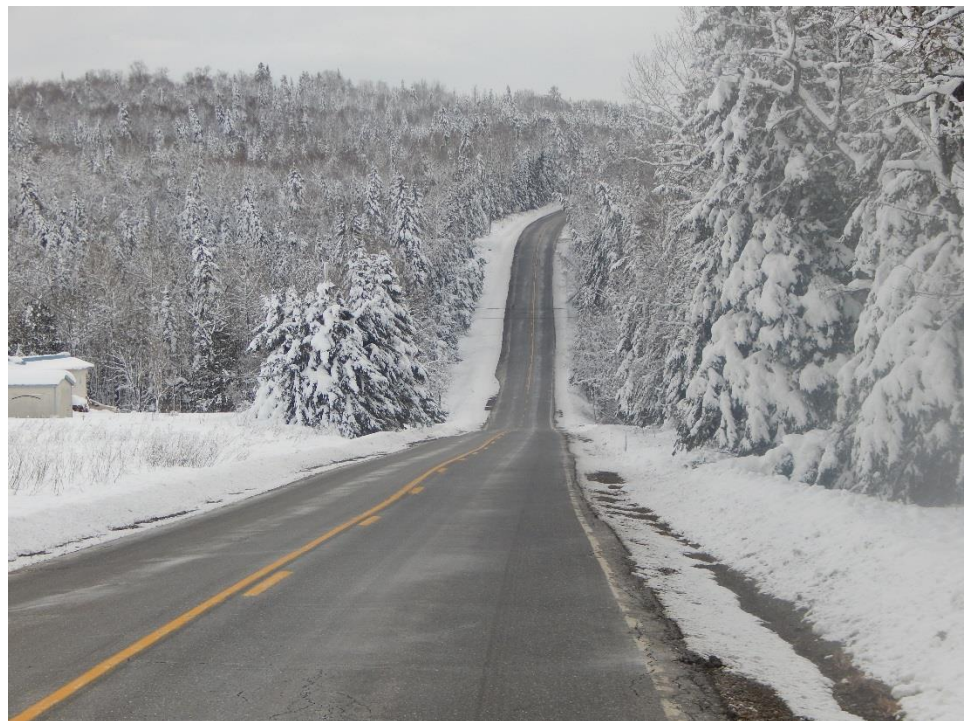
Route 227 westbound looking at York Ridge. This is a relatively steep slope with animal crossings.

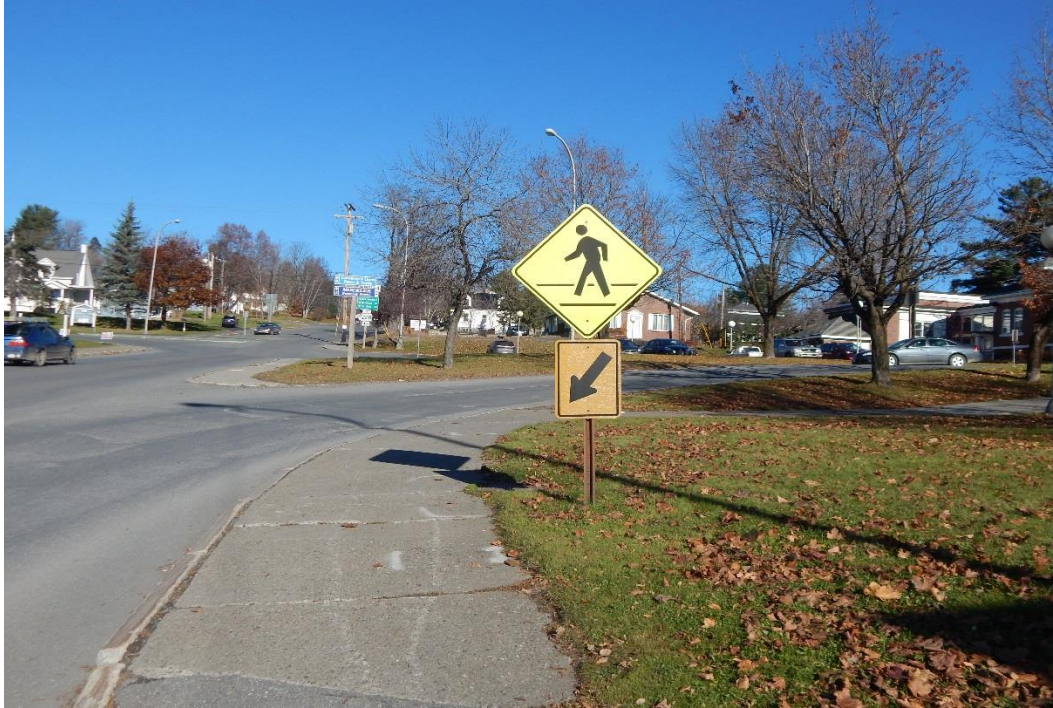
High and Herschel Street intersection looking north. Notice lack of marked pedestrian crosswalk.

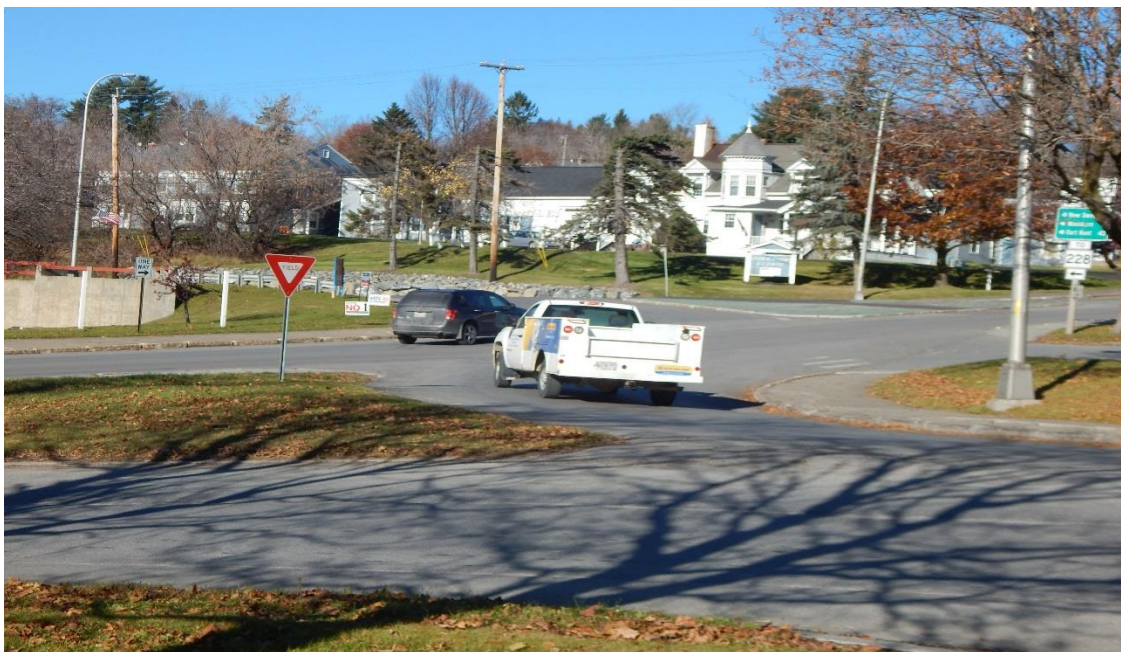
High and Herschel Street intersection looking west. Notice lack of marked pedestrian crosswalk and lane markings.

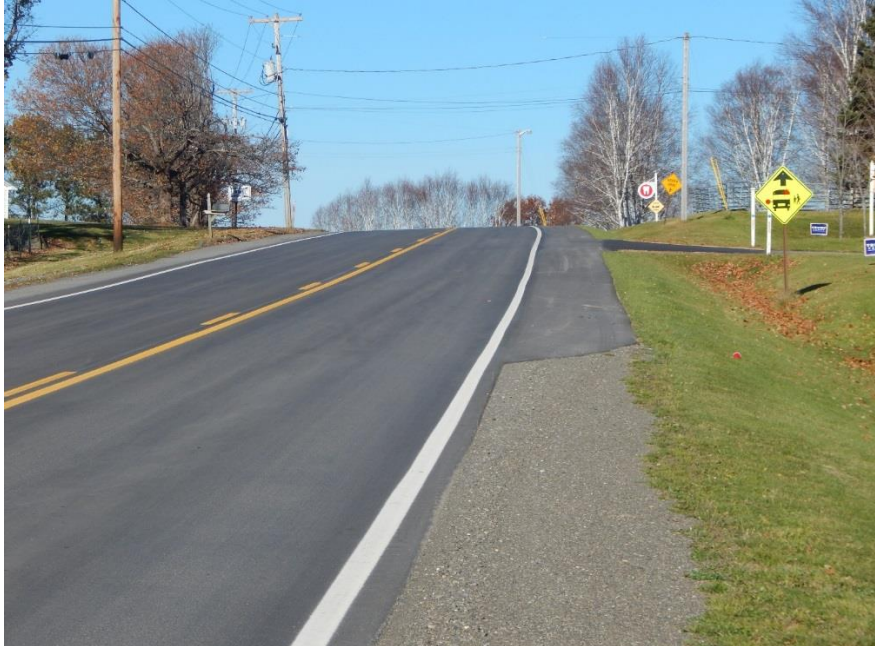
South Main Street looking west toward downtown Caribou. Notice location of commercial entrance and sight distance. Speed limit at this location is 50 mph.

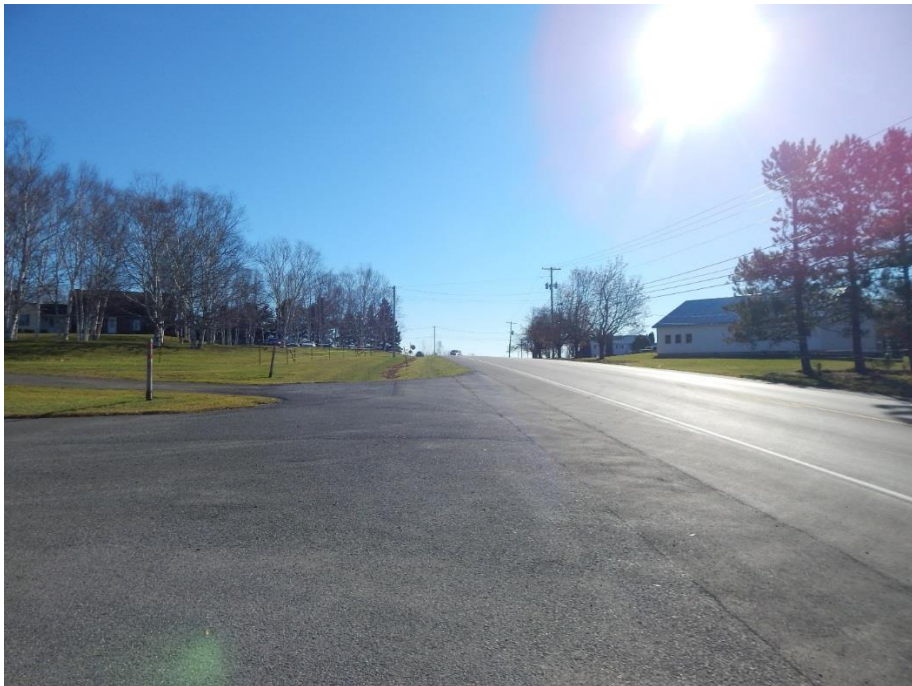
South Main Street Caribou. Decreased sight distance. Notice the vehicle turning into a local business

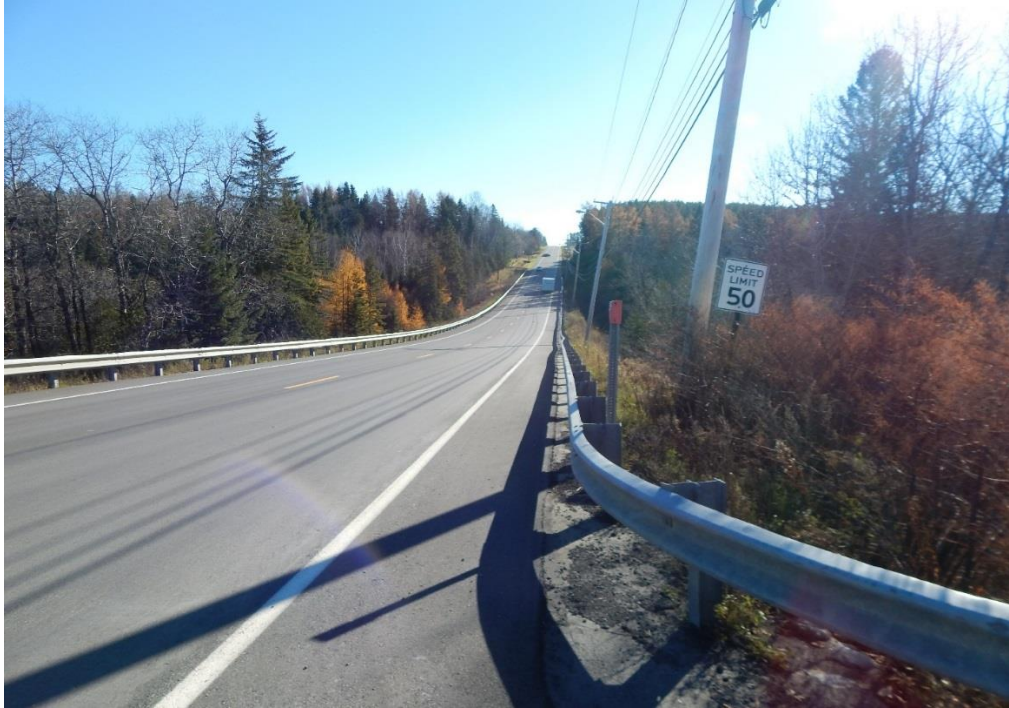
South Main Street, Caribou at Kittenger Drive intersection. Steep slopes at this intersection with a commercial entrance.

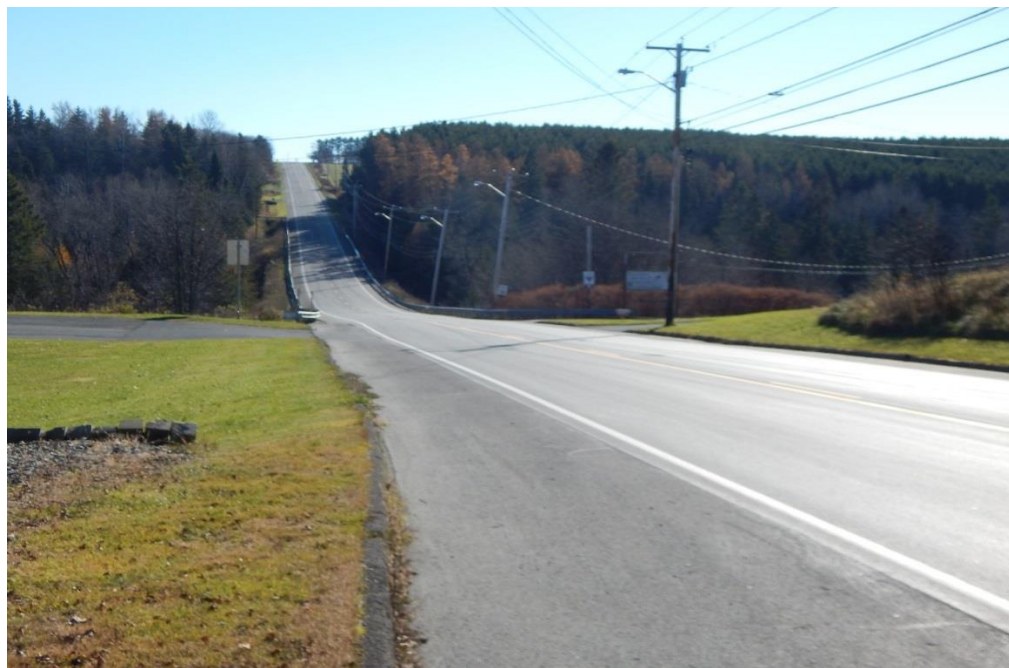
South Main Street, Caribou Maine. Notice steep slope with two commercial entrances

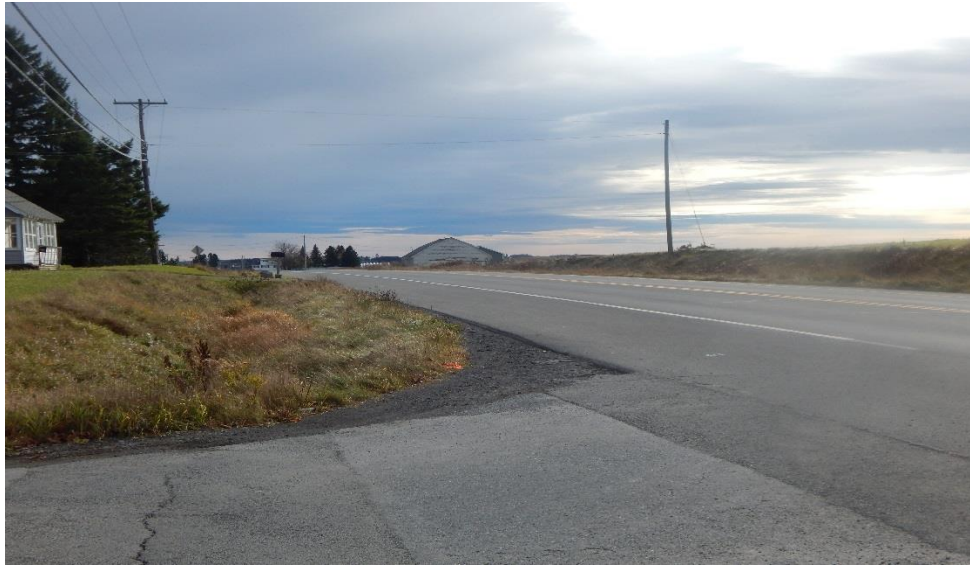
Belanger Road/ Van Buren Road intersection looking south towards Caribou. Note decreased sight distances (both north and southbound)

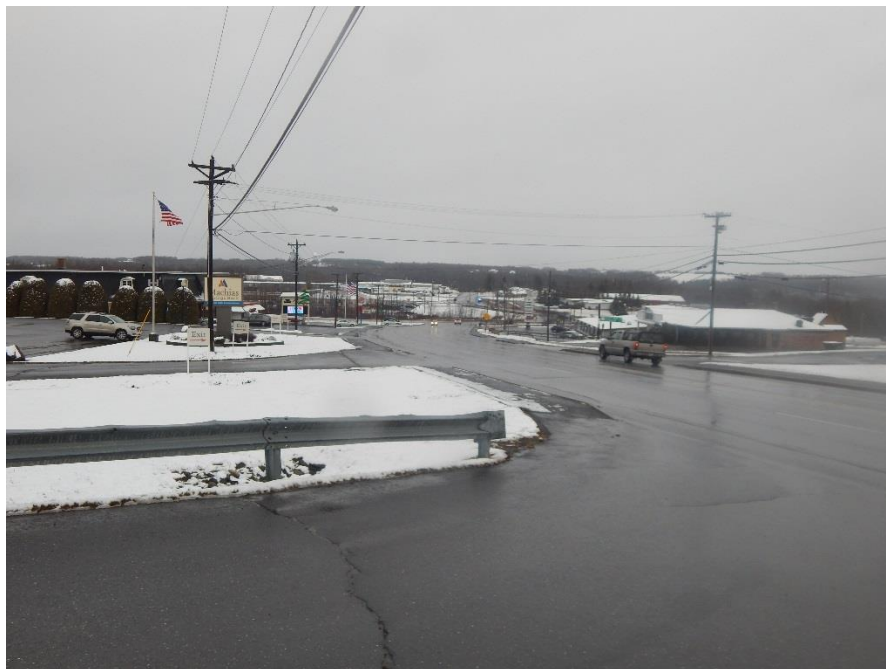
Bennett Drive northbound. Notice the many accesses

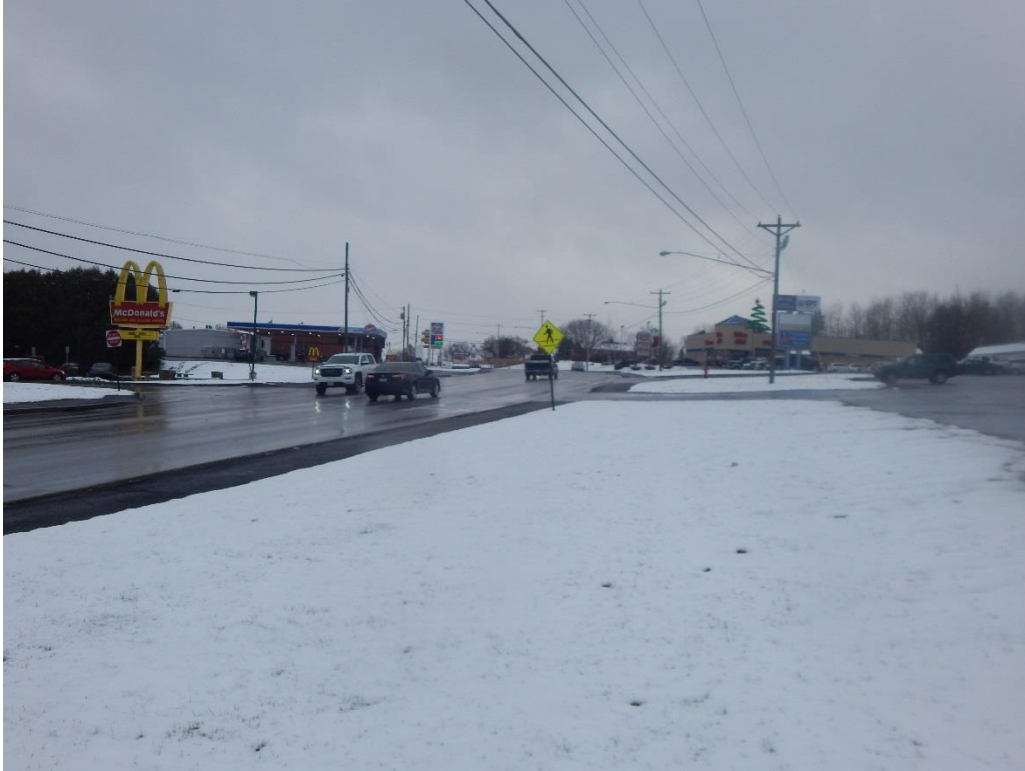
Bennett Drive looking north. Notice the number of accesses, pedestrian crosswalk not well marked, and two vehicles trying to enter different accesses.

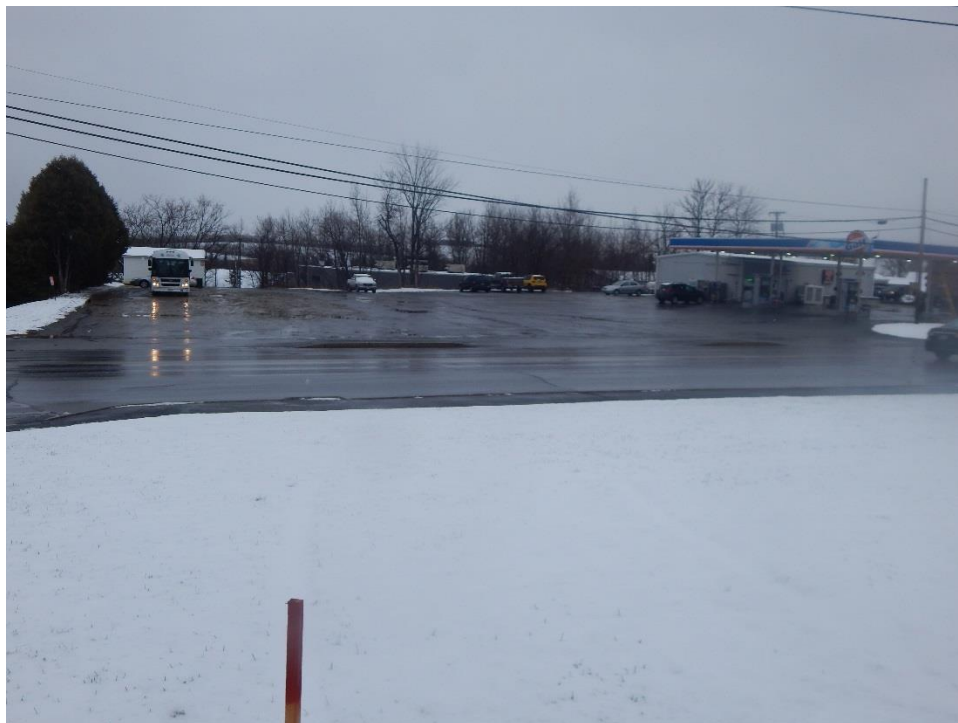
Bennett Drive. A local business with at least 4 entrances.

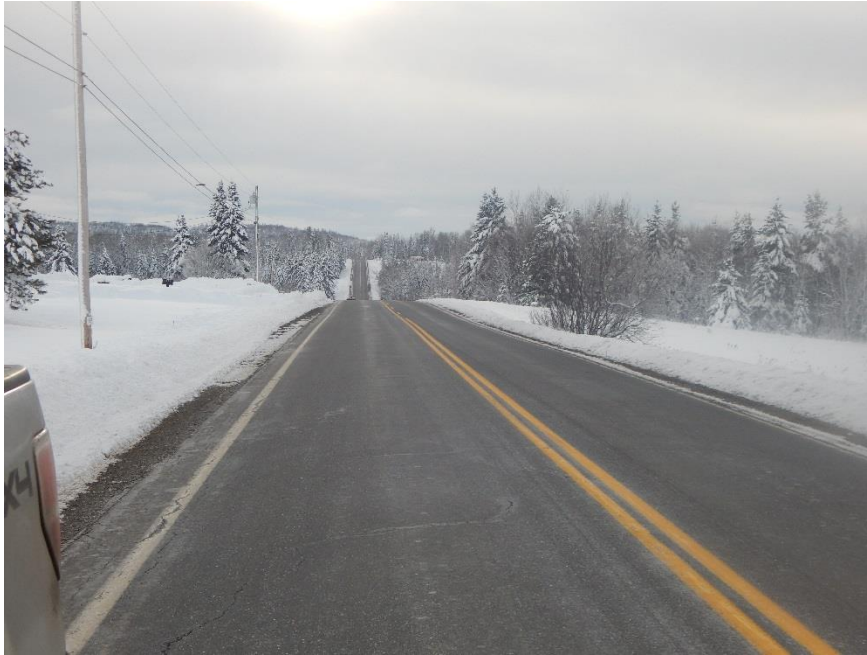
Route 227 in Castle Hill looking west. Passing lane on hill.

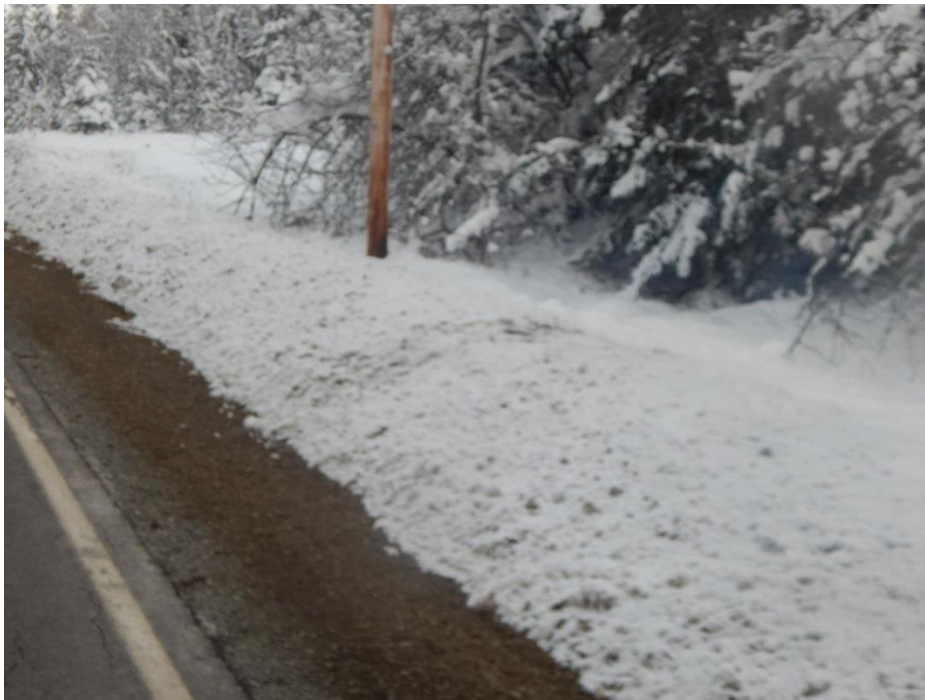
Route 227 in Castle Hill, eastbound. Deer crossing.

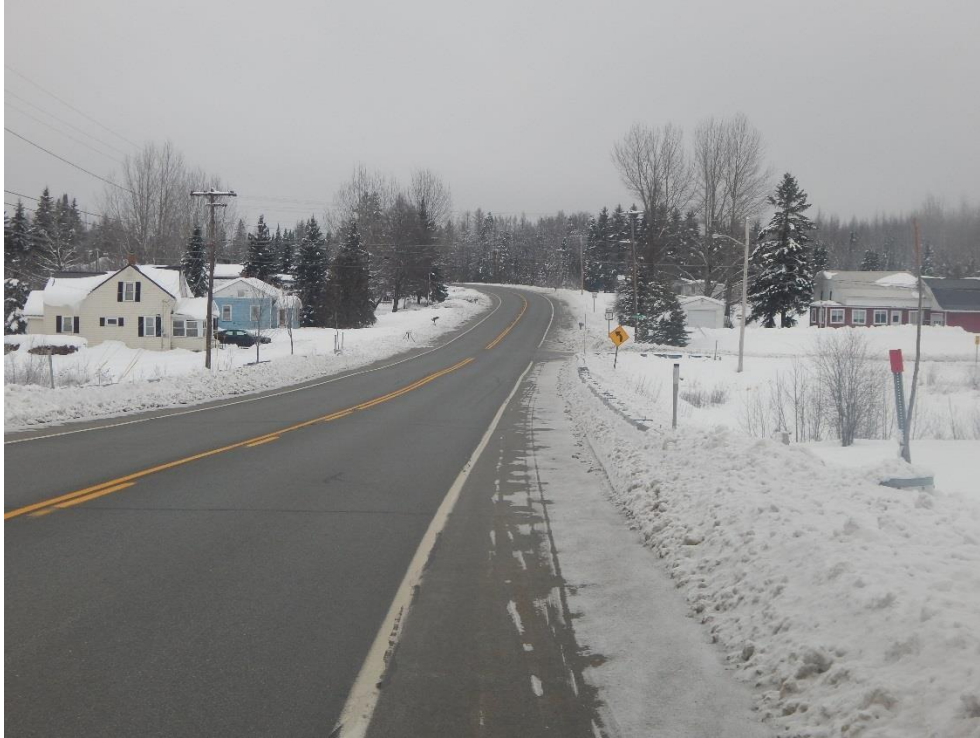
US Route One, northbound looking at the Sheen Road intersection. Notice sharp curve sign.

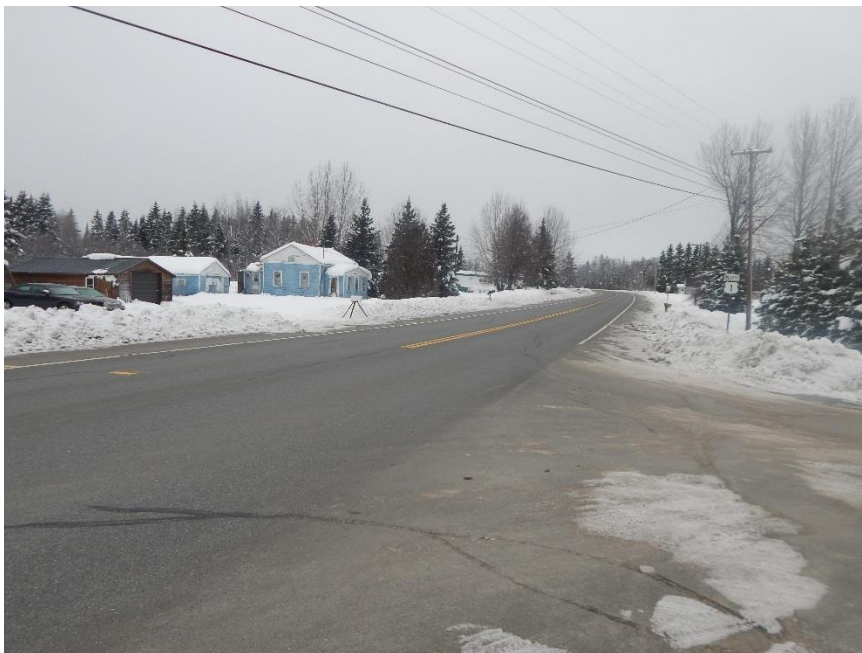
US Route One at Sheen Road intersection northbound. Notice residential driveways on sharp corner.

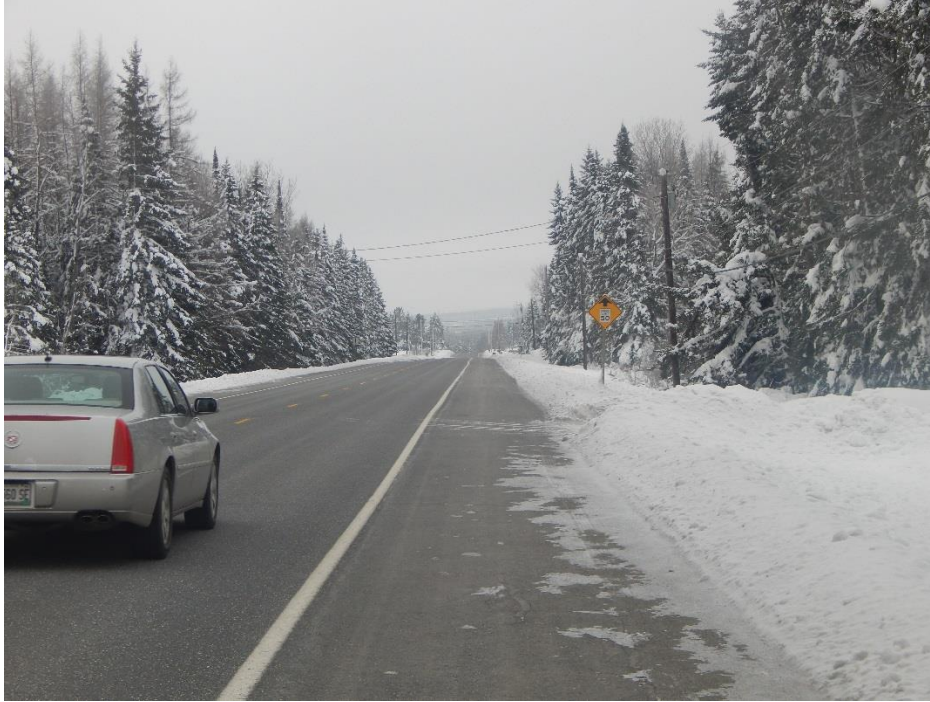
US Route One in Connor Township. Southbound speed reduction located just before residential subdivision and trucking operation.

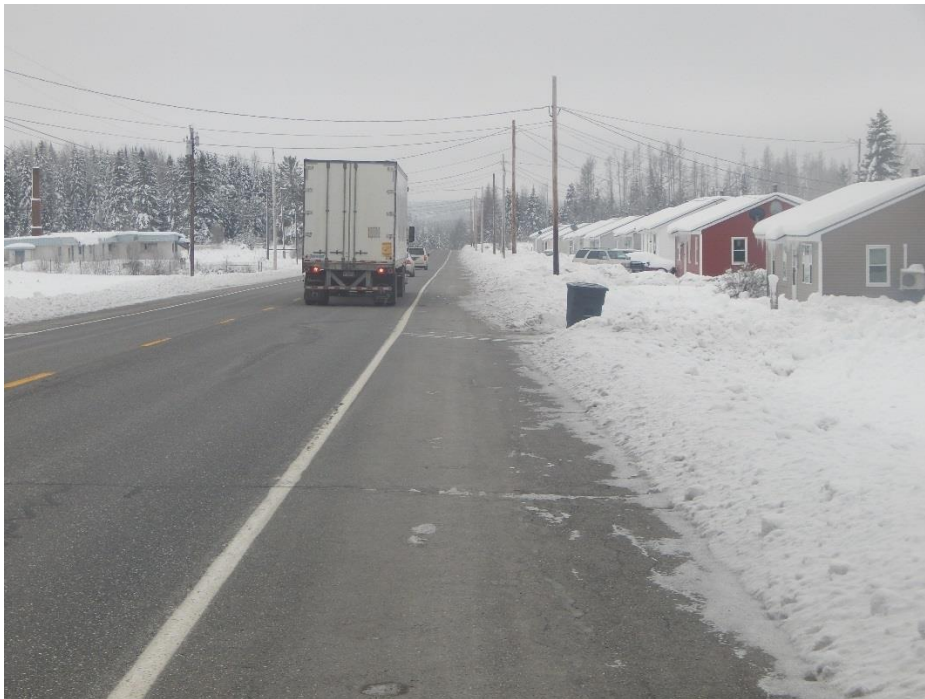
US Route One in Connor Township looking south towards a residential subdivision. Notice the numerous driveways.

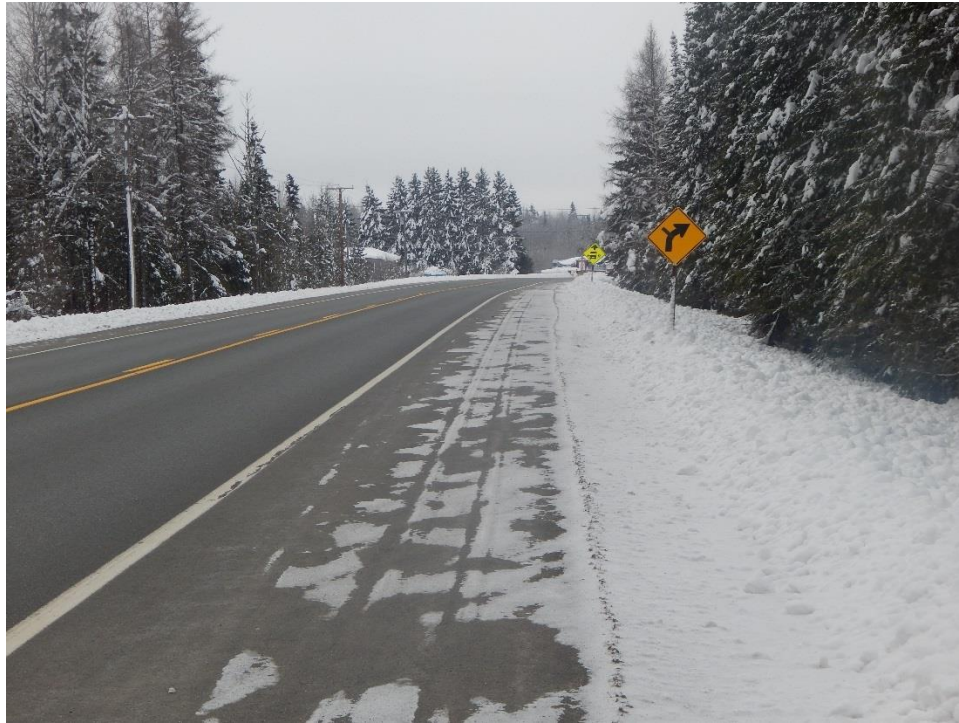
US Route One in Connor Township, southbound. Notice sharp corner and school bus stop sign. Several residences are located just south of this corner.

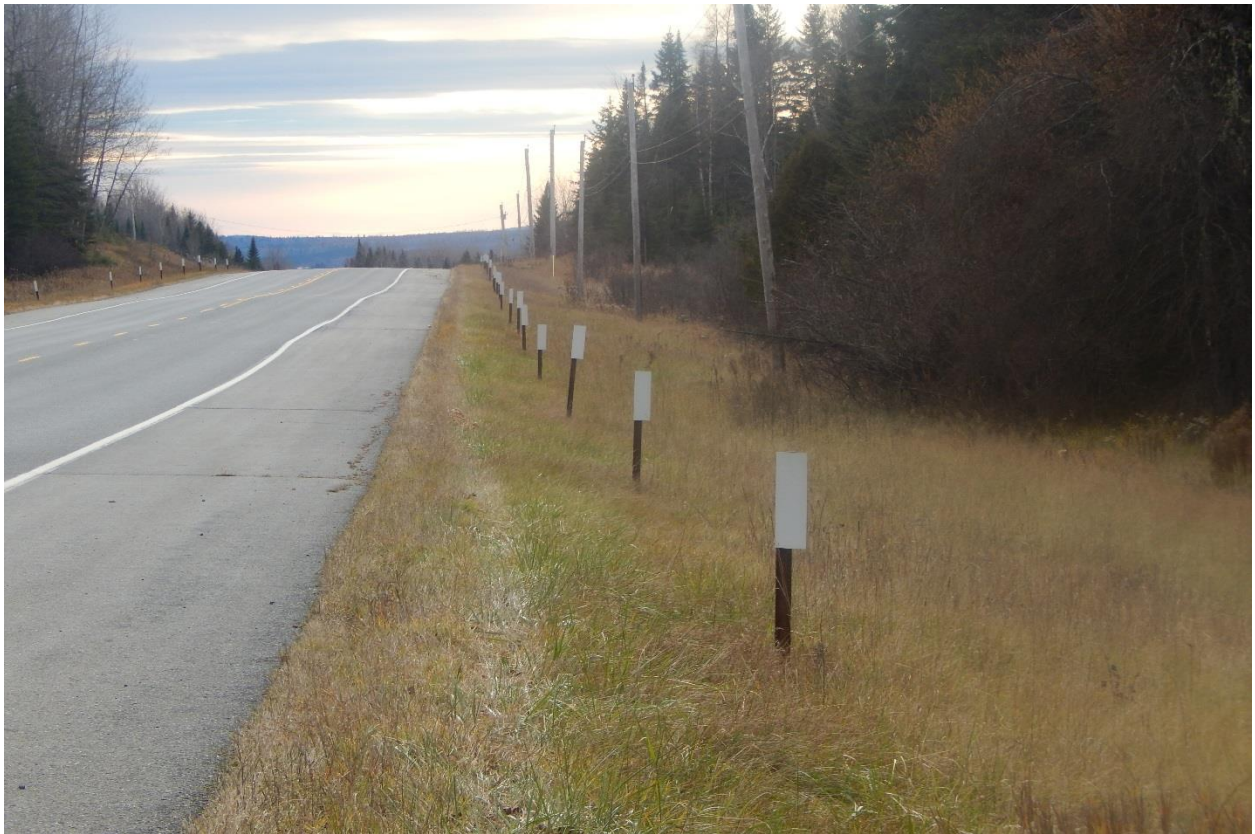
Van Buren Road in Connor Township at Cyr Planation Townline. Road is straight with animal reflectors and vegetation has been trimmed.

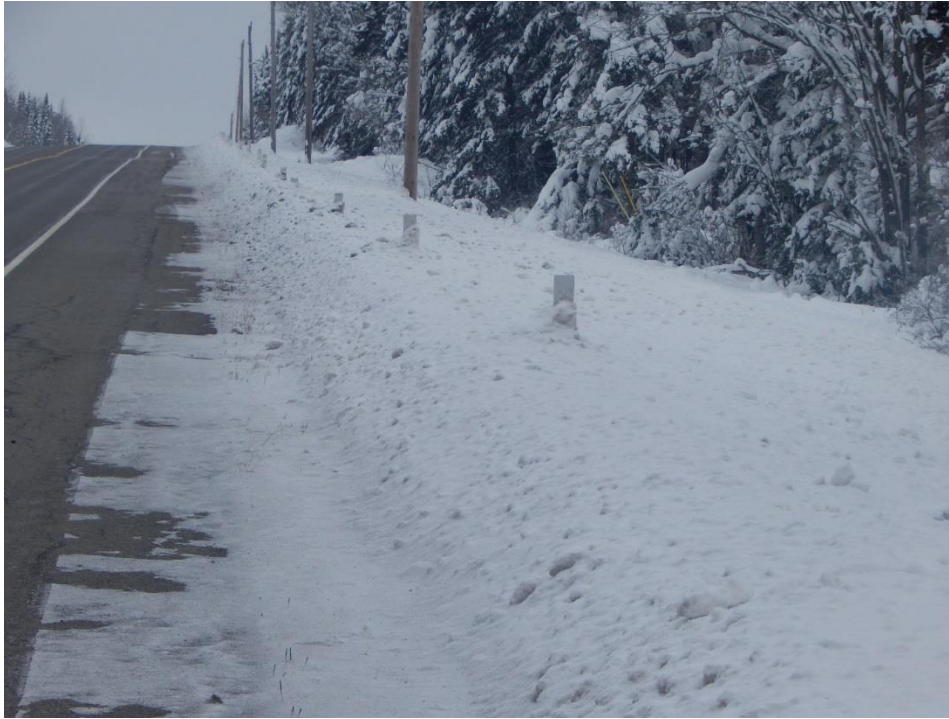
US Route One northbound in Cyr Planation. Animal reflector system is buried in snow.

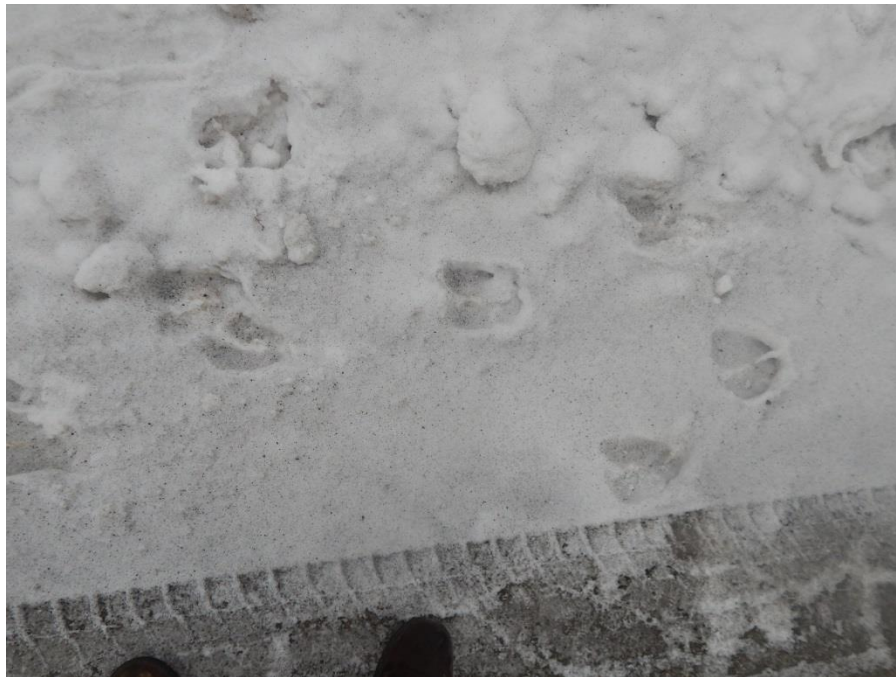
Moose tracks in road on US Route One at the Cyr Planation townline.

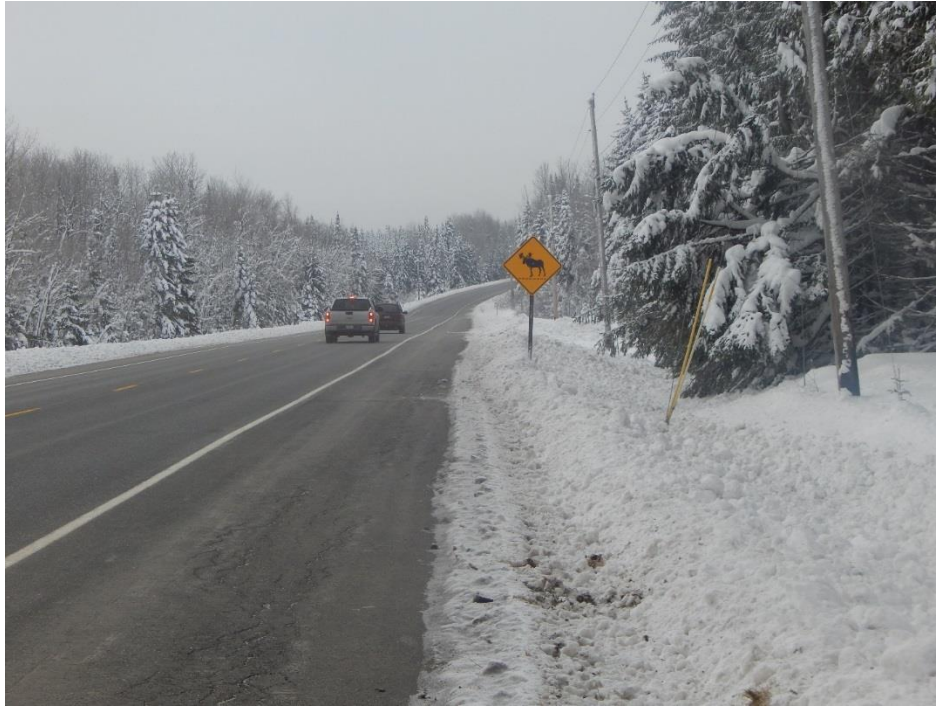
Moose Crossing sign on US Route One in Cyr Plantation, southbound lane.

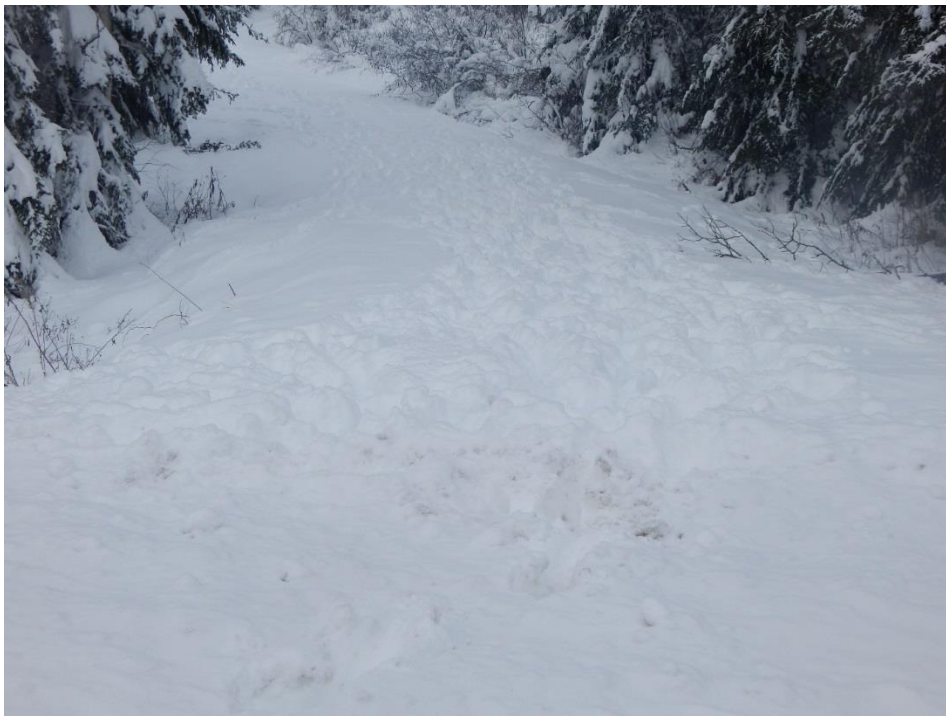
Moose Crossing on US Route One at the Cyr Plantation townline.

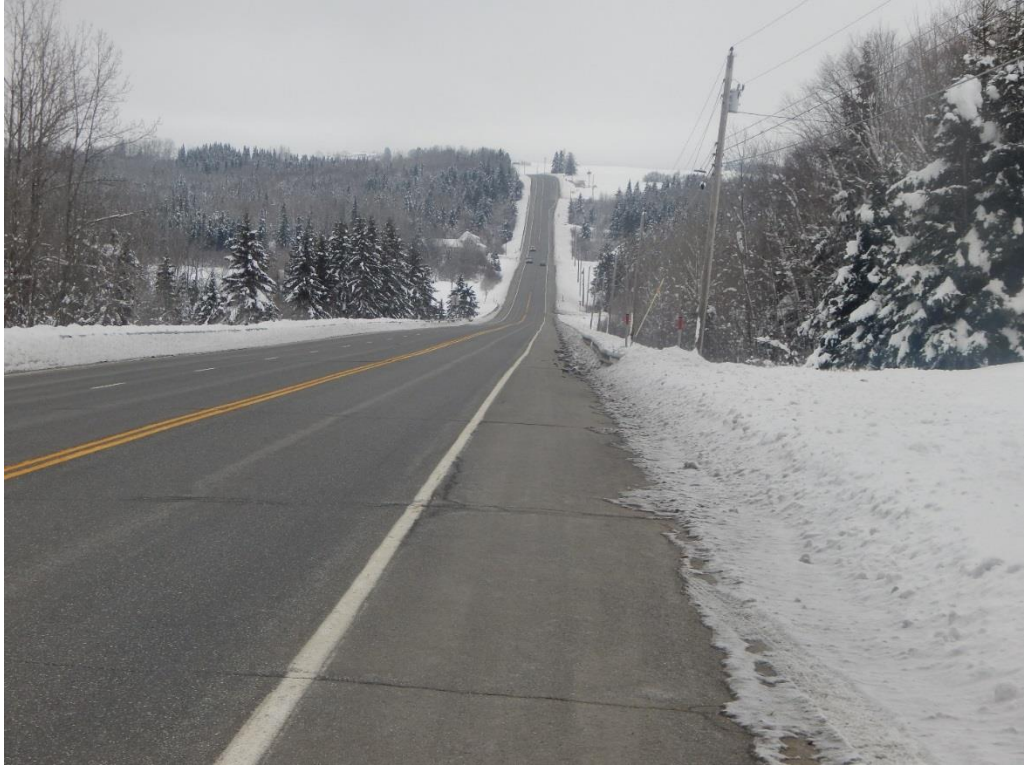
US Route One in Cyr Planation at Vaillancourt Hill. Notice driveways located at bottom of hill.

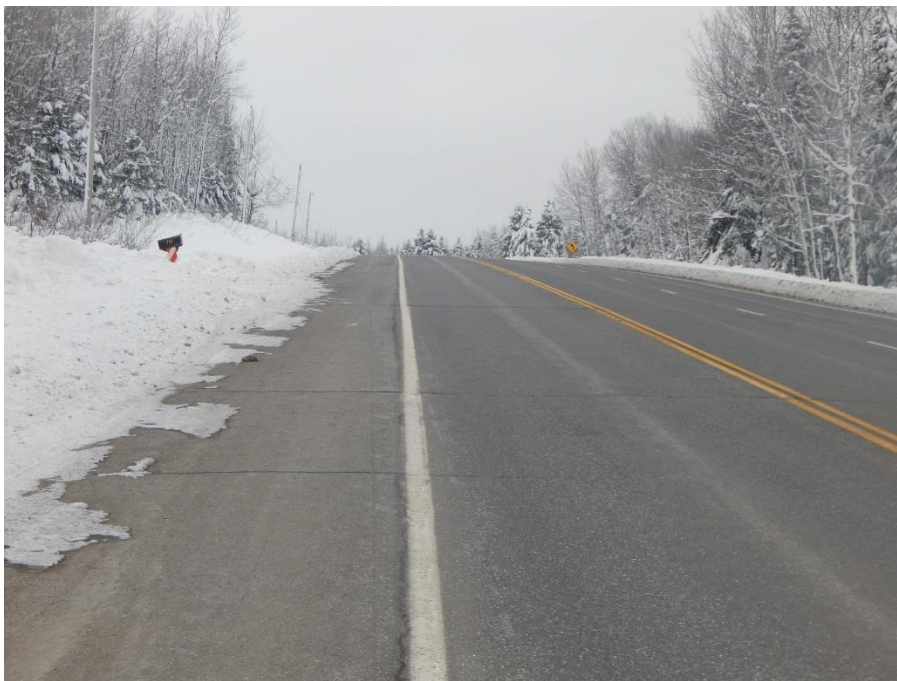
US Route One in Cyr Planation at Vaillancourt Hill. Notice blind driveway.

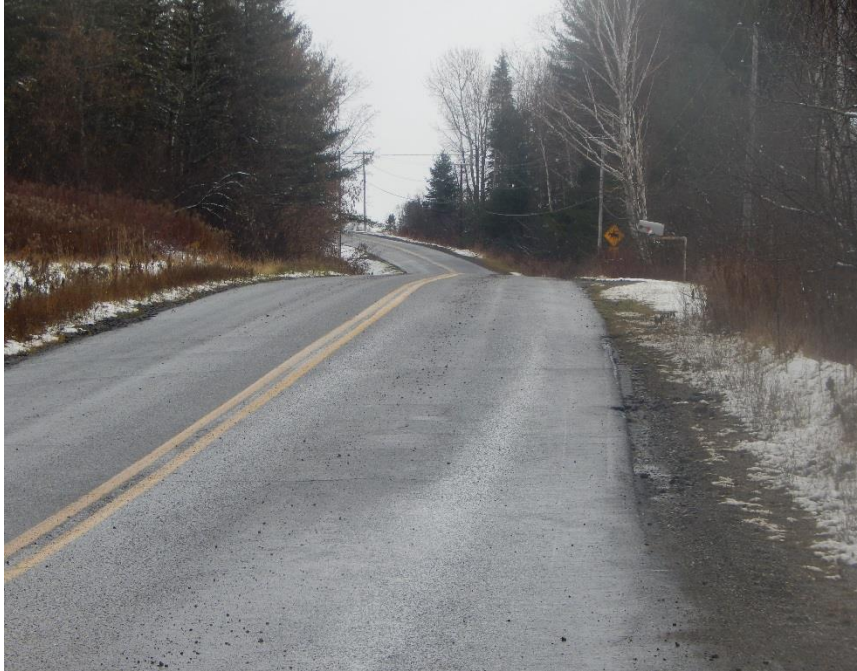
North Caribou Road eastbound. Notice blind curve with driveways and “Horse Crossing” sign partially blocked by vegetation.

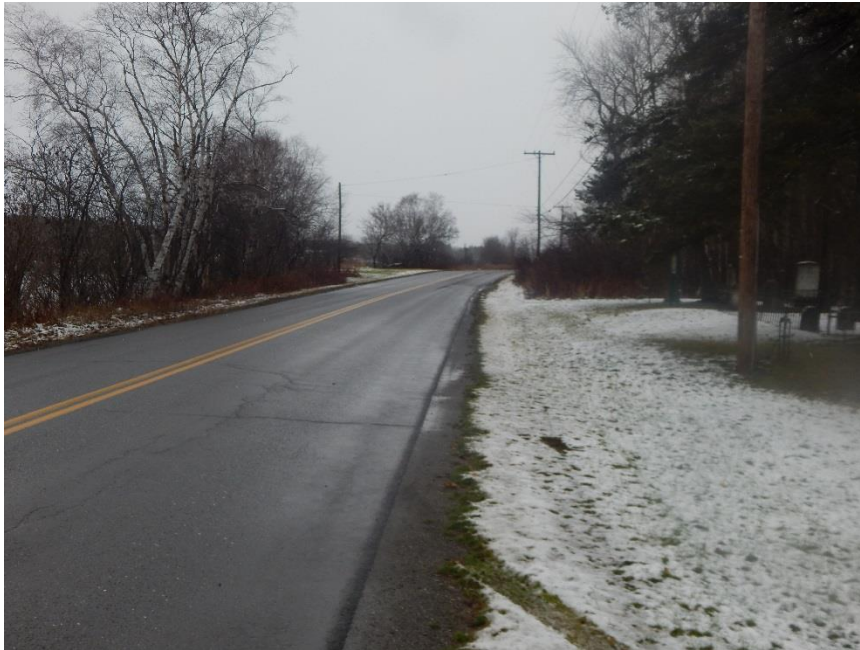
North Caribou Road westbound. Corner with entrance to cemetery.

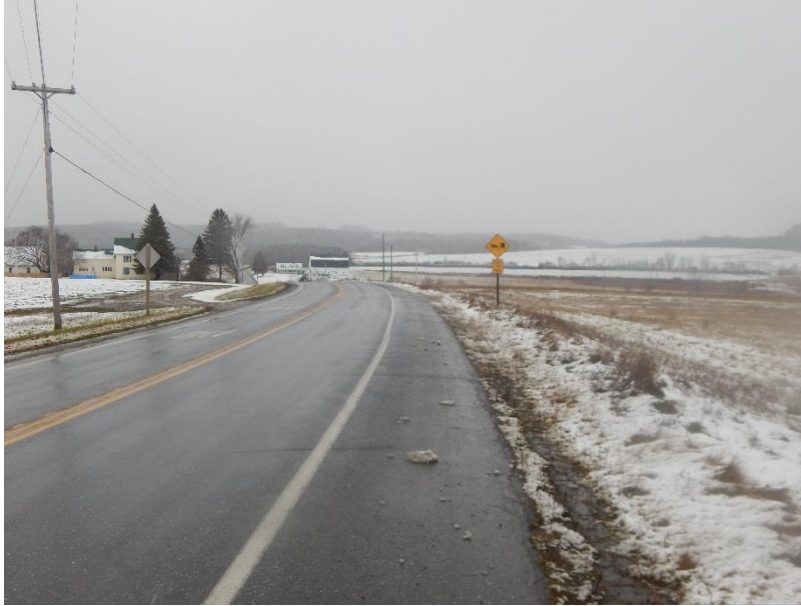
Presque Isle Road westbound. Potential area for blowing and drifting snow. Notice the Share the Road signage.

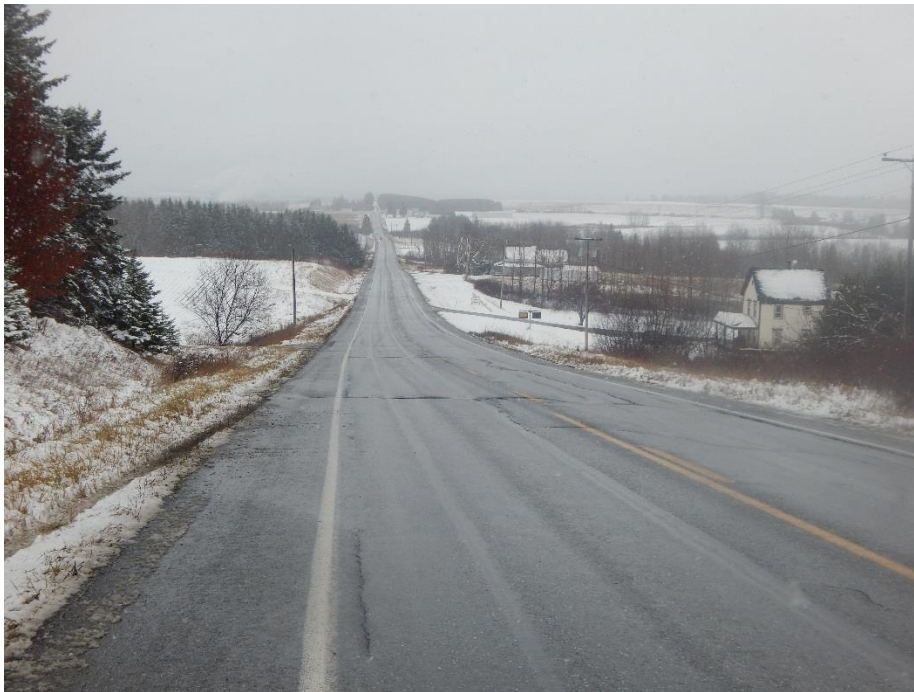
Presque Isle Road eastbound. Passing zone on hill with commercial entrance at bottom of hill. Road on left side of picture is a natural animal crossing (moose/deer). Notice lack of animal crossing sign.

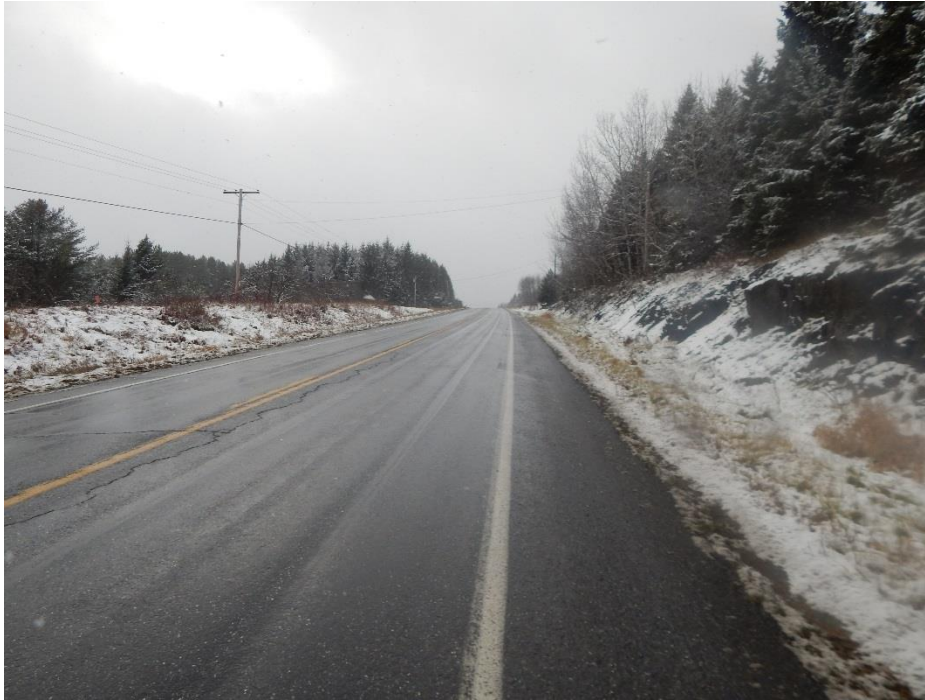
Presque Isle Road westbound. Notice steep hill with driveway located just under the crest of hill.
