# **Short-Term Recommendations for Improving the Safety of High Crash Locations in Rural Aroostook County**

**Northern  
Maine  
Development  
Commission**

December 2016

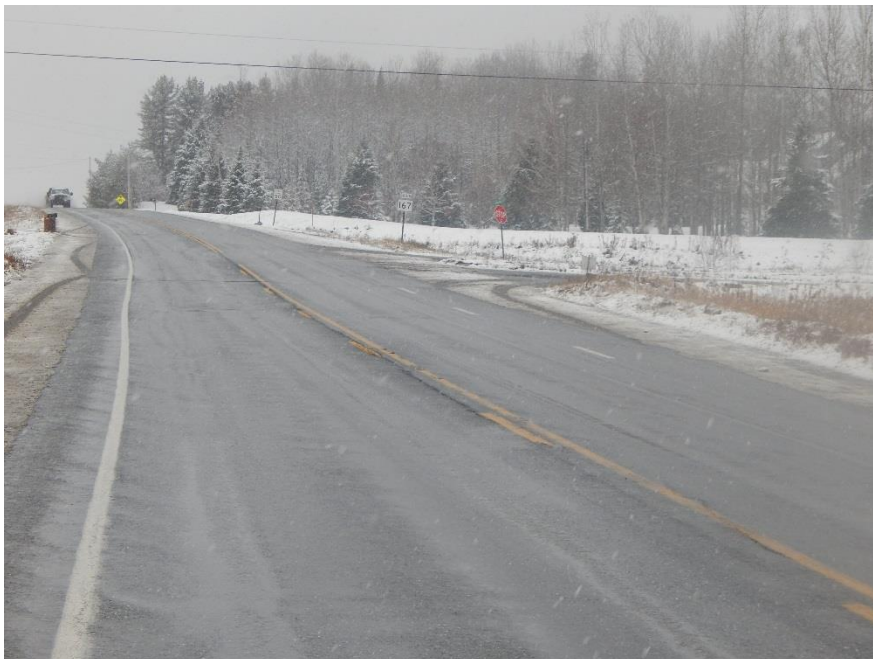
Intersection of Conant Road and Presque Isle Road westbound. Passing lane on Presque Isle Road for vehicles heading east. Turning lane for vehicles eastbound to Conant Road.

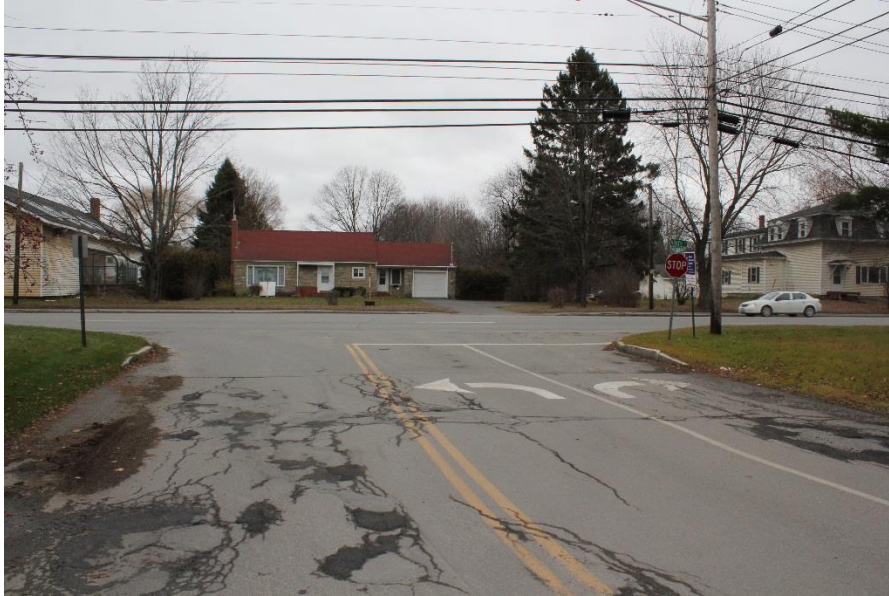
Intersection of Putnam Avenue and North Street (from Putnam Avenue). Notice lane markings.

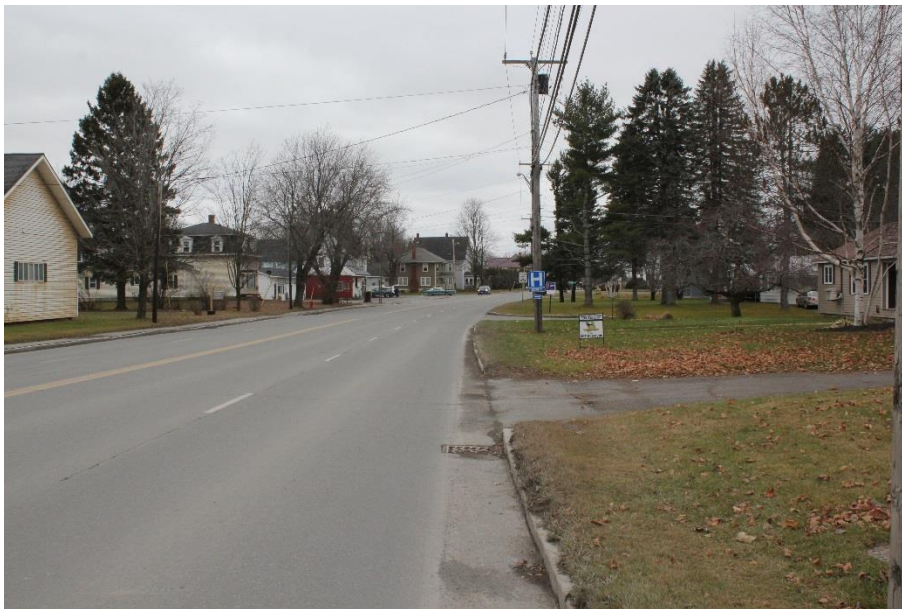
Intersection of North Street and Putnam Avenue (southbound). Notice lack of signal indicating upcoming intersection.

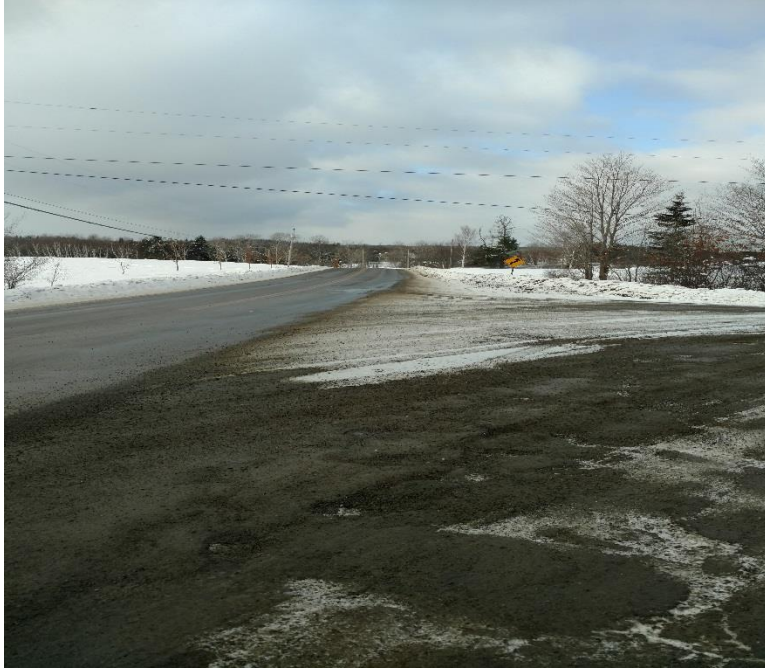
B Road at McSheffery Road intersection looking west. Notice “Curve” sign

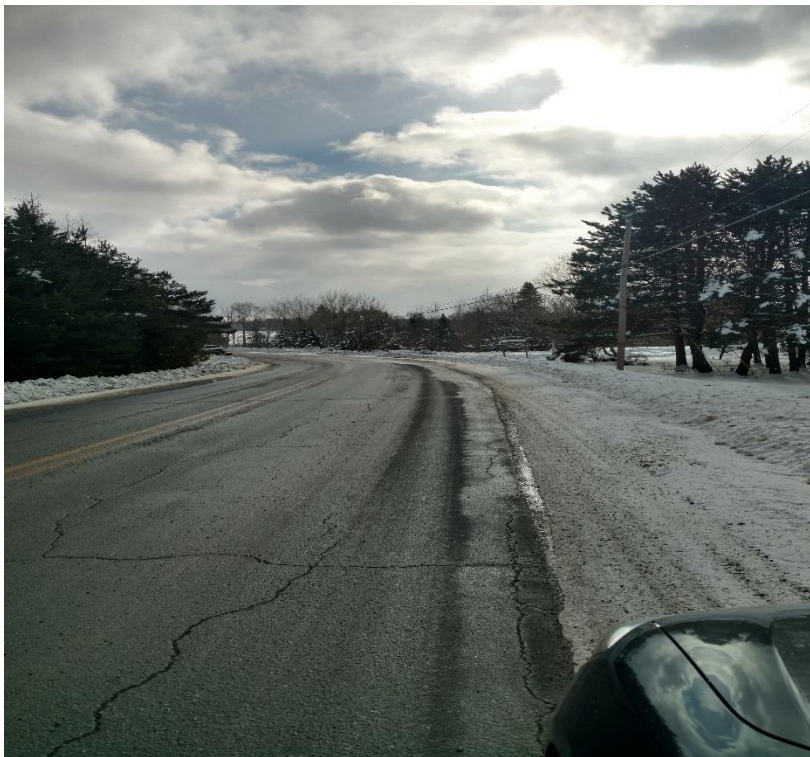
B Road in Houlton. Notice curve with driveway.

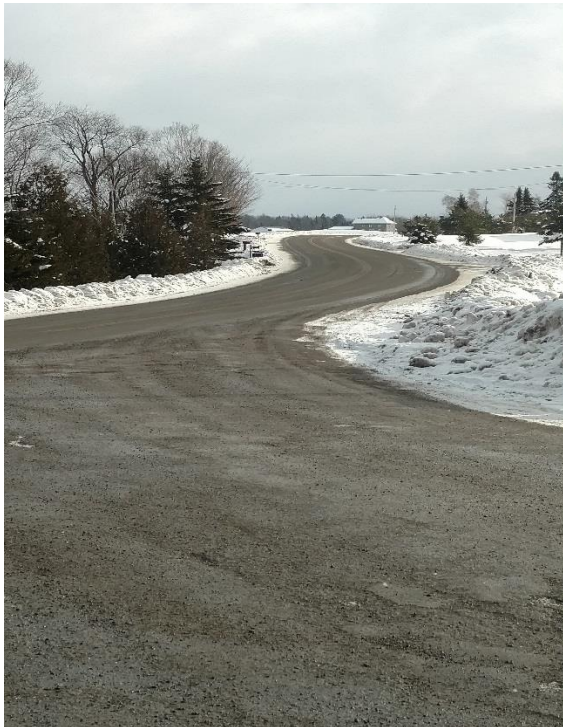
B Road at Cogan Road intersection. Intersection has a Yield sign.

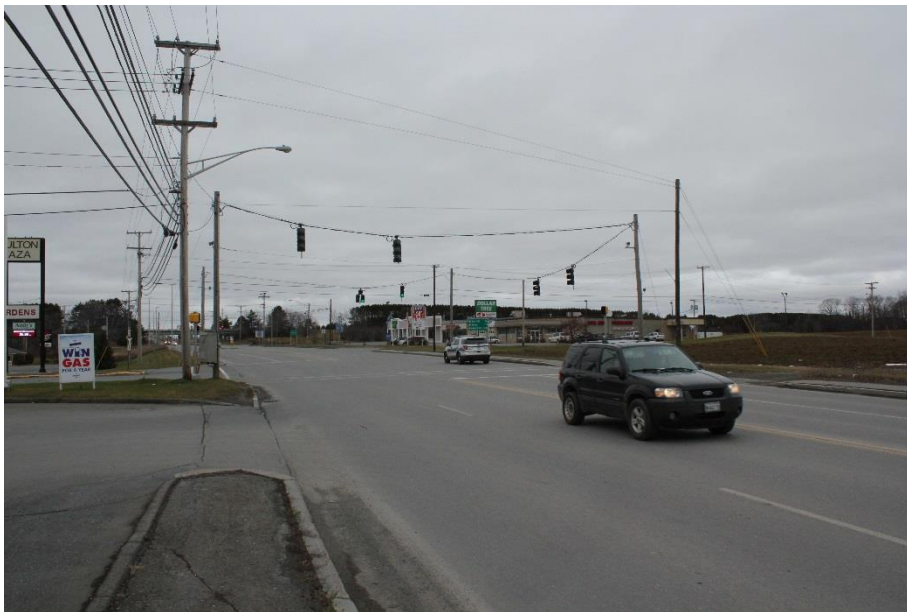
Shopping Center entrance at North Street looking north. Notice the numerous access points along the link.

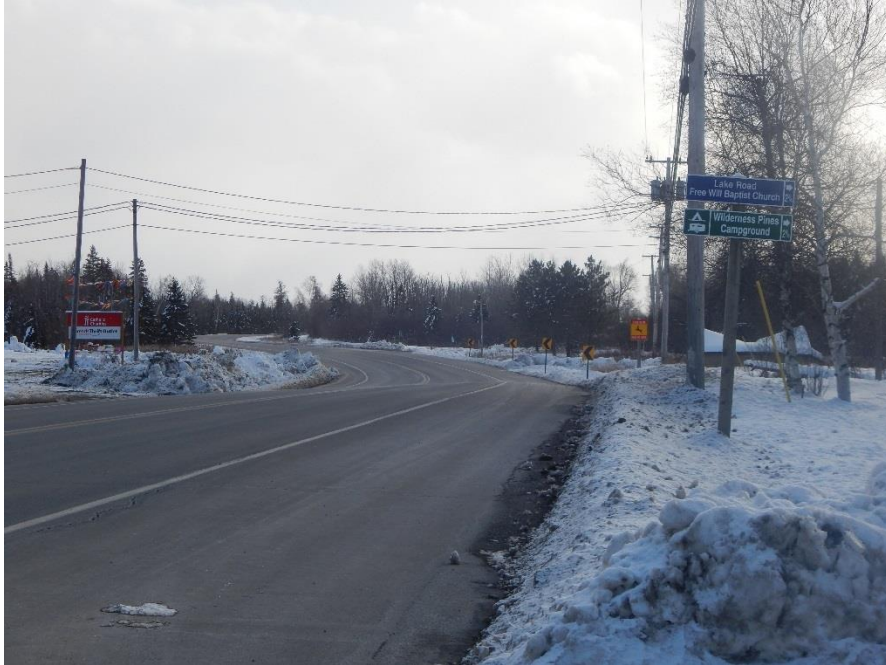
US Route One southbound at the Hill Siding intersection. Notice Chevrons and Deer Crossing sign.

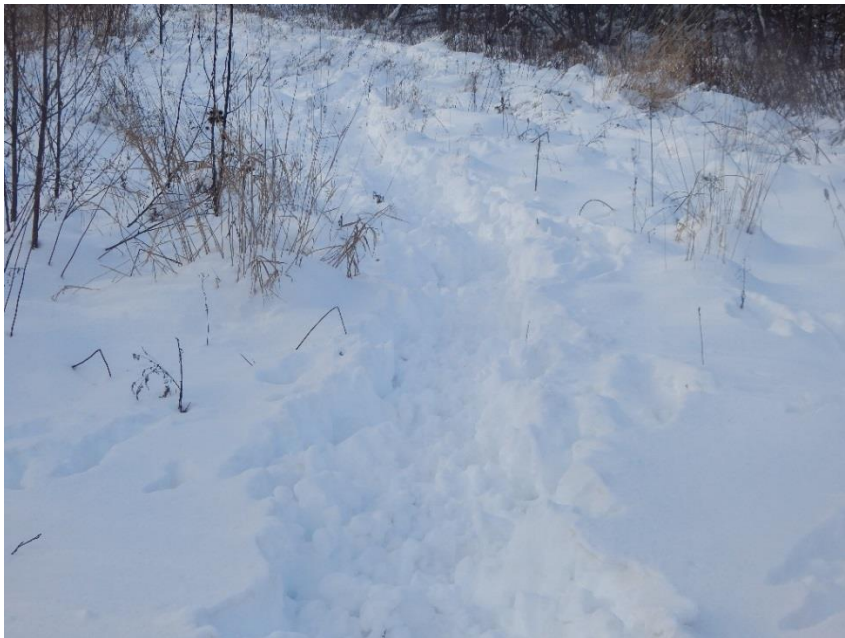
Deer crossing at Hill Siding Road and US Route One in Monticello.

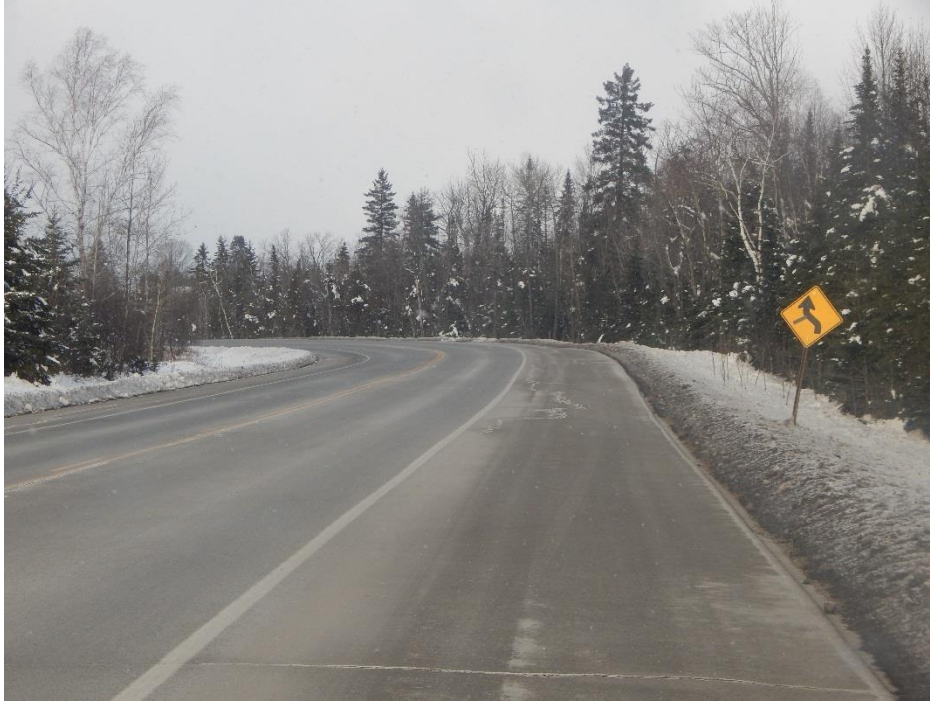
US Route One in Monticello looking northbound. Curve with intersection at Hill Siding Road.

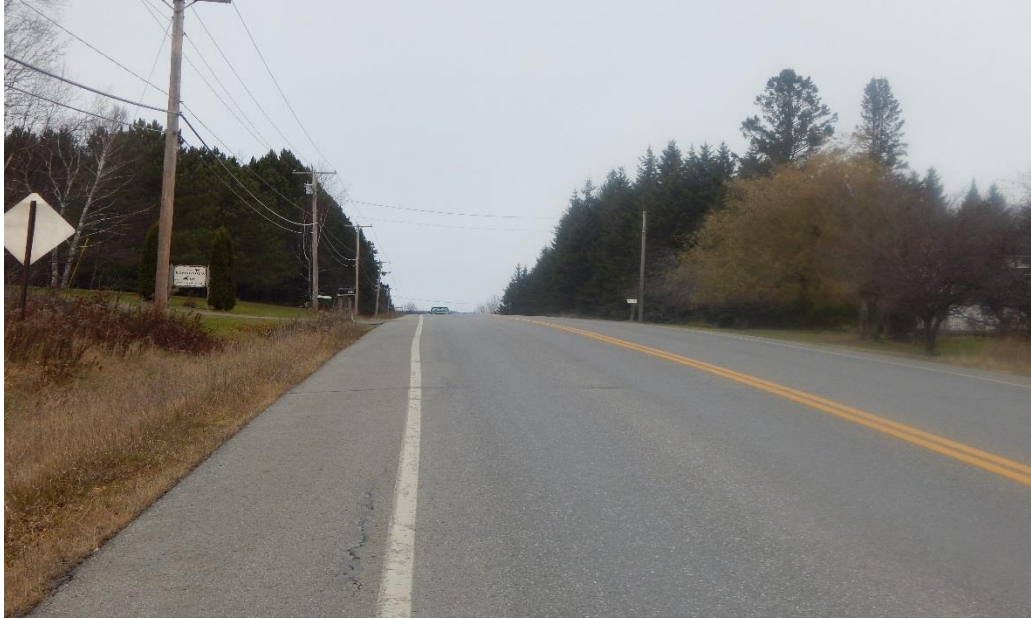
New Sweden Road at Jacobson Hill, Two residential driveways. Notice the decreased site distance as cars travel at 50+ mph.

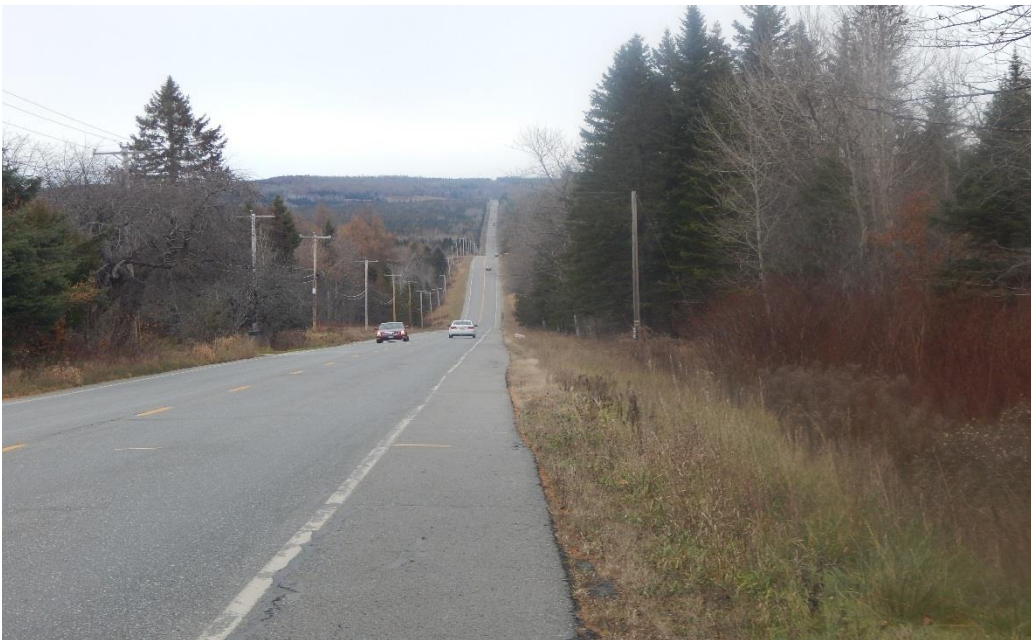
New Sweden Road at Jacobson Hill looking north towards Beardsley Brook. Notice lack of Deer Crossing sign.

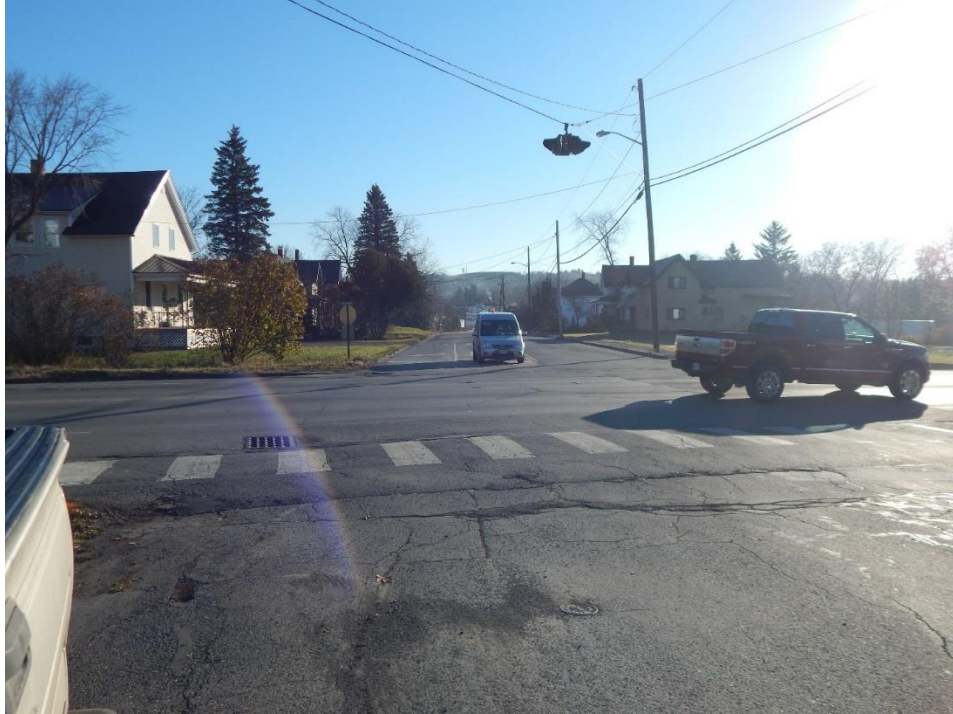
Intersection of Parson and Park street looing east towards downtown Presque Isle. Notice vehicle making wide left hand turn.

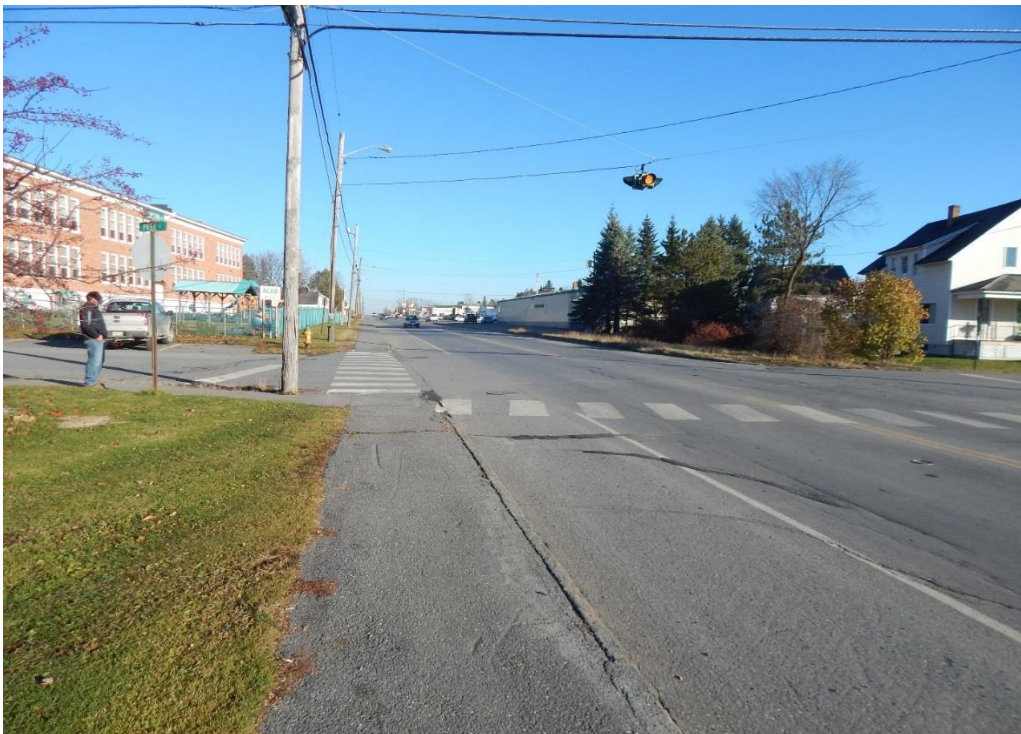
Intersection of Parson and Park Street looking north. Notice that there is no sidewalk on the east side of the road with commercial establishment located to the north.

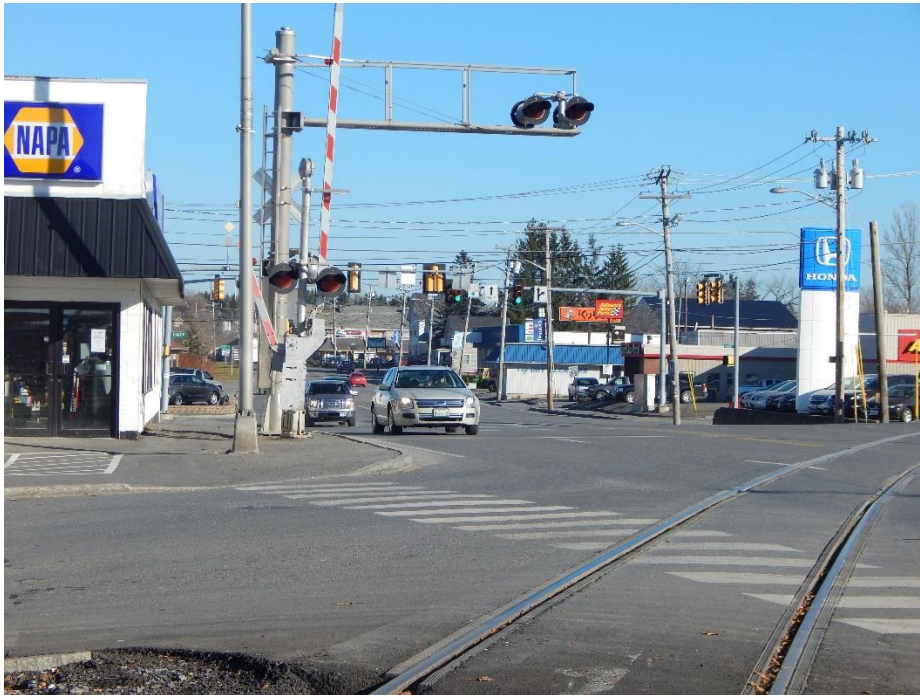
Riverside Drive looking north on Main Street. Railroad Crossing signals could potentially block view.

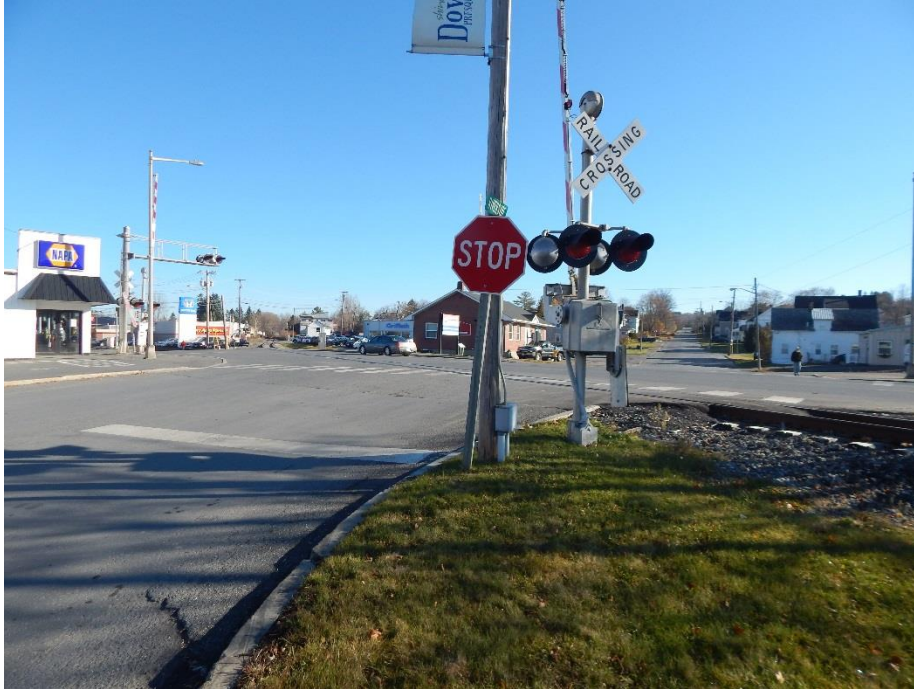
Riverside Drive Intersection. Rail Crossing at intersection could potentially create the need for vehicles to back into following vehicles.

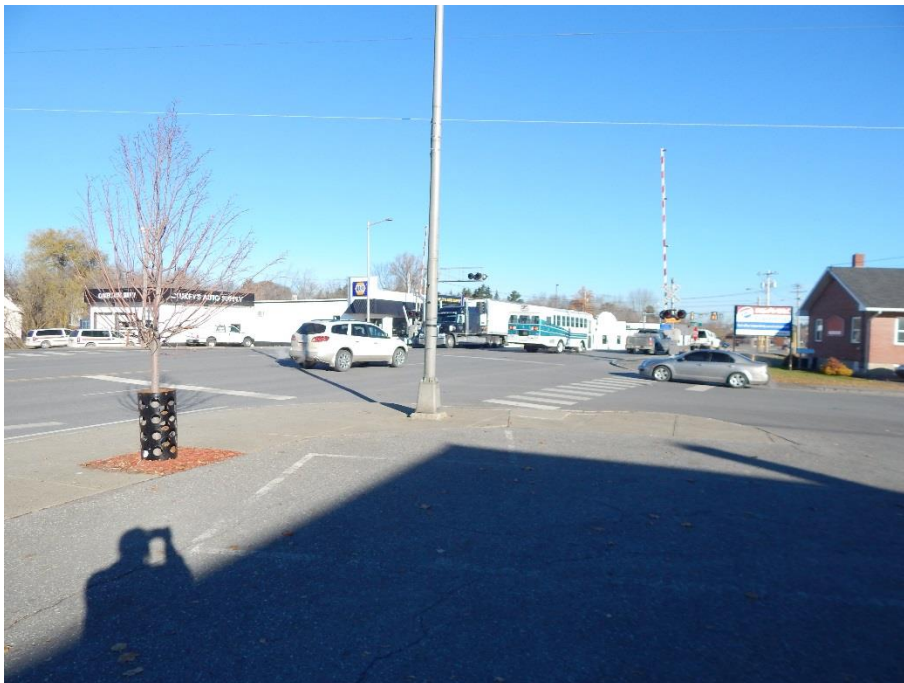
Blake Street and Main Street Intersection. Staff noticed that when the ARTS bus stopped at the crossing there appeared to be confusion from other drivers heading south.

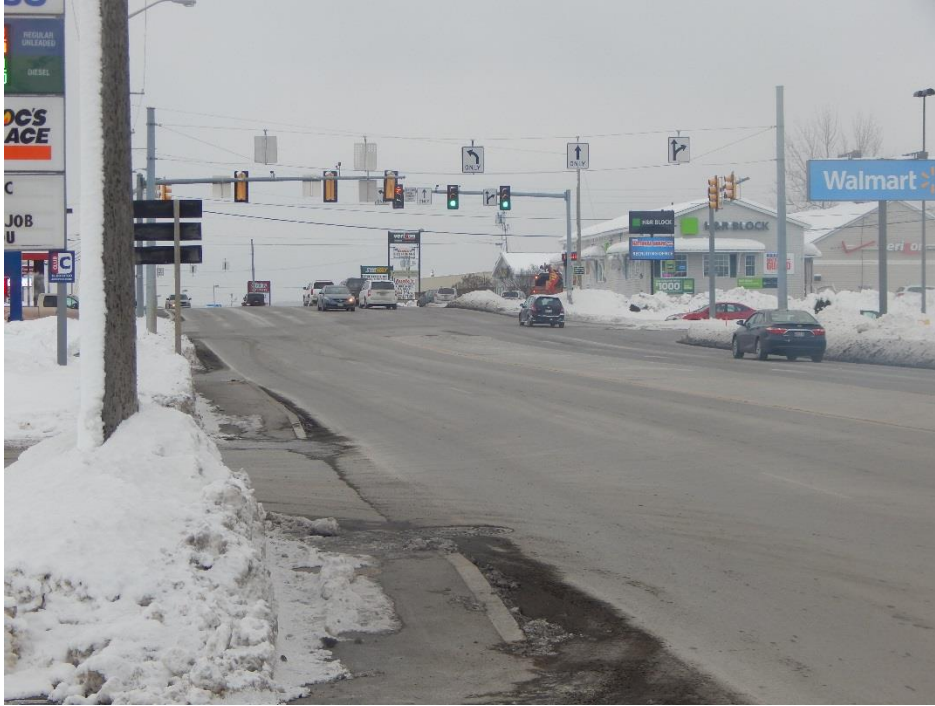
Intersection of County Federal Credit Union, Walmart, and Maine Street in Presque Isle, looking southbound. While lanes are normally well marked, notice lack of lane markings (December 2016).

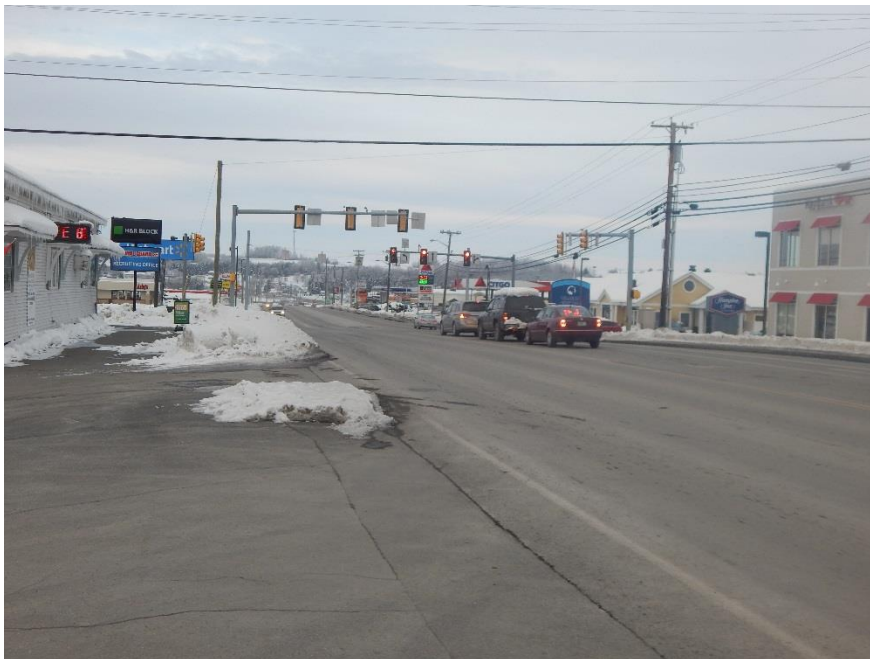
Intersection of County Federal Credit Union, Walmart, and Main Street in Presque Isle looking northbound. Several accesses located near intersection.

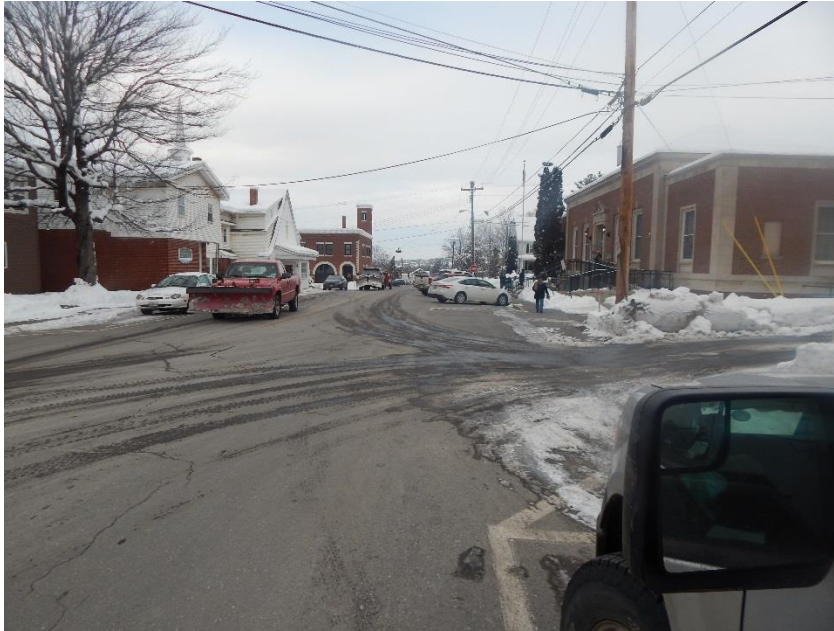
Intersection of Church and Second Street in Presque Isle looking north towards the US Post Office. Notice vehicles perpendicular parked and pedestrians.

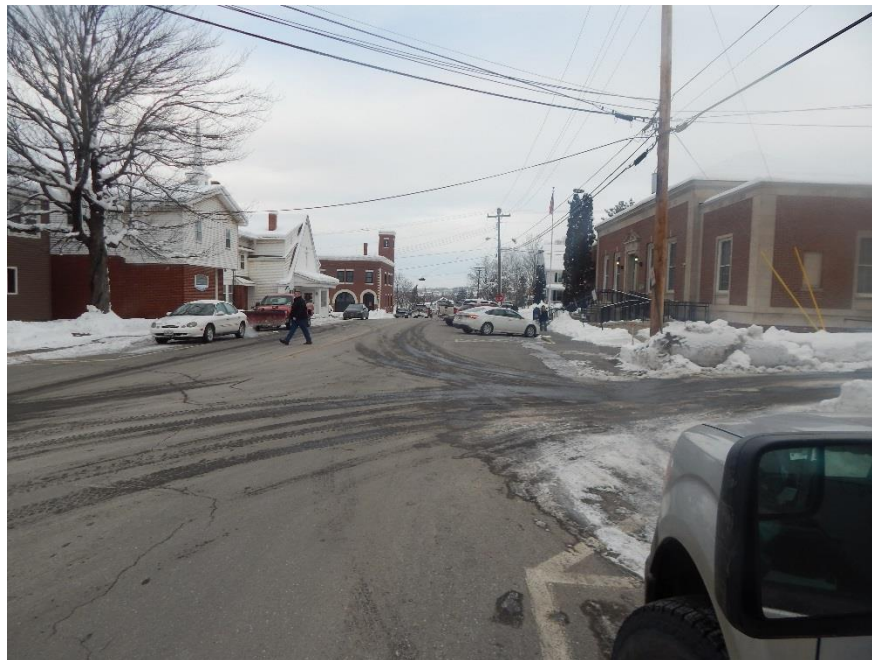
Intersection of Church and Second Street in Presque Isle looking towards the US Post Office. Notice pedestrian crossing mid-block.

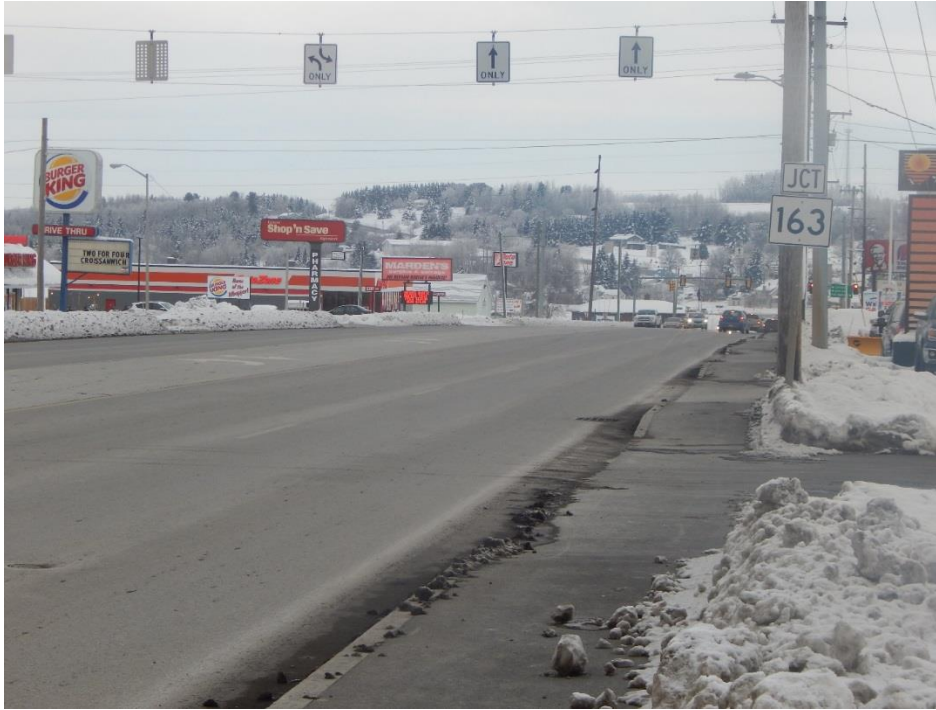
Main Street in Presque Isle looking south. Notice number of accesses.

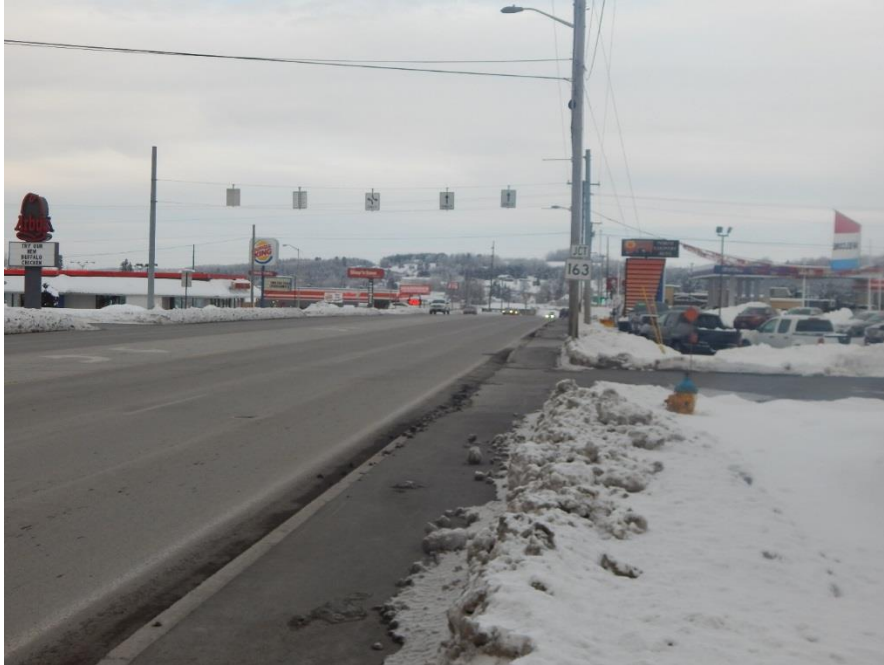
Main Street looking north. Consider reducing number of accesses.

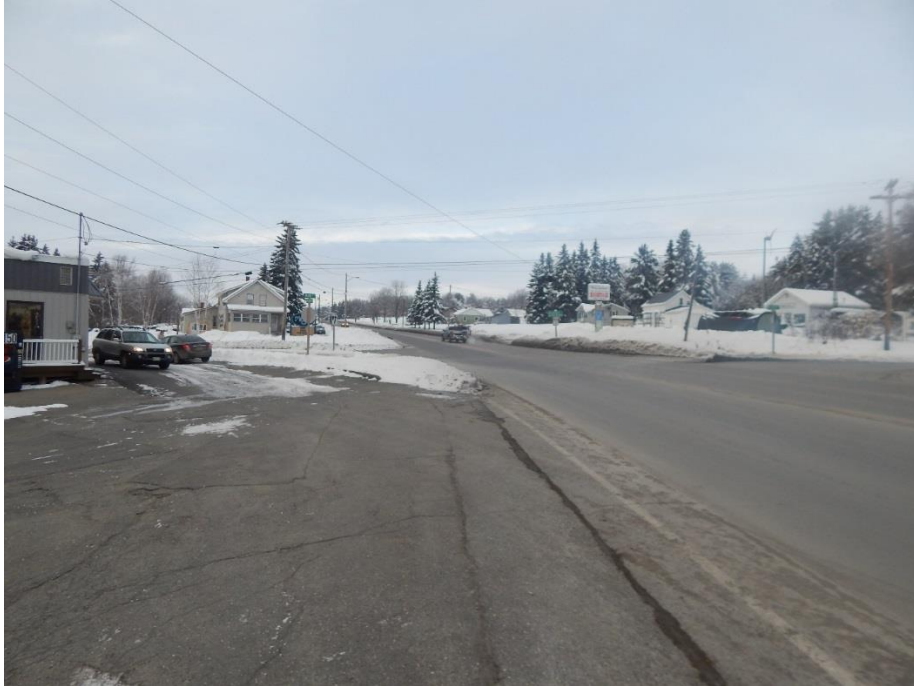
US Route One looking north.

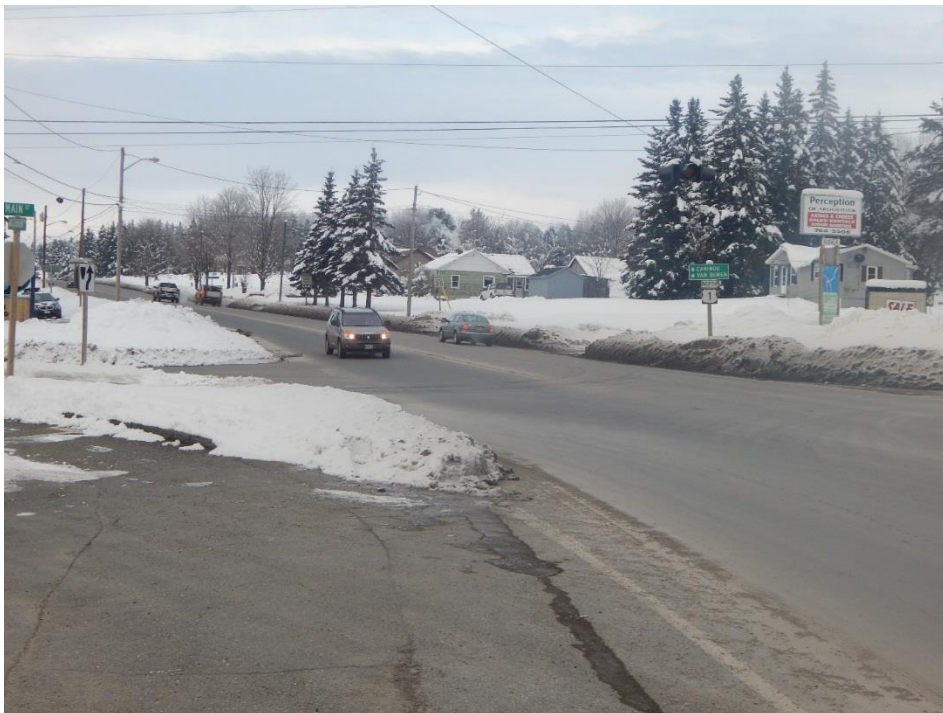
US Route One looking north

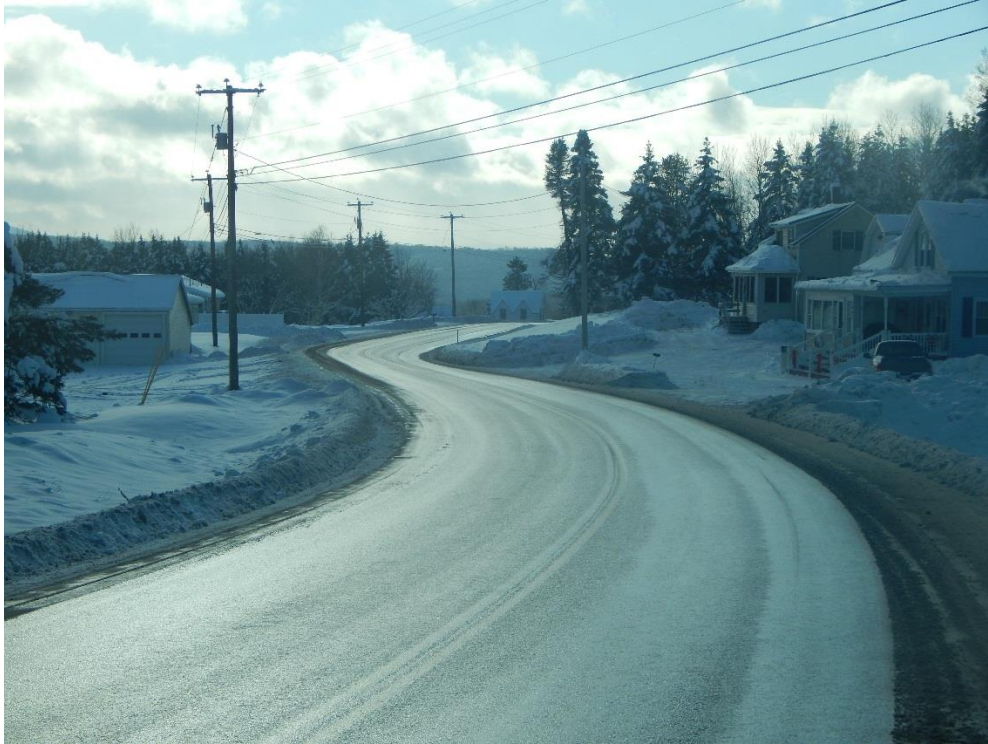
Aroostook Road southbound. Notice residences with two and wide driveways located on curves.

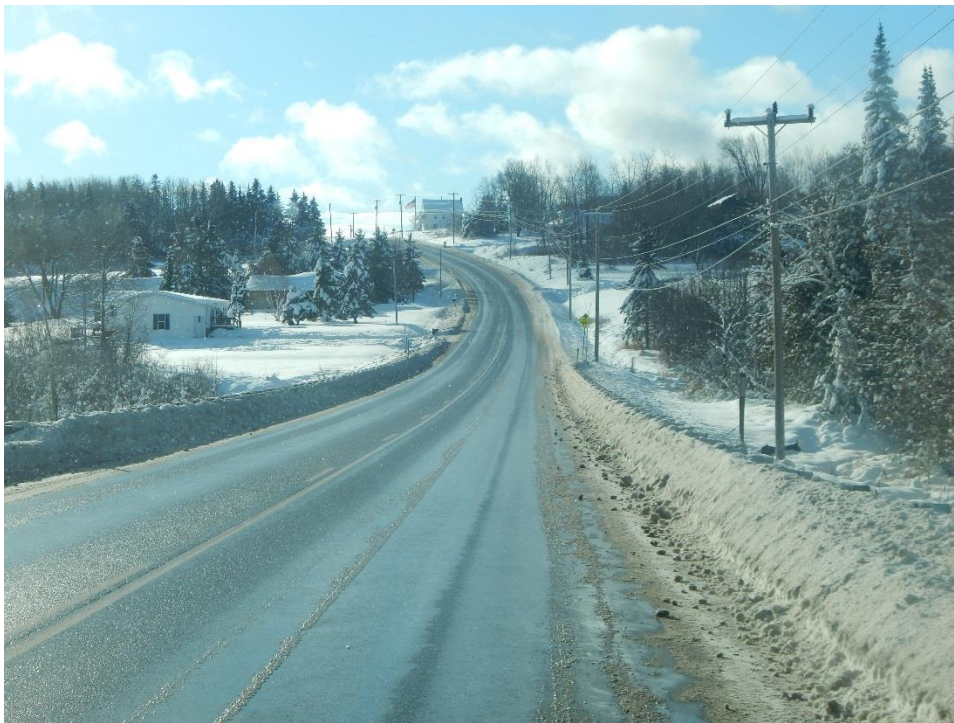
Aroostook Road, southbound. Notice steep hill and curves.

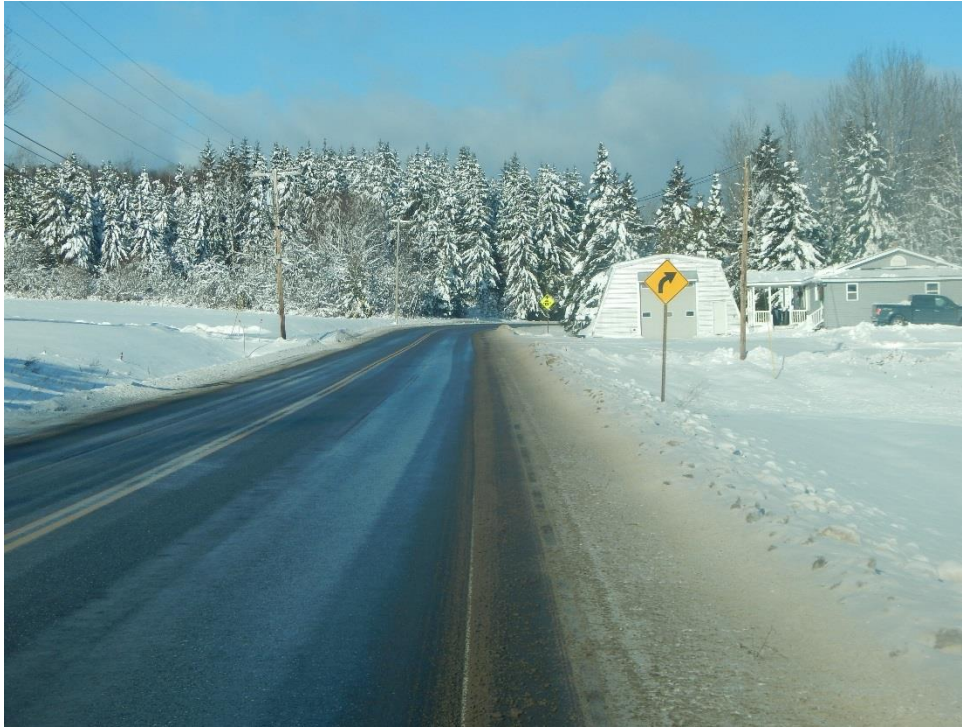
Aroostook Road northbound. Notice driveway on sharp corner. Notice sharp curve and school bus stop sign.

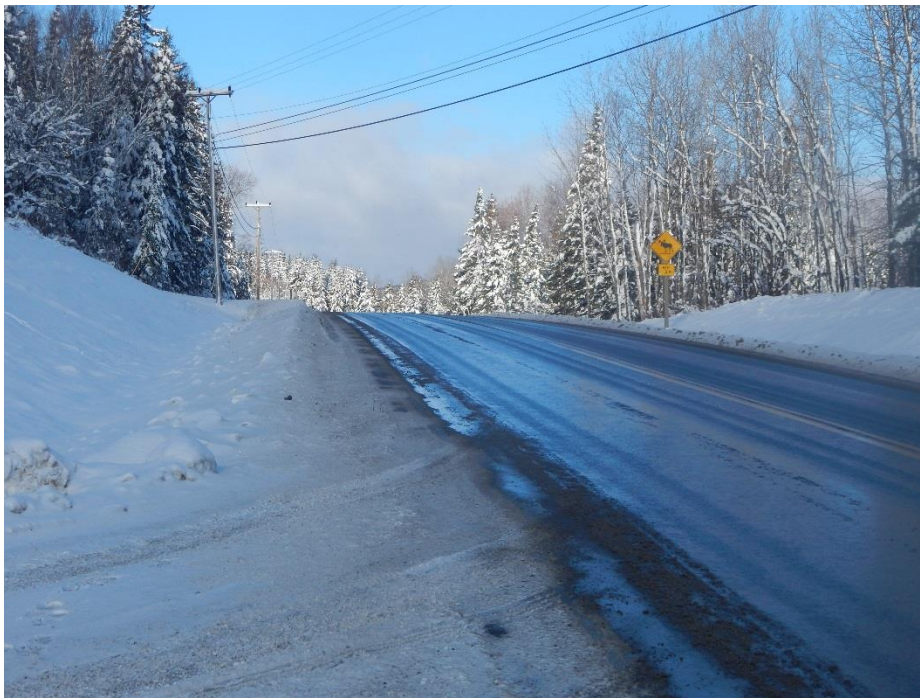
Aroostook Road, northbound. Moose crossing at crest of hill. Notice crossing in left center of photograph.
